## CONDITION REPORT

Report No:  
2016957348  
DATE  
24/07/2025

| Manufacturer | VOLKSWAGEN | Registration Number | KZM034NW |
| Model | GOLF 7 1.0 TSI TRENDLINE BLUEMOTION<br>81KW 5-DR [2017-2019] | Register Number | |

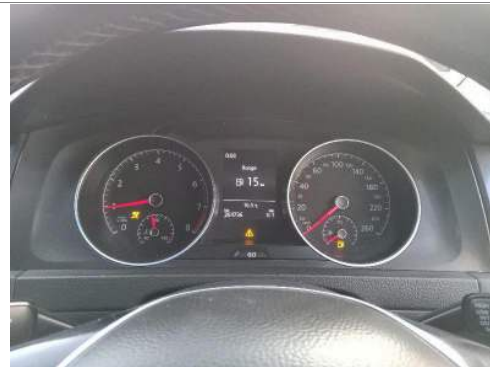
DASHBOARD (W/ ENGINE RUNNING)

| Damage | Repair Way |
|---|---|
| Warning lights illuminated on dashboard | Repair |

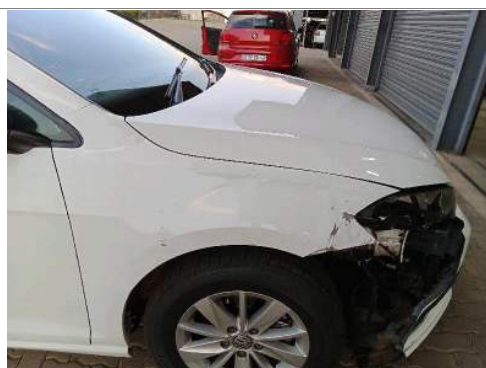
| Damage | Repair Way |
|---|---|
| Front Fender Right Damaged | Repair |

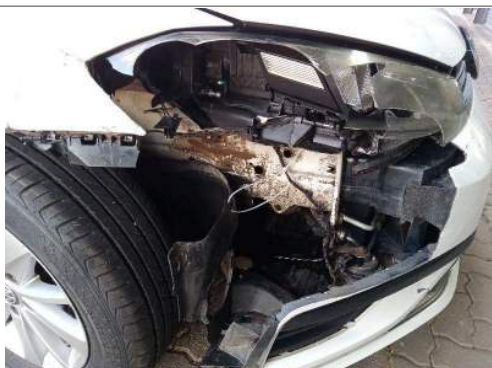
| Damage | Repair Way |
|---|---|
| Front Fender Right / Inner Tray Damaged | Replace |

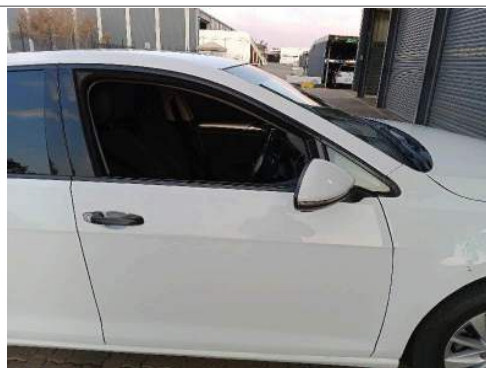
| Damage | Repair Way |
|---|---|
| Door Front Right Residual Traces of Repair | Repair |

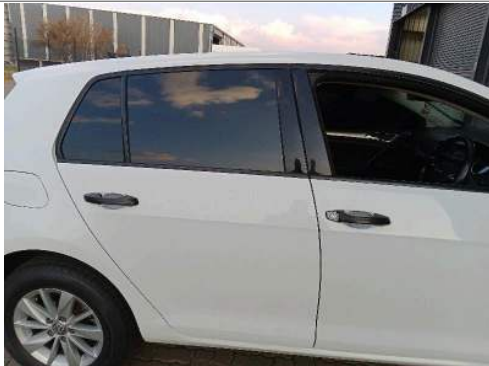
| Damage | Repair Way |
|---|---|
| Door Rear Right Residual Traces of Repair | Repair |

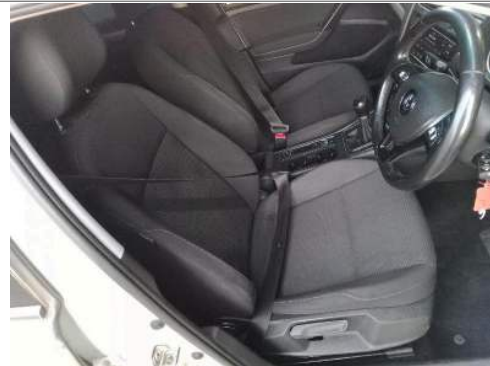
| Damage | Repair Way |
|---|---|
| Seat Front Right Damaged | Repair |

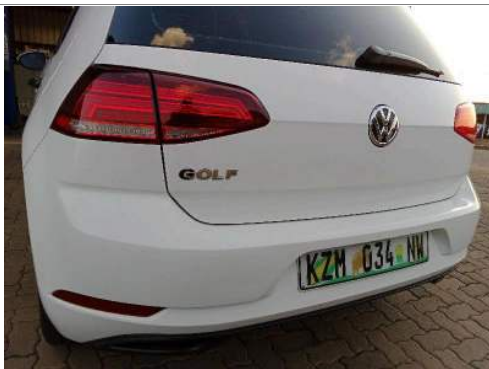
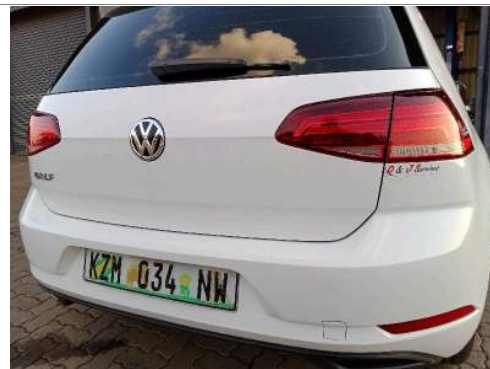
| Damage | Repair Way |
|---|---|
| Rear bumper Residual Traces of Repair | Repair |

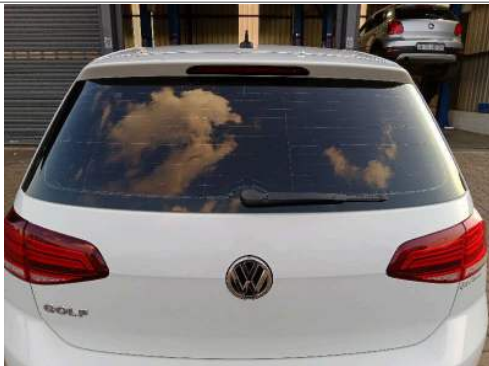
| Damage | Repair Way |
|---|---|
| Boot Lid / Hatch door Dented | Repair |

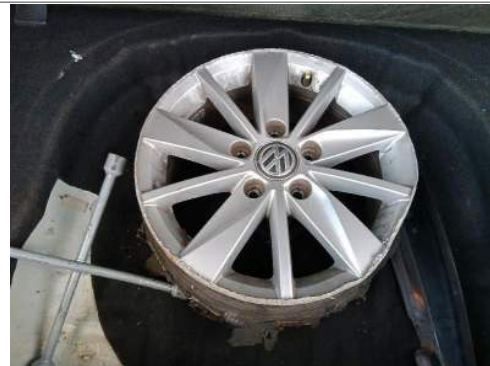
| Damage | Repair Way |
|---|---|
| Rim Spare Wheel Damaged | Replace |

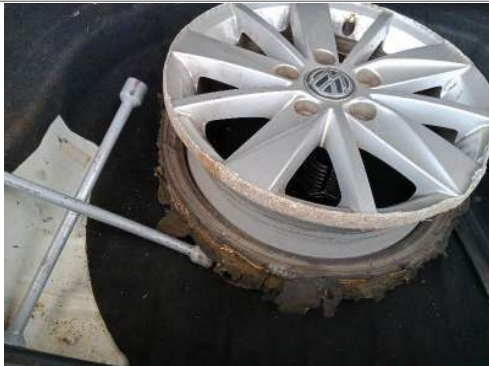
| Damage | Repair Way |
|---|---|
| Spare Tyre Damaged | Replace |

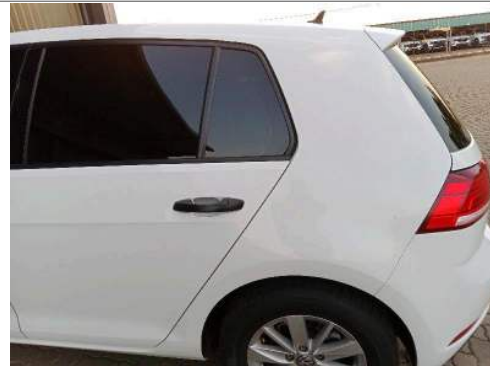
| Damage | Repair Way |
|---|---|
| Rear Fender Left Dented | Repair |

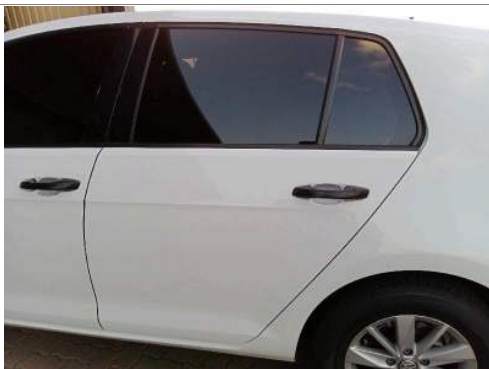
| Damage | Repair Way |
|---|---|
| Door Rear Left Residual Traces of Repair | Repair |

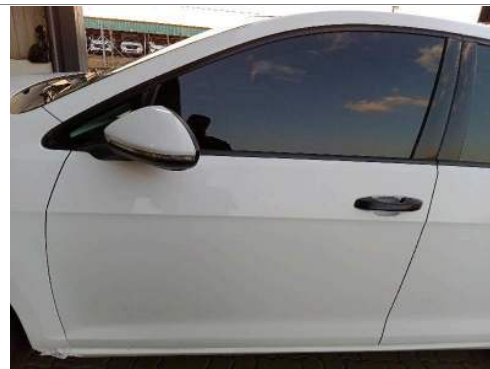
| Damage | Repair Way |
|---|---|
| Door Front Left Residual Traces of Repair | Repair |

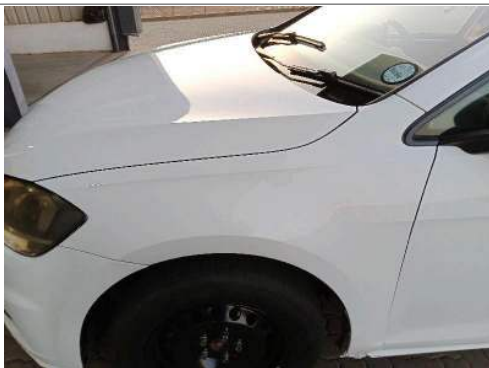
| Damage | Repair Way |
|---|---|
| Front Fender Left Paintwork • Scratched | Repair |

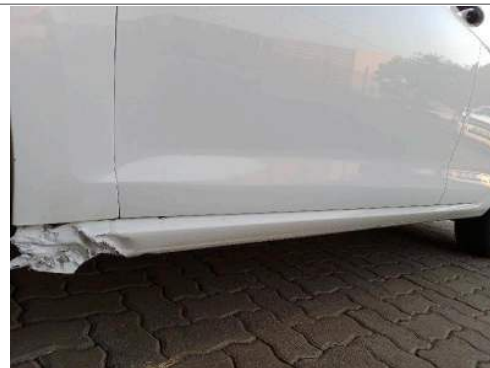
| Damage | Repair Way |
|---|---|
| Sill Panel Left Damaged | Repair |

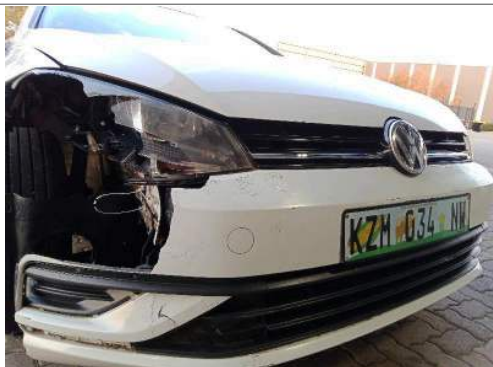
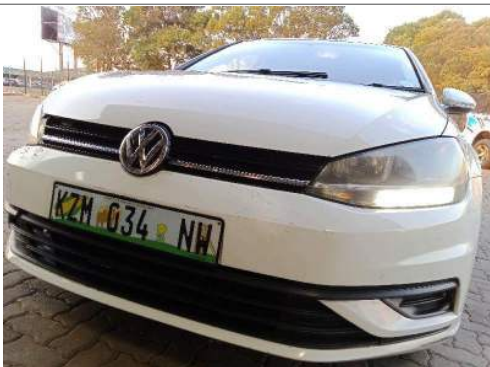
| Damage | Repair Way |
|---|---|
| Front Bumper Damaged | Replace |

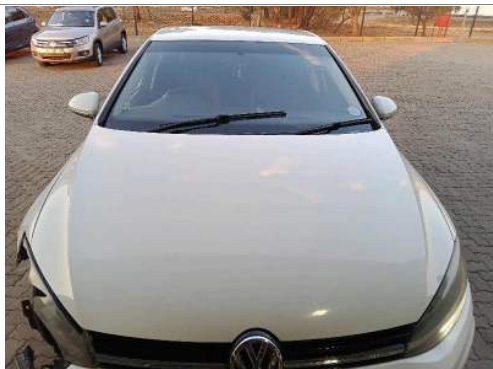
| Damage | Repair Way |
|---|---|
| Bonnet Residual Traces of Repair | Repair |

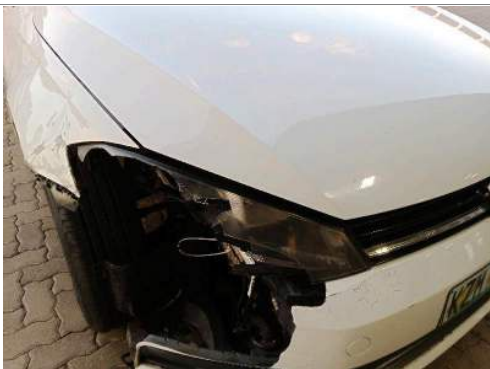
| Damage | Repair Way |
|---|---|
| Headlight Right Damaged | Replace |

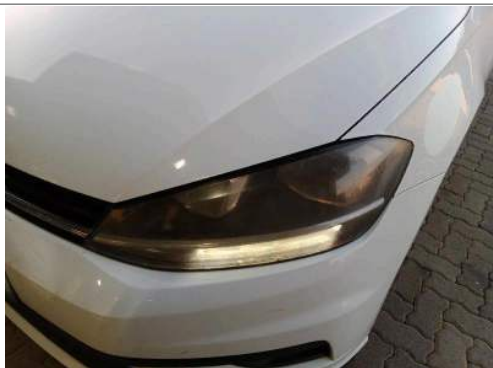
| Damage | Repair Way |
|---|---|
| Headlight Left Defective | Repair |

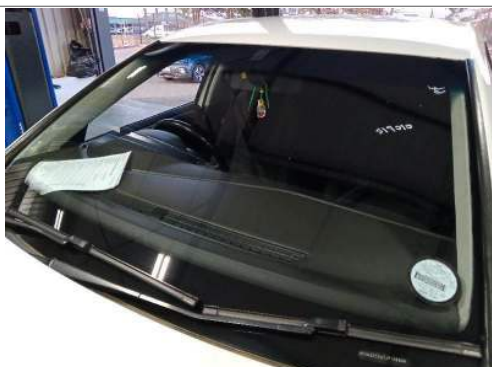
| Damage | Repair Way |
|---|---|
| Windscreen Chipped | Repair |

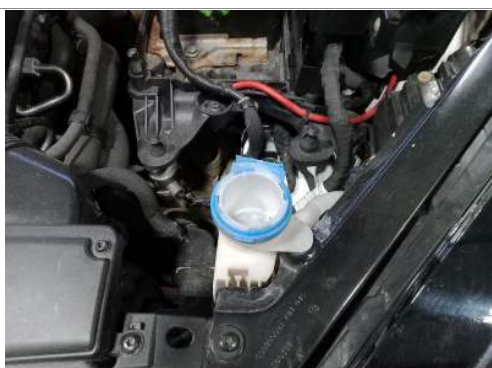
| Damage | Repair Way |
|---|---|
| Caps Missing | Replace |

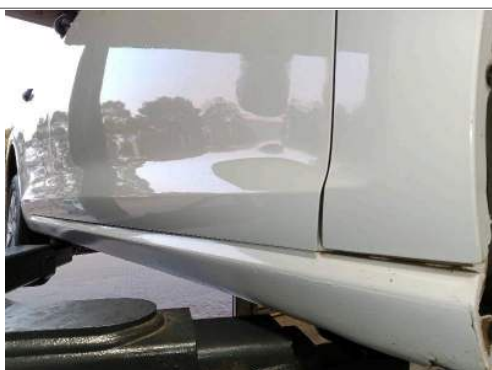
| Damage | Repair Way |
|---|---|
| Sill Panel Right Damaged | Repair |

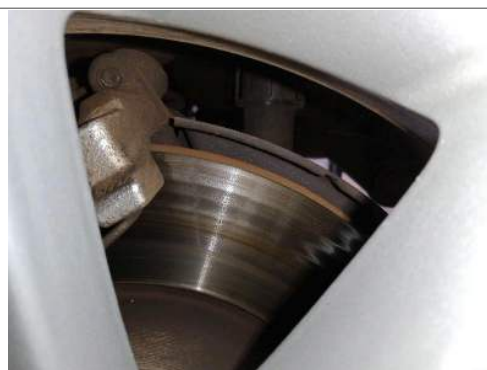
| Damage | Repair Way |
|---|---|
| Wheel Cylinder / Caliper 2. Axle left Defective | Replace |

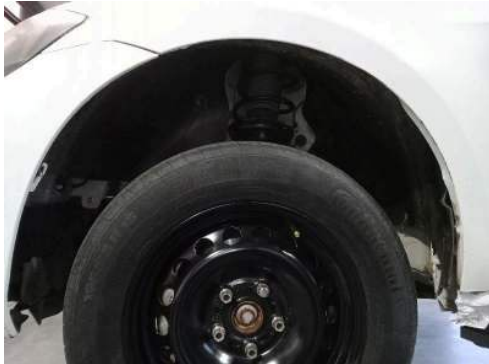
| Damage | Repair Way |
|---|---|
| Front Fender Left / Inner Tray Damaged | Replace |

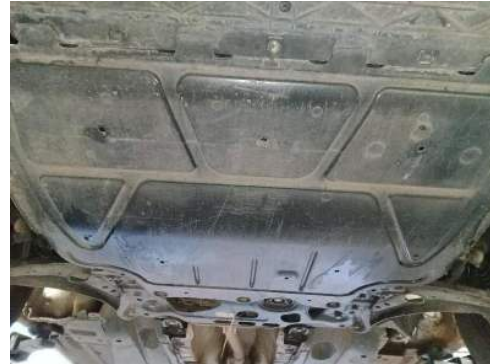
| Damage | Repair Way |
|---|---|
| Engine Oil Leak | Repair |
| Undercarriage | Excessive oil leak on engine splash plate |
| Undercarriage | Bottom of engine and gearbox fully covered |
| Undercarriage | Cannot pin direction of oil leak |

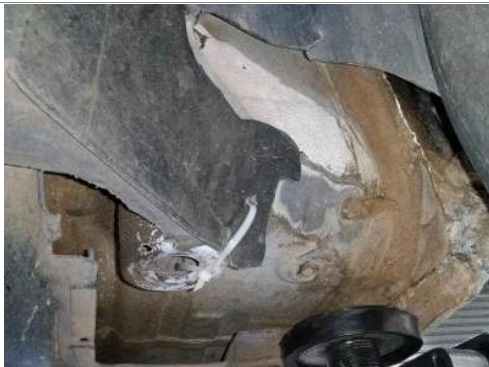
| Damage | Repair Way |
|---|---|
| Chassis Dented | Repair |

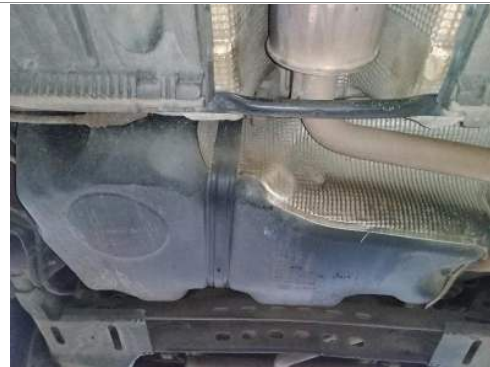
| Damage | Repair Way |
|---|---|
| Fuel Tank Defective | Repair |
