CONDITION REPORT

Report No:
2016943873
DATE
11/07/2025

Vehicle Type	PASSENGER VEHICLE	Registered Owner	
Manufacturer	VOLVO	Registration Number	KW08TYGP
Model	S60 T4 2.0 MOMENTUM GEARTRONIC [2015-2016]	Register Number	
		Date Of First Licensing	
VIN	YV1FS41C0G2400123	Last COR	
Engine Number		License Expiry Date	31/03/2026
Doors	4	Power / Displacement	
Color	SILVER	Paint Finish	TWO COAT UNI
Year Model	2015	Fuel	PETROL
Km Reading	167,700 KM	Transmission	AUTOMATIC
Cab / Body Type	SEDAN

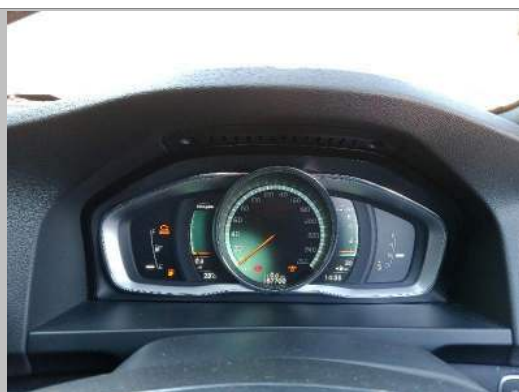
DASHBOARD (W/ ENGINE RUNNING)

Tyre Front Right Damaged	Replace
Tyre Rear Left Damaged	Replace
Rim Front Left Scratched	Repair
Rim Front Right Scratched	Repair
Rim Rear Left Scratched	Repair
Rim Rear Right Scratched	Repair
Sub Frame Dented	Repair
Engine Noise Excessive	Repair
Warning lights illuminated on dashboard	Repair
Engine	Signs rodent in engine bay
Body and Exterior	Residual traces of repair on some body panels
Body and Exterior	Stone chips and spray work on some body panels
Body and Exterior	Dents and scratches on some body panels
Interior/ Gear knob cracked	Replace
Engine bay dirty.	Clean
Engine splash plate missing	Replace
Parking brake switch faulty	Repair
Oil level could not be checked	Repair
Spare wheel missing.	Replace

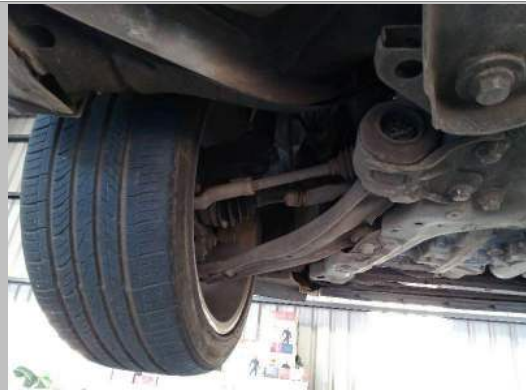
LF TYRE TREAD

Size	Load/Speed Index	Manufacture	Model	Type*	Production Date	Tread Depth (mm)
Front Left	P235/40Z R18	95W	Nexen	Nfera	V	0923	4 mm
Front Right	P235/40Z R18	95W	Nexen	Nfera	V	0923	4 mm
Rear Left	235/40Z R18	95W	Roadshine	RS922	V	3422	0 mm
Rear Right	235/40Z R18	95W	Nexen	Nfera	V	1523	1 mm

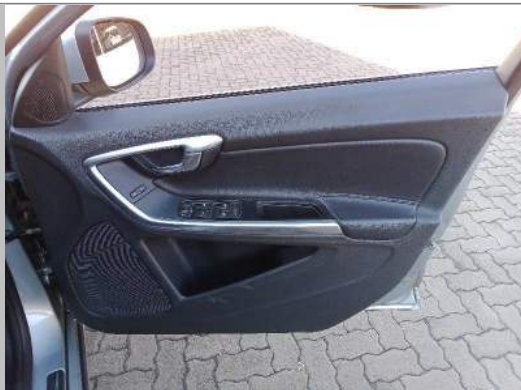
Damage	Repair Way
Hoses Oil Sweat	Repair
Air Conditioner Insufficient	Replace
Indicator Light Front Left Damaged	Replace
Headlight Left Damaged	Replace
Door Panel Front Right Defective	Repair
Door Panel Rear Right Damaged	Repair
Side Mirror Left Damaged	Replace
Side Mirror Right Paintwork • Scratched	Repair
Front Bumper Damaged	Repair
Bonnet Paintwork • Scratched	Repair
Front Fender Left Paintwork • Scratched	Repair
Front Fender Right Residual Traces of Repair	Repair
Rear Fender Left Damaged	Repair
Rear Fender Right Damaged	Repair
Door Front Left Damaged	Repair
Door Front Right Paintwork • Scratched	Repair
Door Rear Left Paintwork • Scratched	Repair
Door Rear Right Paintwork • Scratched	Repair
Boot Lid / Hatch door Paintwork • Scratched	Repair
Rear bumper Paintwork • Scratched	Repair
Sill Panel Left Dented	Repair
Parking Brake Performance Left / Right Difference out of legal range	Repair
Tyre Front Left Damaged	Replace
