## CONDITION REPORT

Report No:  
2017303120  
DATE  
25/09/2026

| Manufacturer | VOLVO | Registration Number | KW53KXGP |
| Model | S60 T5 2.0 R-DESIGN [2012-2013] | Register Number | |

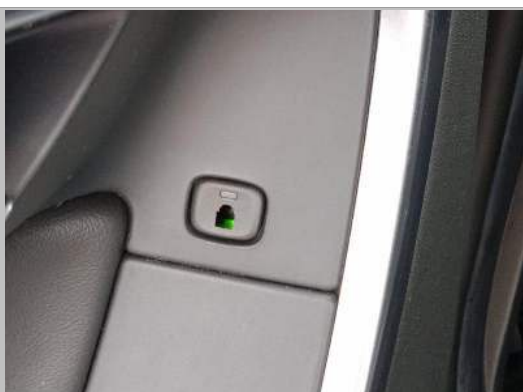
| Damage | Repair Way |
|---|---|
| Rear left door lock switch damaged | Replace |

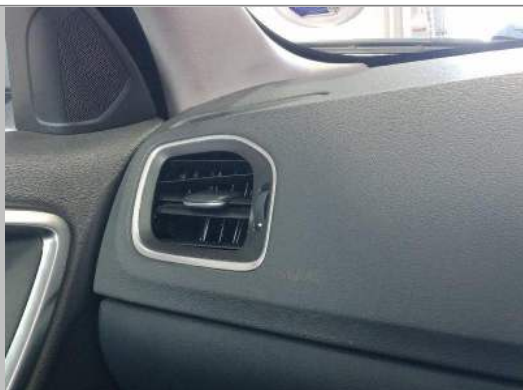
| Damage | Repair Way |
|---|---|
| Central Air Vent Damaged | Replace |

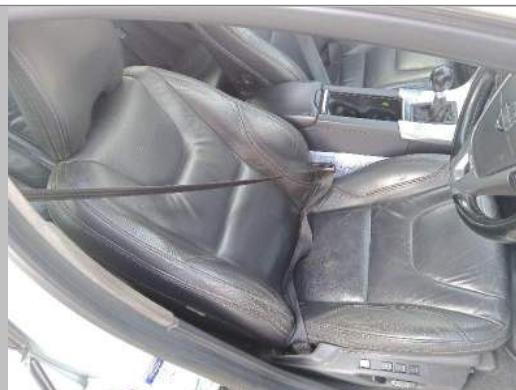
| Damage | Repair Way |
|---|---|
| Seat Front Right Excessive Wear & Tear | Repair |

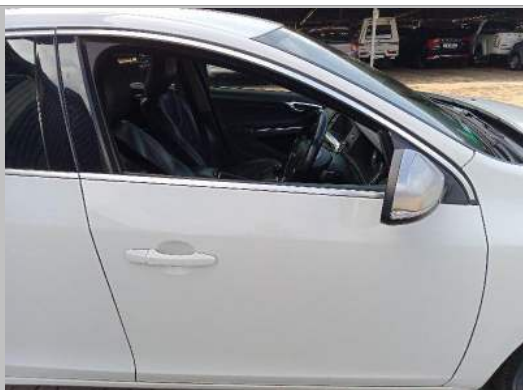
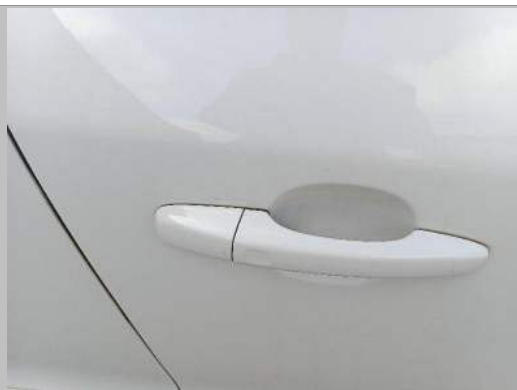
| Damage | Repair Way |
|---|---|
| Door Front Right Paintwork • Scratched | Repair |

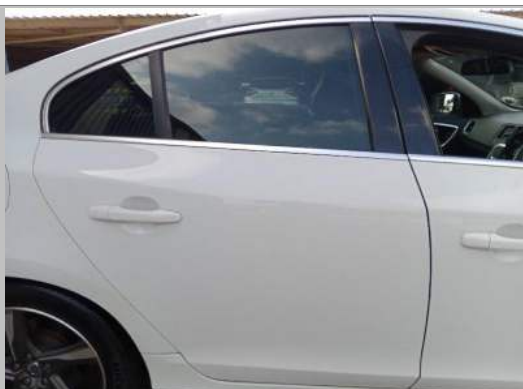
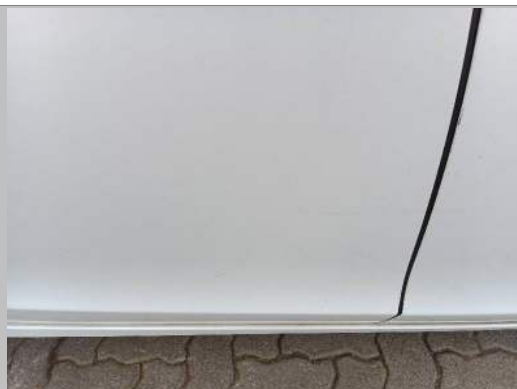
| Damage | Repair Way |
|---|---|
| Door Rear Right Paintwork • Scratched | Repair |

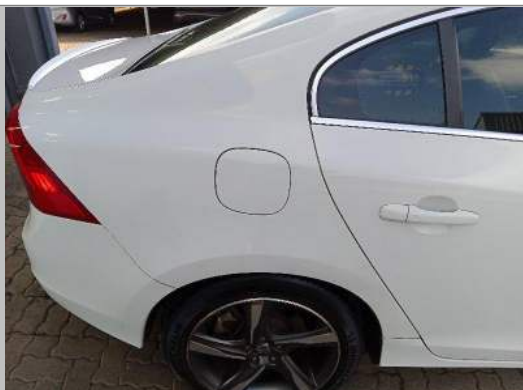
| Damage | Repair Way |
|---|---|
| Rear Fender Right Residual Traces of Repair | Repair |

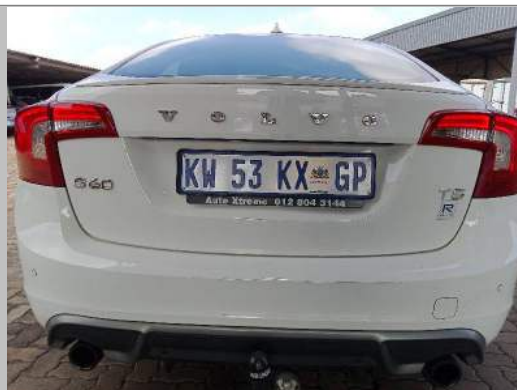
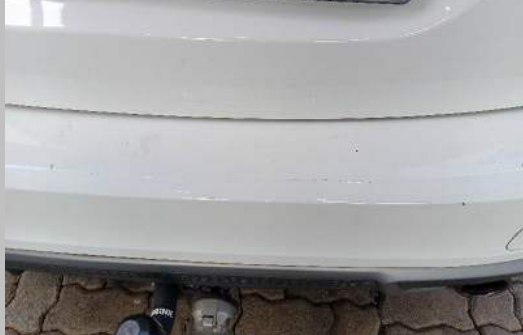
| Damage | Repair Way |
|---|---|
| Rear bumper Paintwork • Scratched | Repair |

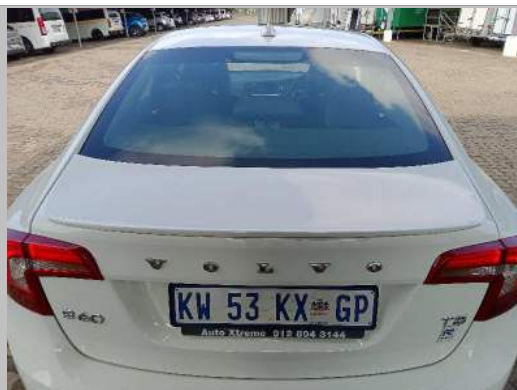
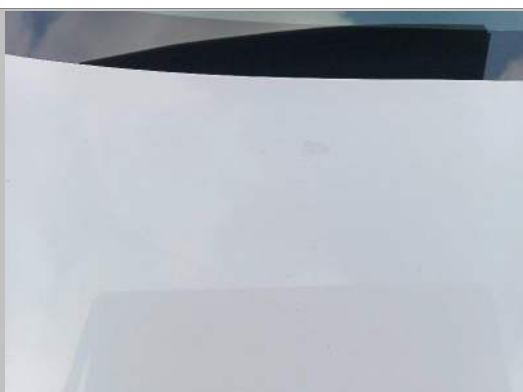
| Damage | Repair Way |
|---|---|
| Boot Lid / Hatch door Paintwork • Scratched | Repair |

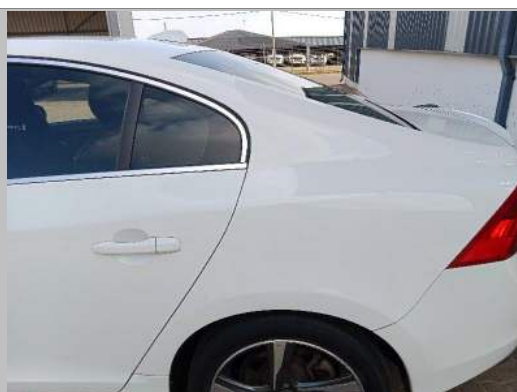
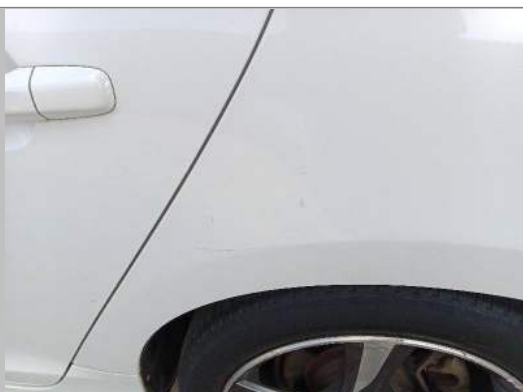
| Damage | Repair Way |
|---|---|
| Rear Fender Left Paintwork • Scratched | Repair |

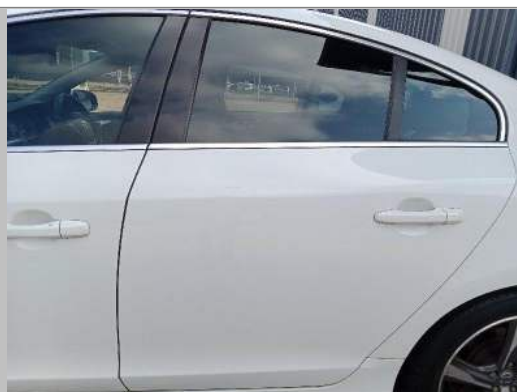
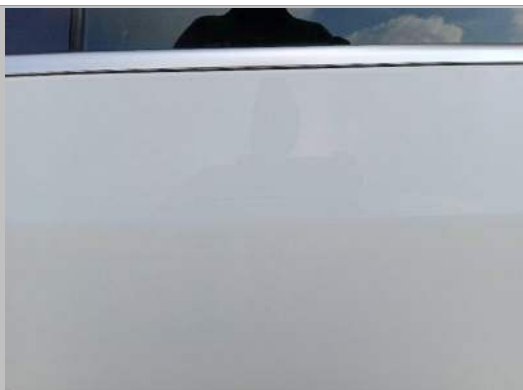
| Damage | Repair Way |
|---|---|
| Door Rear Left Paintwork • Scratched | Repair |

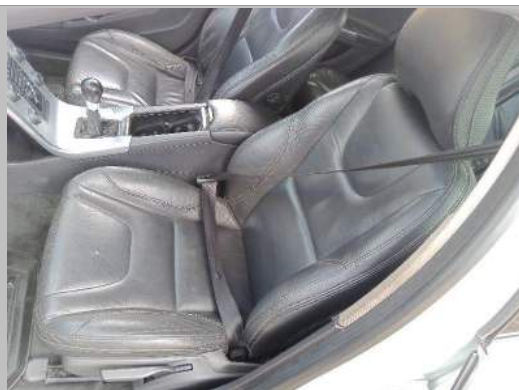
| Damage | Repair Way |
|---|---|
| Seat Front Left Excessive Wear & Tear | Repair |

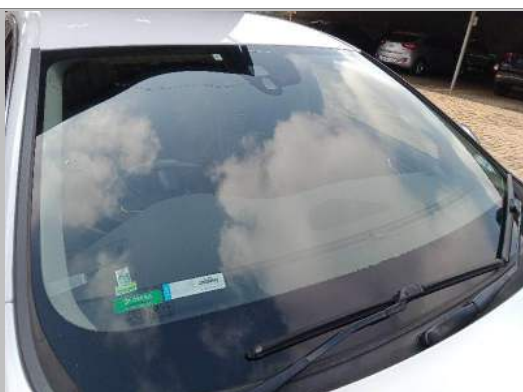
| Damage | Repair Way |
|---|---|
| Windscreen Cracked | Replace |

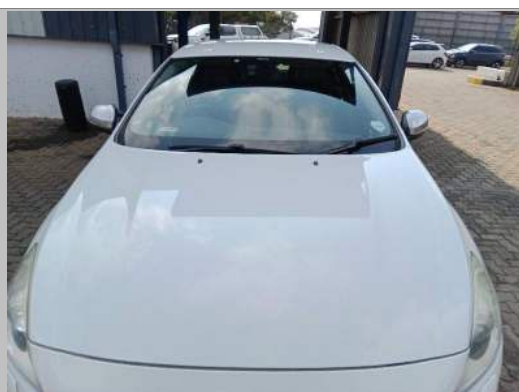
| Damage | Repair Way |
|---|---|
| Bonnet Dented | Repair |

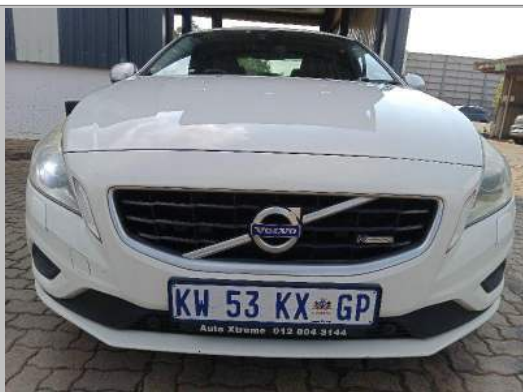
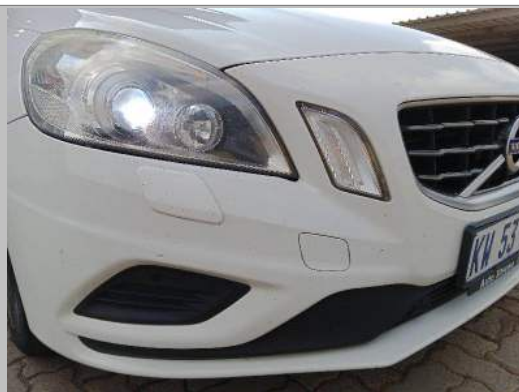
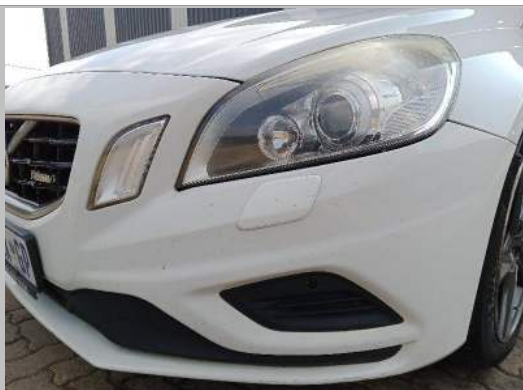
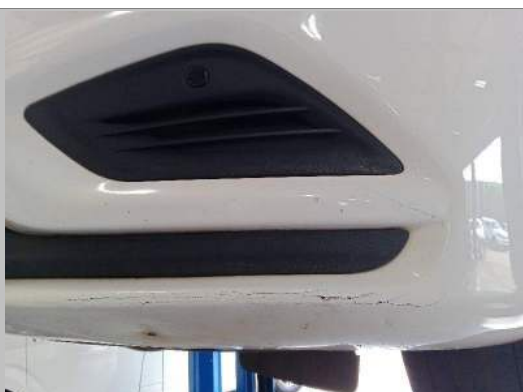
| Damage | Repair Way |
|---|---|
| Front Bumper Damaged | Repair |

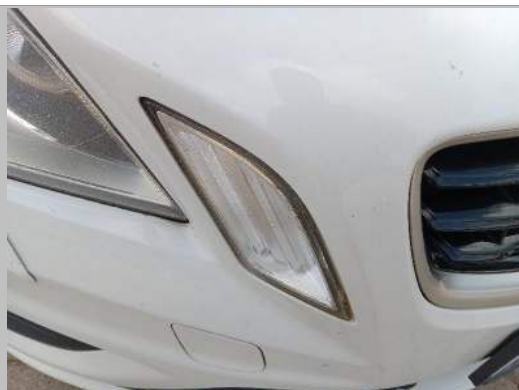
| Damage | Repair Way |
|---|---|
| Fog Light Front Right Cracked | Replace |

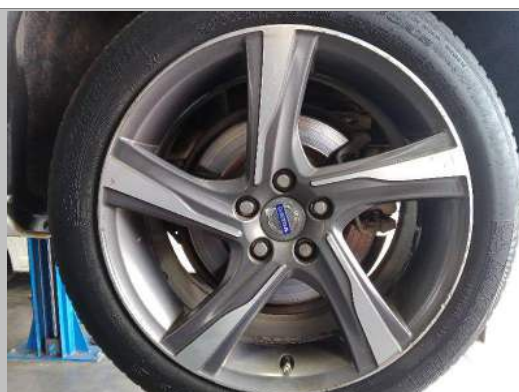
| Damage | Repair Way |
|---|---|
| Rim Rear Left Scratched | Repair |

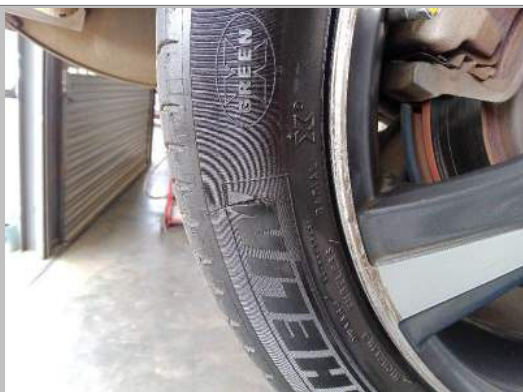
| Damage | Repair Way |
|---|---|
| Tyre Rear Right Torn / Cut | Replace |

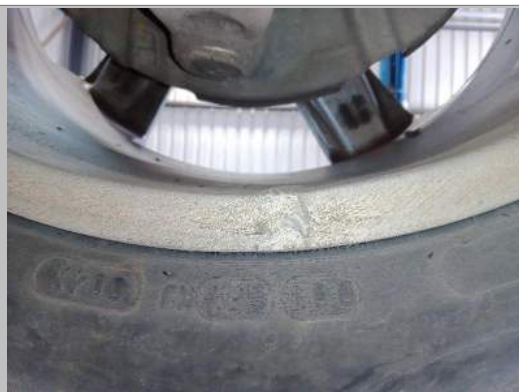
| Damage | Repair Way |
|---|---|
| Rim Front Right Welded | Repair |

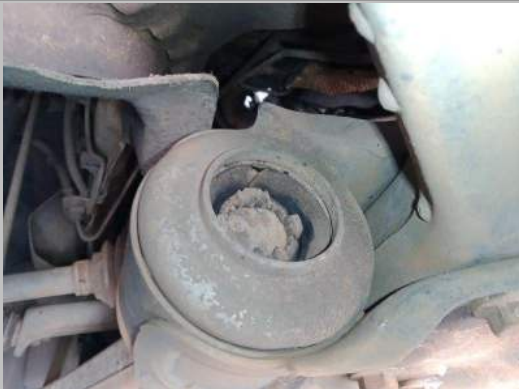
| Damage | Repair Way |
|---|---|
| Control Arm Bush(es) Front Axle Left Cracked | Replace |

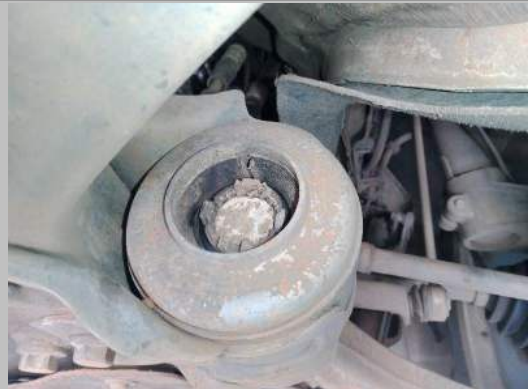
| Damage | Repair Way |
|---|---|
| Control Arm Bush(es) Front Axle Right Cracked | Replace |

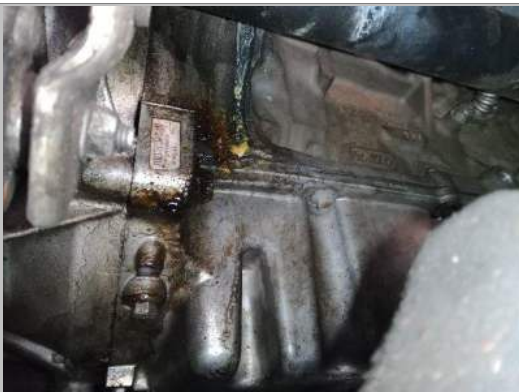
| Damage | Repair Way |
|---|---|
| Engine Oil Leak | Repair |

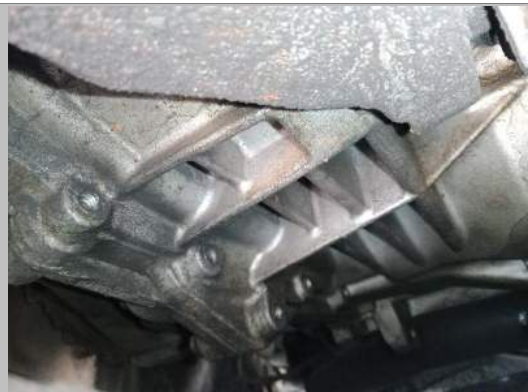
| Damage | Repair Way |
|---|---|
| Gearbox Oil Sweat | Repair |

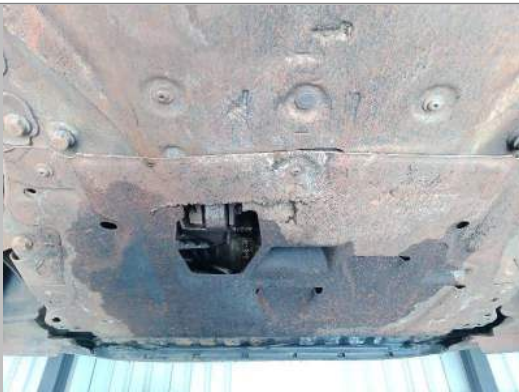
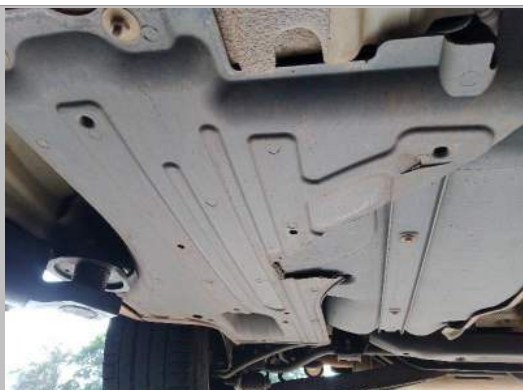
| Damage | Repair Way |
|---|---|
| Belly plates Damaged | Replace |

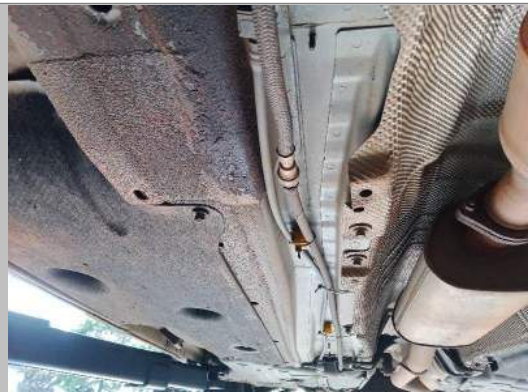
| Damage | Repair Way |
|---|---|
| Fuel Lines Defective | Repair |

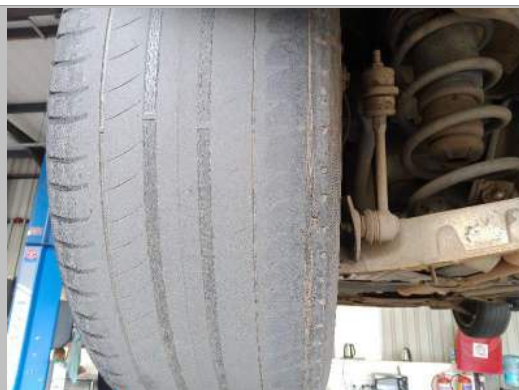
| Damage | Repair Way |
|---|---|
| Tyre Rear Left Damaged | Replace |

| | Size | Load/Speed Index | Manufacture | Model | Type* | Production Date | Tread Depth (mm) |
|---|---|---|---|---|---|---|---|
| Rear Left | 215/50 R18 | 92W | Michelin | Primacy 3 | V | 3916 | 0 mm |

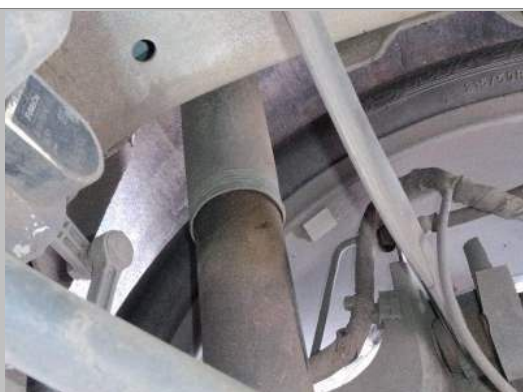
| Damage | Repair Way |
|---|---|
| Shock Absorber Rear Right Sweat | Replace |

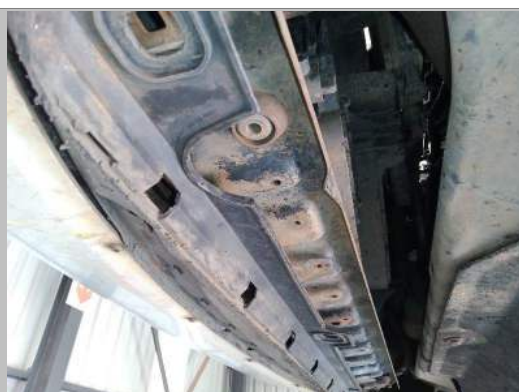
| Damage | Repair Way |
|---|---|
| Radiator Cradle Dented | Repair |

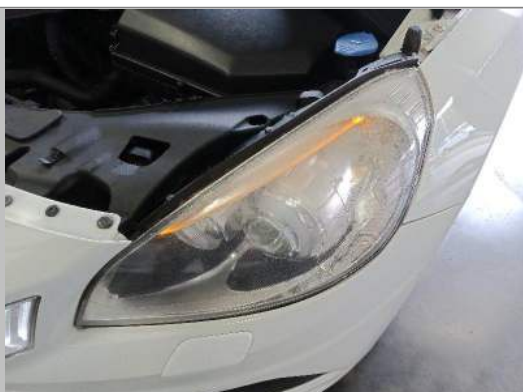
| Damage | Repair Way |
|---|---|
| Headlight Left Defective | Repair |

| No | System | Code | Description | Status |
|---|---|---|---|---|
| 1 | CEM(CENTRAL ELECTRONIC MODULE) | B103C04 | LEFT HEADLAMP CONTROL, GENERAL FAULT INFORMATION,S | |

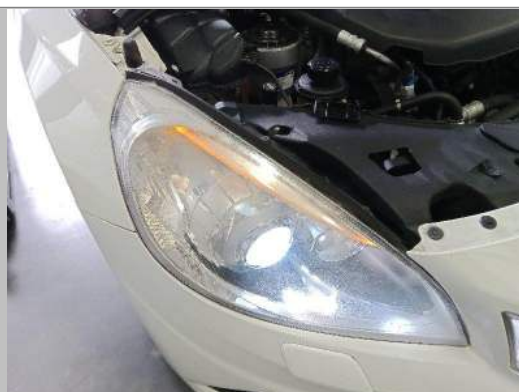
| Damage | Repair Way |
|---|---|
| Headlight Right Defective | Repair |
