CONDITION REPORT

Report No: 2016335407

MFC Auction House  
M57 Pretoria Rd, Glenmarais, KEMPTON PARK  
Gauteng

Vehicle Type	PASSENGER VEHICLE	Registered Owner	MFC AUCTION HOUSE
Manufacturer	JEEP	Registration Number	FP96TBGP
Model	GRAND CHEROKEE	Register Number	
VIN	1C4RJFGM0FC829321	Date Of First Licensing	
Engine Number		Last COR	
Doors	5	License Expiry Date	29/02/2024
Color	GREY	Power / Displacement	
Year Model		Paint Finish	M - METALLIC
Km Reading	209,968 KM	Fuel	DIESEL
Cab / Body Type	STATION WAGON	Transmission	AUTOMATIC

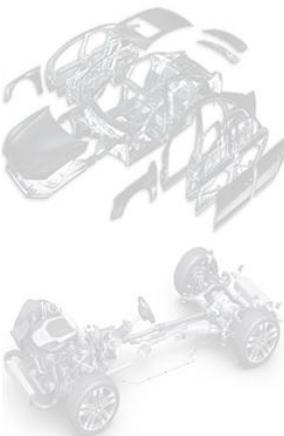
VEHICLE INSPECTION

Damage	Repair Way
Seat Belt Front Right Defective	Repair
Front Bumper Paintwork • Scratched	Repair
Front Fender Left Paintwork • Scratched	Repair
Door Front Left Paintwork • Scratched	Repair
Door Front Right Paintwork • Scratched	Repair
Door Rear Left Paintwork • Scratched	Repair
Rear bumper Paintwork • Scratched	Repair
Windscreen Cracked	Replace
Belly plates Damaged	Replace
Body exterior	Vehicle got minor scratches, stone chips and dents
Brakes	No brake test done vehicle is 4wd

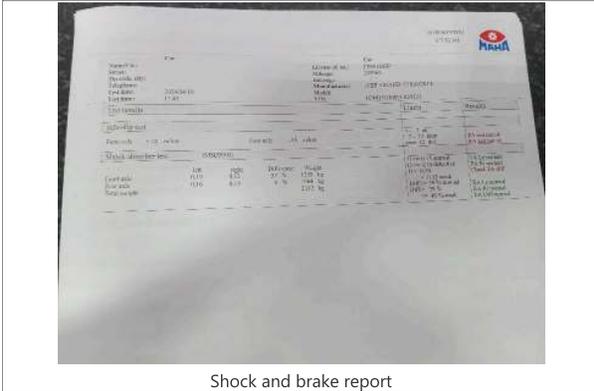
Shock and brake report

No Brake Test on a brake test machine has been performed.

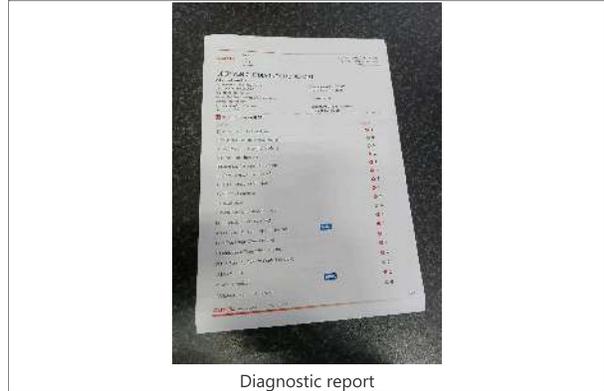
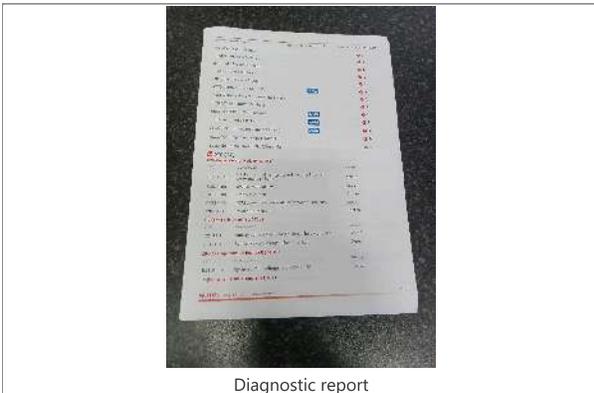
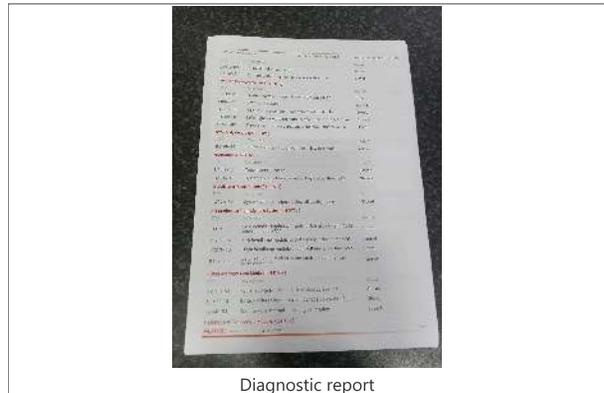
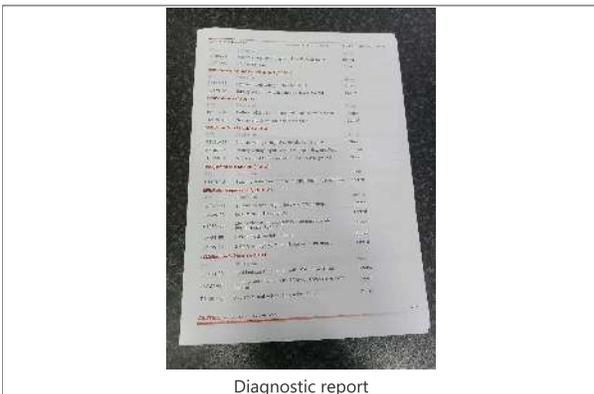
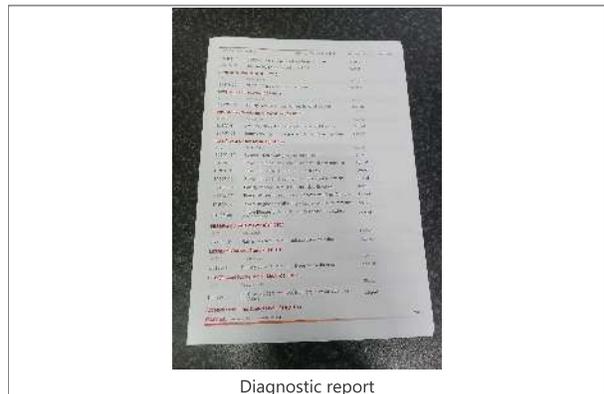
Diagnostic report

During the diagnostic the following error messages were detected: (See also attached Diagnostic Report. For more information regarding the Fault Codes (DTC) and the recommended rectifications please contact the workshops of the vehicle manufacture).

No	System	Code	Description	Status
1	EDM (EXTERNAL DISC MODULE) (1 DTC)	B1423-00	VES DVD READ ERROR/ INOPERABLE DISC	ACTIVE

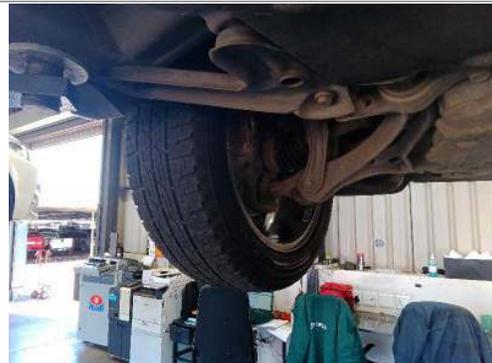
LF TYRE TREAD

Size	Load/Speed Index	Manufacture	Model	Type*	Production Date	Tread Depth (mm)
Front Left	255/50R20	109Y	Pirelli	Scorpion	V	3323	6 mm
Front Right	255/50R20	109Y	Michelin	Latitude	V	3613	2 mm
Rear Left	255/50R20	109Y	Continental	Contact	V	4121	4 mm
Rear Right	255/50R20	109Y	Continental	Contact	V	4121	4 mm
Spare	245/65R18	110H	Kumho	Solus	V	////	5 mm
