MFC Auction House
M57 Pretoria Rd, Glenmarais, KEMPTON PARK
Gauteng

DEKRA MFC
M57 Pretoria Rd - 1619
KEMPTON PARK - GT
08610 33572

VEHICLE INSPECTION

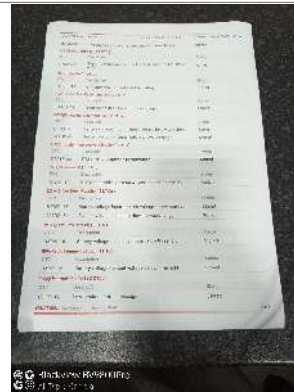
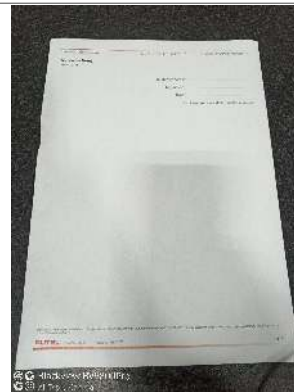
Diagnostic report

During the diagnostic no active error messages were detected. (See also attached Diagnostic Report. For more information regarding the Fault Codes (DTC) and the recommended rectifications please contact the workshops of the vehicle manufacture).

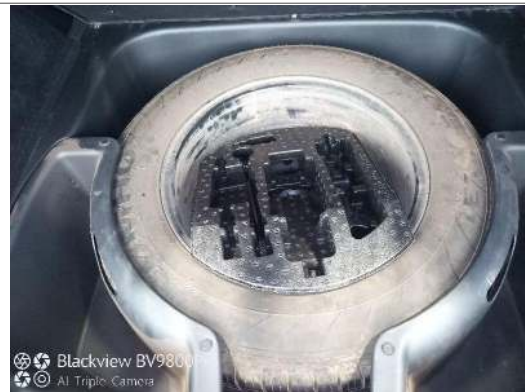
Spare wheel

Size	Load/Speed Index	Manufacture	Model	Type*	Production Date	Tread Depth (mm)
Front Left	265/50R20	107V	Kumho	Solus	V	2719	1 mm
Front Right	265/50R20	107V	Kumho	Solus	V	2719	3 mm
Rear Left	265/50R20	107V	Kumho	Solus	V	2515	2 mm
Rear Right	265/50R20	107V	Kumho	Solus	V	1819	3 mm
Spare	245/65R18	110H	Kumho	KI21	V	---	5 mm

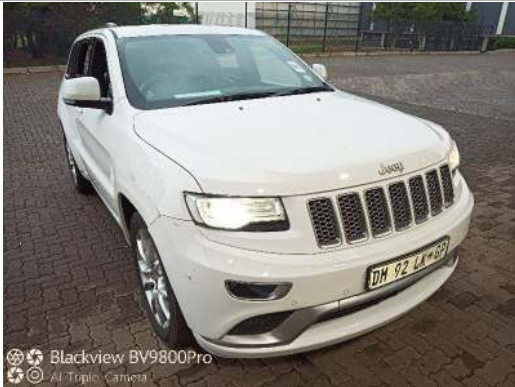
FRONT RIGHT CORNER

Damage	Repair Way
Engine Oil Leak	Repair
Fog Light Front Right Malfunction	Repair
Front Bumper Paintwork • Scratched	Repair
Front Fender Right Dented	Repair
Gearbox Oil Leak	Repair

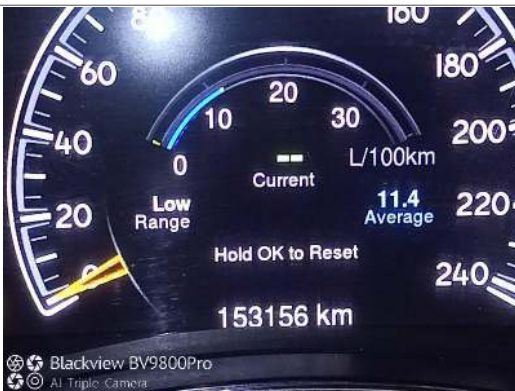
ODOMETER

Vehicle Type	PASSENGER VEHICLE	Registered Owner	MFC
Manufacturer	JEEP	Registration Number	DM92LKGP
Model	GRAND CHEROKEE	Register Number	
VIN	1C4RJFKGXFC721824	Date Of First Licensing	
Engine Number		Last COR	
Doors	5	License Expiry Date	31/10/2024
Color	WHITE	Power / Displacement	
Year Model		Paint Finish	C - COMMON
Km Reading	153,155 KM	Fuel	PETROL
Cab / Body Type	STATION WAGON	Transmission	AUTOMATIC
