## CONDITION REPORT

Report No:  
2017235744  
DATE  
13/05/2026

| Model | TUCSON 2.0 ELITE AT [2016-2018] | Register Number | |
| VIN | AAPV0202500705193 | Date Of First Licensing | |

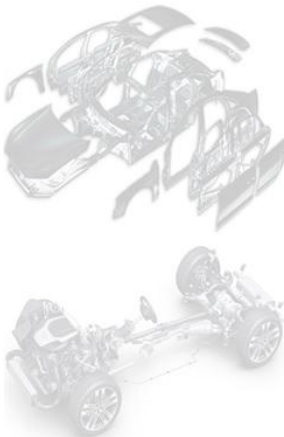
| | Damage | Repair Way |
|---|---|---|
| | Engine Oil Sweat<br>Seat Front Right Torn / Cut<br>Door Sealing Rubber Front Right Damaged<br>Front Fender Left Paintwork • Scratched<br>Rear Fender Left Dented<br>Door Rear Left Paintwork • Scratched<br>Boot Lid / Hatch door Residual Traces of Repair<br>Rear bumper Damaged<br>Inner Boot Floor Pan and Spare Wheel Well Damaged<br>Tyre Front Left Damaged<br>Tyre Front Right Worn<br>Engine Noise Excessive<br>Rear right door doesn't open | Repair<br>Repair<br>Replace<br>Repair<br>Repair<br>Repair<br>Repair<br>Repair<br>Replace<br>Replace<br>Replace<br>Repair<br>Repair |

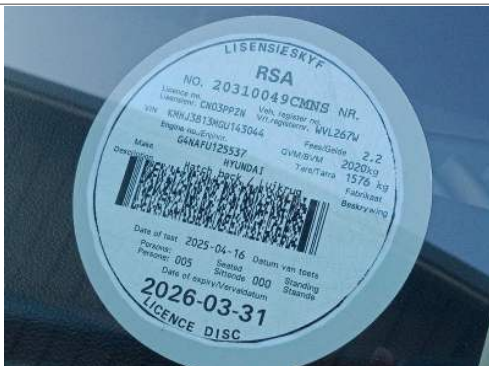
LICENSE DISC

General Comments: ACCORDING TO AGE AND MILEAGE OF VEHICLE NORMAL WEAR AND TEAR ON INTERIOR, EXTERIOR, ELECTRICAL AND MECHANICAL PARTS.AAPV0202500705193VIN NUMBER STAMPED ON VEHICLE.LICENCE DISK VIN DOES NOT MATCH AAPV VIN NUMBER.Body • Exterior: Residual traces of repair on some body panels.Stone chips and spray work on some body panels.Some body panels misaligned.Dents and scratches on some body panels.

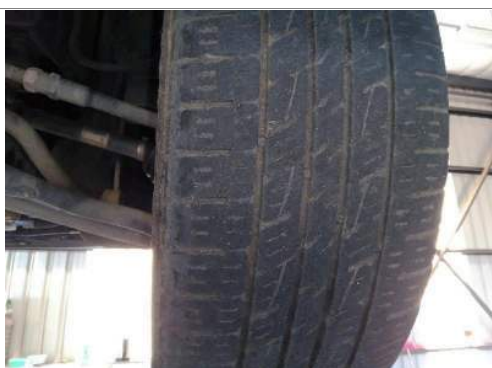
Tyre Front Left

| | Size | Load/Speed Index | Manufacture | Model | Type* | Production Date | Tread Depth (mm) |
|---|---|---|---|---|---|---|---|
| Front Left | 225/55Z R18 | 102W | Windforce | Catchfors | V | 0922 | 3 mm |
