CONDITION REPORT

Report No:  
2017302488  
DATE  
23/09/2026

| Manufacturer | VOLKSWAGEN | Registration Number | LKG715NW |
| Model | POLO VIVO 1.6 77KW COMFORTLINE 5-DR TIPTRONIC [2023-2024] | Register Number | |

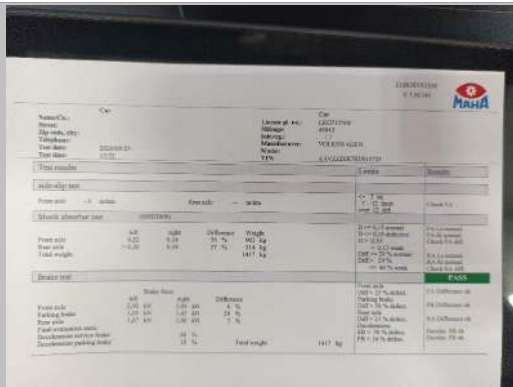
Shock and brake report

Brake Test Results

| | Left | Right | | |
|---|---|---|---|---|
| Front | 2.9 | 3.0 | - | |
| Rear | 1.6 | 1.8 | - | |
| Emergency / Parking | 1 | 1.4 | - | |

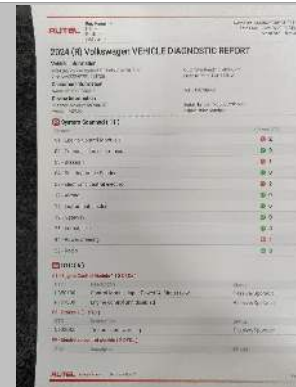
## Diagnostics report

During the diagnostic the following error messages were detected: (See also attached Diagnostic Report. For more information regarding the Fault Codes (DTC) and the recommended rectifications please contact the workshops of the vehicle manufacture).

| No | System | Code | Description | Status |
|---|---|---|---|---|
| 1 | BRAKES | C102D00 | TIRE PRESSURE WARNING | |

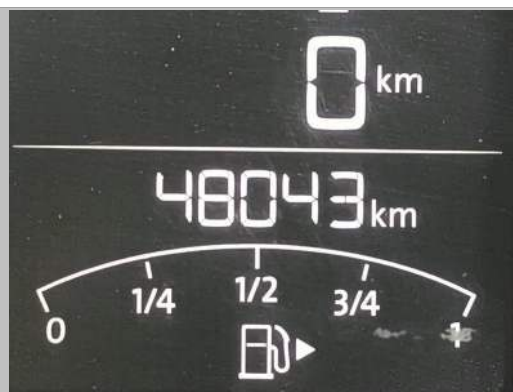
ODOMETER

| Km Reading | 48,043 KM | Transmission | AUTOMATIC |

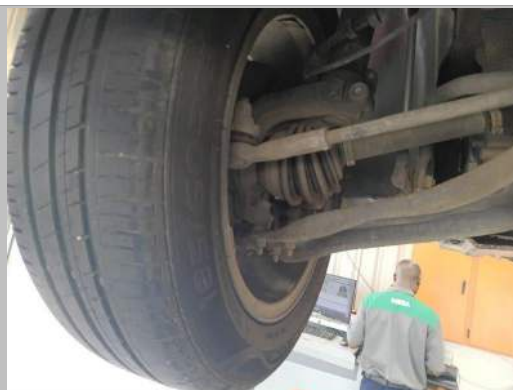
LF TYRE TREAD

| | Size | Load/Speed Index | Manufacture | Model | Type* | Production Date | Tread Depth (mm) |
|---|---|---|---|---|---|---|---|
| Front Left | 185/60R15 | 84H | Powertrac | Eco comfort | V | 4425 | 5 mm |

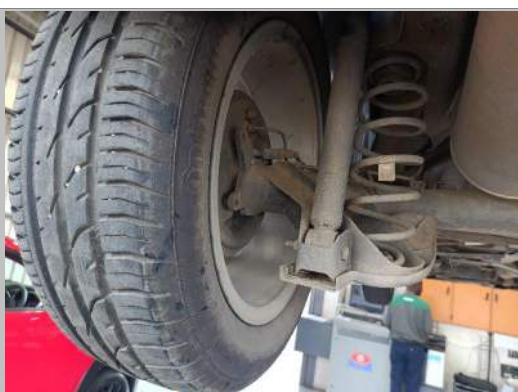
LR TYRE TREAD

| | Size | Load/Speed Index | Manufacture | Model | Type* | Production Date | Tread Depth (mm) |
|---|---|---|---|---|---|---|---|
| Rear Left | 185/60R15 | 84H | Continental | Contact | V | 1024 | 6 mm |

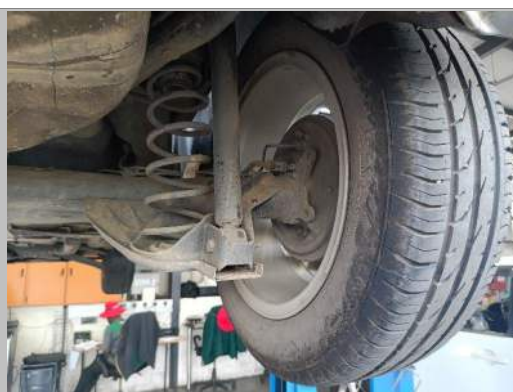
RR TYRE TREAD

| | Size | Load/Speed Index | Manufacture | Model | Type* | Production Date | Tread Depth (mm) |
|---|---|---|---|---|---|---|---|
| Rear Right | 185/60R15 | 84H | Continental | Contact | V | 1024 | 7 mm |

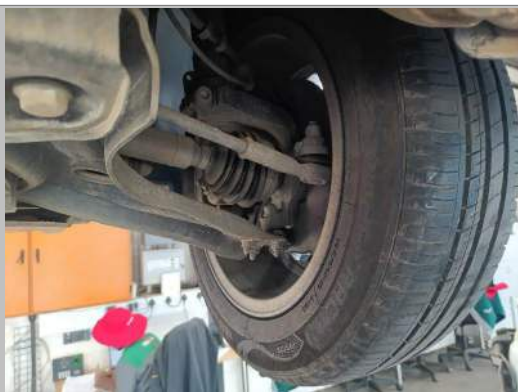
RF TYRE TREAD

| | Size | Load/Speed Index | Manufacture | Model | Type* | Production Date | Tread Depth (mm) |
|---|---|---|---|---|---|---|---|
| Front Right | 185/60R15 | 84H | Powertrac | Eco comfort | V | 4425 | 5 mm |

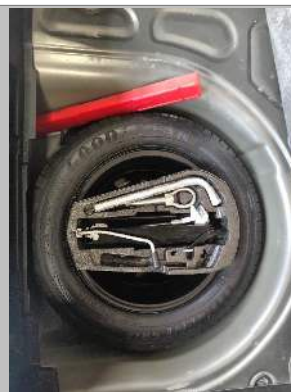
Sparewheel

| | Size | Load/Speed Index | Manufacture | Model | Type* | Production Date | Tread Depth (mm) |
|---|---|---|---|---|---|---|---|
| Spare | 185/60R14 | 82H | Goodyear | Efficient | V | 0000 | 6 mm |

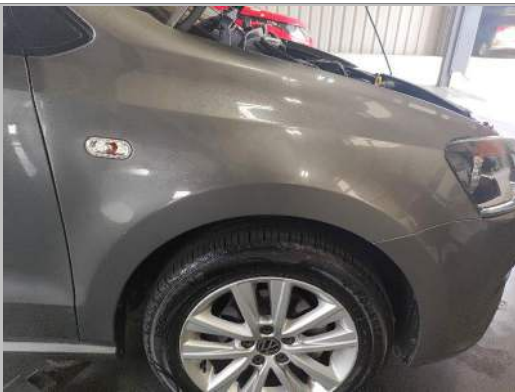
| Damage | Repair Way |
|---|---|
| Front Fender Right Residual Traces of Repair | Repair |

Body • Exterior: Signs of spray work done on body panels.
