MFC Auction House
M57 Pretoria Rd, Glenmarais, KEMPTON PARK
Gauteng

Vehicle Type	PASSENGER VEHICLE	Registered Owner	MFC
Manufacturer	VOLKSWAGEN	Registration Number	JP74CHGP
Model	POLO VIVO	Register Number	
VIN	AAVZZZ6RZKU001867	Date Of First Licensing	
Engine Number		Last COR	
Doors	5	License Expiry Date	31/07/2022
Color	GREY	Power / Displacement	
Year Model		Paint Finish	TWO COAT METALLIC
Km Reading	108,278 KM	Fuel	PETROL
Cab / Body Type	HATCHBACK	Transmission	MANUAL

VEHICLE INSPECTION

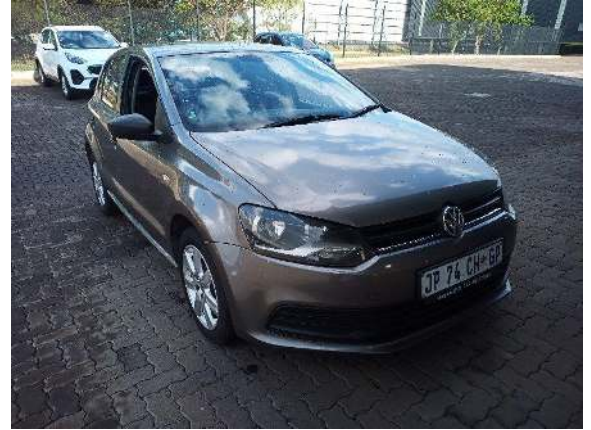
FRONT RIGHT CORNER

Damage	Repair Way
Headlight Left Damaged	Replace
Seat Front Right Damaged	Repair
Front Bumper Damaged	Repair
Bonnet Damaged	Repair
Front Fender Left Damaged	Repair
Front Fender Right Damaged	Repair
Door Front Left Damaged	Repair
Door Front Right Damaged	Repair
Rear bumper Damaged	Repair
Tyre Front Left Worn	Replace
Tyre Front Right Worn	Replace
Tyre Rear Left Damaged	Replace
Tyre Rear Right Worn	Replace
Radiator Cradle Damaged	Replace

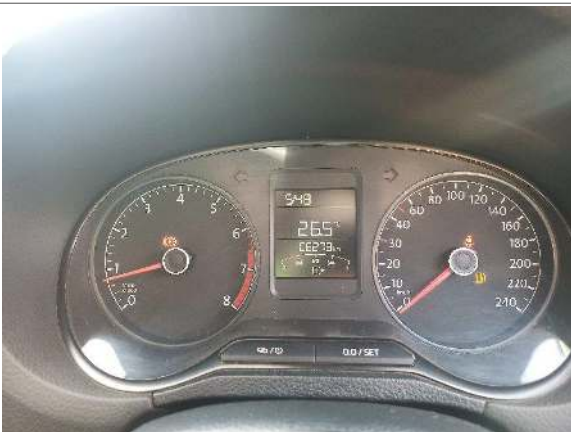
DASHBOARD (W/ ENGINE RUNNING)

During the diagnostic no active error messages were detected. (See also attached Diagnostic Report. For more information regarding the Fault Codes (DTC) and the recommended rectifications please contact the workshops of the vehicle manufacture).

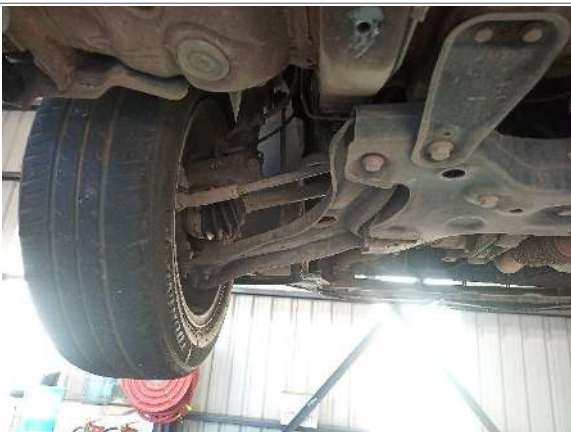
LF TYRE TREAD

Size	Load/Speed Index	Manufacture	Model	Type*	Production Date	Tread Depth (mm)
Front Left	185/60R15	88H	Firestone	Radial	V	3018	0 mm
Front Right	185/60R15	84T	Goodyear	radial	V	3020	0 mm
Rear Left	195/60R15	88H	Dunlop	Sp	V	3721	0 mm
Rear Right	195/60R15	88H	Radar	Radial	V	4419	0 mm

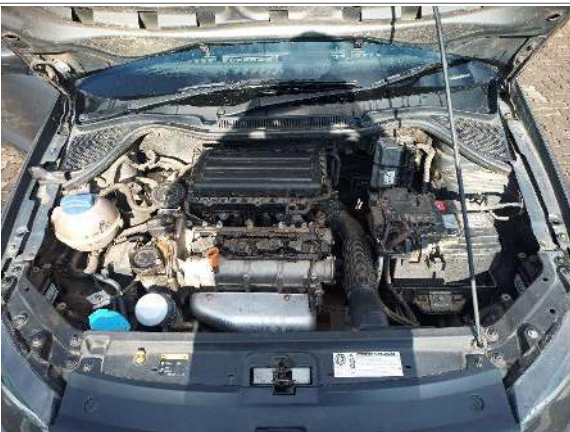
ENGINE 1

No Test Drive
 Rain at time of inspection
 Battery Flat
 Engine number – not possible to verify engine number (not visible without dismantling)
 Inspection conditions for the vehicle inspection were sufficient
