CONDITION REPORT

Report No: 201656799

Vehicle Type	PASSENGER VEHICLE	Registered Owner	
Manufacturer	VOLKSWAGEN	Registration Number	HR98MKGP
Model	POLO VIVO 1.4 63KW COMFORTLINE 5-DR [2018-2020]	Register Number	
VIN	AAVZZZ6RZKU004329	Date Of First Licensing	
Engine Number		Last COR	
Doors	5	License Expiry Date	30/11/2023
Color	SILVER	Power / Displacement	
Year Model	2018	Paint Finish	TWO COAT METALLIC
Km Reading	125,339 KM	Fuel	PETROL
Cab / Body Type	HATCHBACK	Transmission	MANUAL

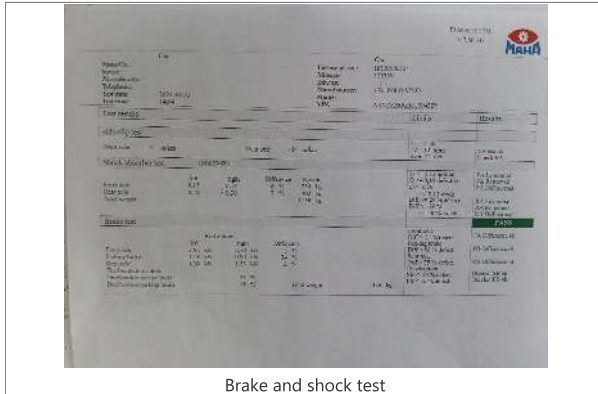
Brake and shock test

Left	Right	Axle Weight [KG]	Deceleration [m/s <sup>2</sup> ]
	Braking Force [KN]	Braking Force [KN]		
Front	2.62	2.7	-	
Rear	1.3	1.33	-	
Emergency / Parking	1.18	0.9	-

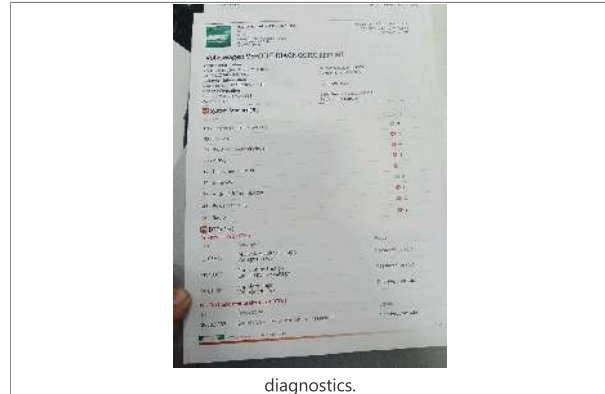
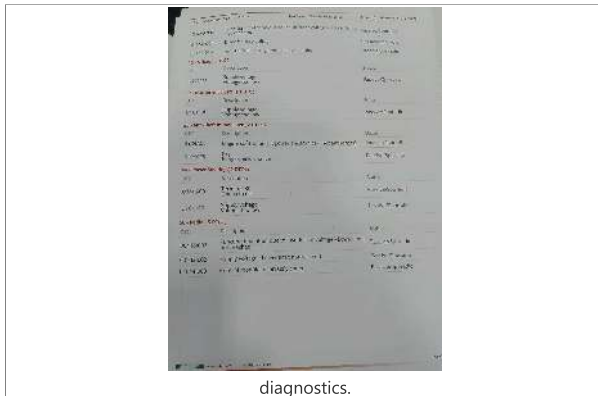
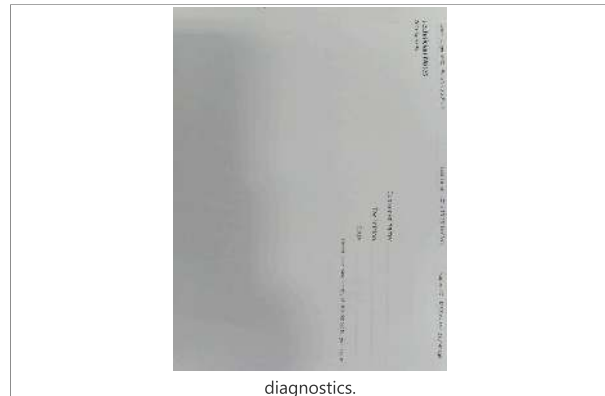
diagnostics.

No	System	Code	Description	Status
1	BRAKES 1	U101100	SUPPLY VOLTAGE VOLTAGE TOO LOW

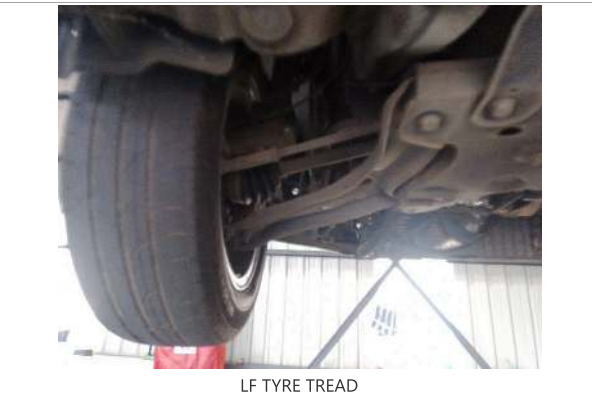
LF TYRE TREAD

Size	Load/Speed Index	Manufacture	Model	Type*	Production Date	Tread Depth (mm)
Front Left	185/60R15	84H	Continental	Conti	V	0917	0 mm
Front Right	195/50R15	82v	Tracmax	Radial	V	1921	0 mm
Rear Left	185/60R15	84H	Continental	Contipremium	V	2115	2 mm
Rear Right	185/60R15	84H	Continental	Contipremium	V	3618	2 mm

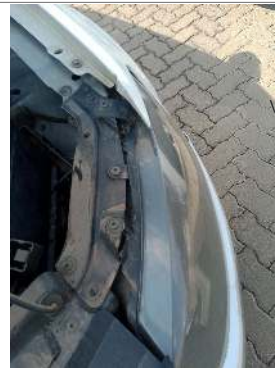
Damage	Repair Way
Engine Oil Leak	Repair
Radiator Damaged	Replace
Tail Light Right Damaged	Replace
Headlight Left Damaged	Replace
Headlight Right Damaged	Replace
Side Mirror Left Damaged	Replace
Side Mirror Right Damaged	Replace
Front Bumper Damaged	Repair
Bonnet Damaged	Repair
Front Fender Left Damaged	Repair
Front Fender Right Damaged	Repair
Rear Fender Left Damaged	Repair
Rear Fender Right Damaged	Repair
Door Front Right Damaged	Repair
Door Rear Left Damaged	Repair
Rear bumper Damaged	Repair
Windscreen Damaged	Replace
Tyre Front Left Worn	Replace
Tyre Front Right Worn	Replace
Tyre Rear Left Damaged	Replace
Engine to silencer pipe Damaged	Replace
Gearbox Damaged	Replace
Radiator Cradle Damaged	Replace
Engine	Battery loose
Body and exterior	Signs of impact damage to front of vehicle.
Body and exterior	bonnet struggles to open.
Body and exterior	Minor dents and scratches and stone chips.
Body and exterior	Signs of repair work done to somebody panels.
