## CONDITION REPORT

Report No:  
2017294612  
DATE  
04/09/2026

| Manufacturer | VOLKSWAGEN | Registration Number | LPL238MP |
| Model | POLO VIVO 1.4 63KW COMFORTLINE 5-DR [2021-2023] | Register Number | |

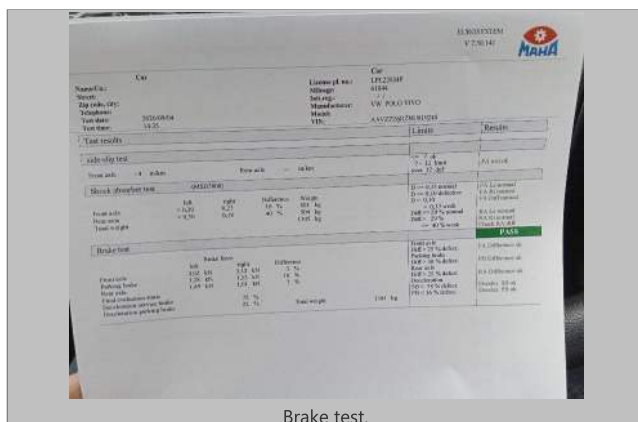
Brake test.

| | Left | Right | | |
|---|---|---|---|---|
| Front | 3.02 | 3.12 | - | |
| Rear | 1.49 | 1.61 | - | |
| Emergency / Parking | 1.28 | 1.53 | - | |

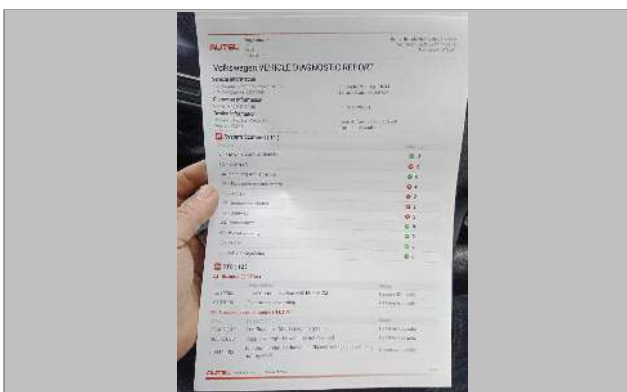
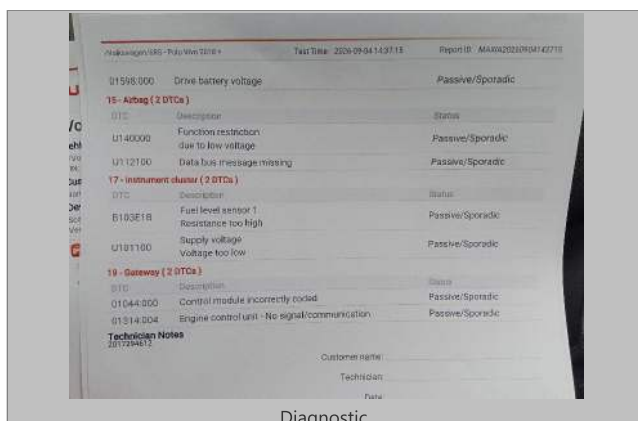
Diagnostic.

During the diagnostic no active error messages were detected. (See also attached Diagnostic Report. For more information regarding the Fault Codes (DTC) and the recommended rectifications please contact the workshops of the vehicle manufacture).

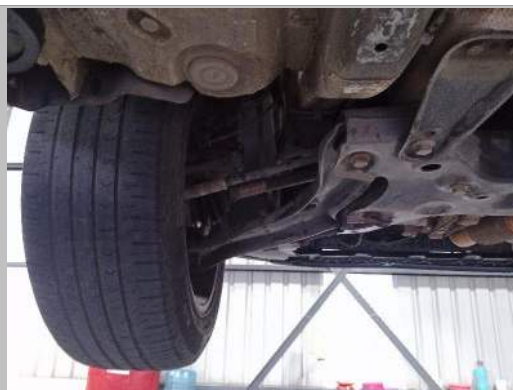
LF TYRE TREAD

| | Size | Load/Speed Index | Manufacture | Model | Type* | Production Date | Tread Depth (mm) |
|---|---|---|---|---|---|---|---|
| Front Left | 195/55R16 | 91V | Continental | Contipremiu | V | 2822 | 2 mm |

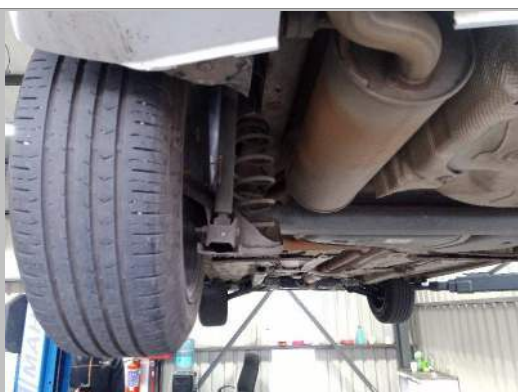
LR TYRE TREAD

| | Size | Load/Speed Index | Manufacture | Model | Type* | Production Date | Tread Depth (mm) |
|---|---|---|---|---|---|---|---|
| Rear Left | 195/55R16 | 91V | Continental | Contipremiu | V | 2822 | 3 mm |

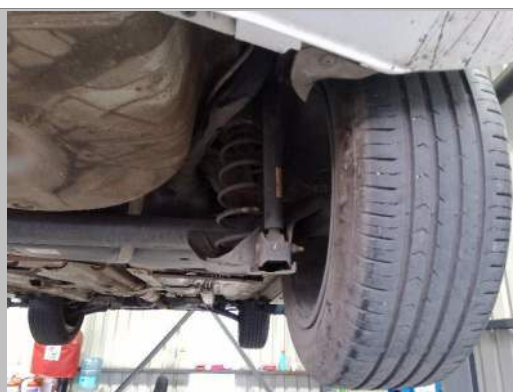
RR TYRE TREAD

| | Size | Load/Speed Index | Manufacture | Model | Type* | Production Date | Tread Depth (mm) |
|---|---|---|---|---|---|---|---|
| Rear Right | 195/55R16 | 91V | Continental | Contipremiu | V | 2822 | 3 mm |

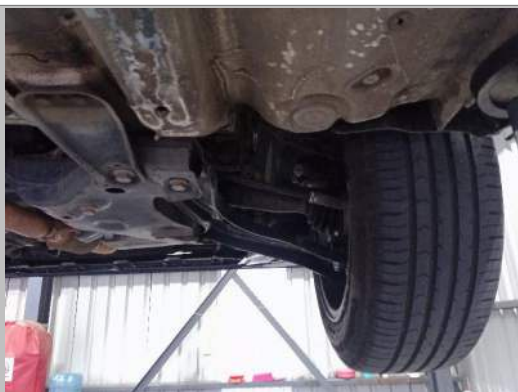
RF TYRE TREAD

| | Size | Load/Speed Index | Manufacture | Model | Type* | Production Date | Tread Depth (mm) |
|---|---|---|---|---|---|---|---|
| Front Right | 195/55R16 | 91V | Continental | Contipremiu | V | 3923 | 2 mm |

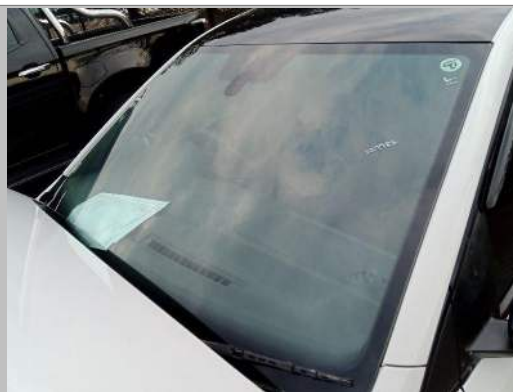
No license disc

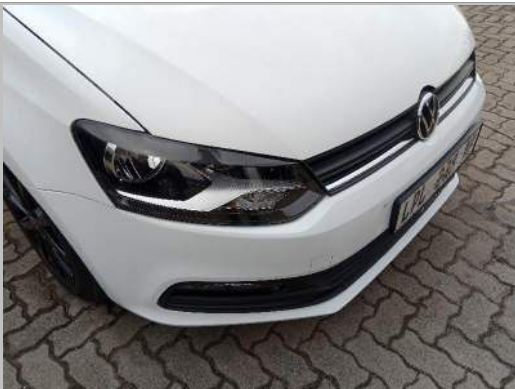
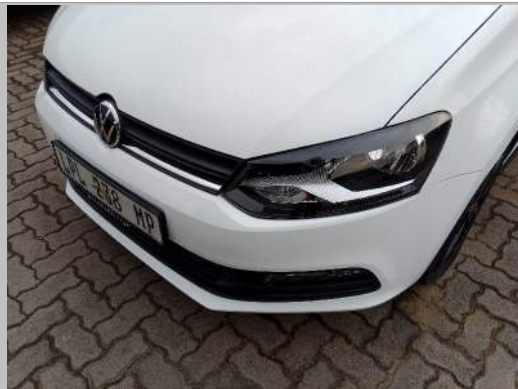
| Front Bumper Damaged | Repair |

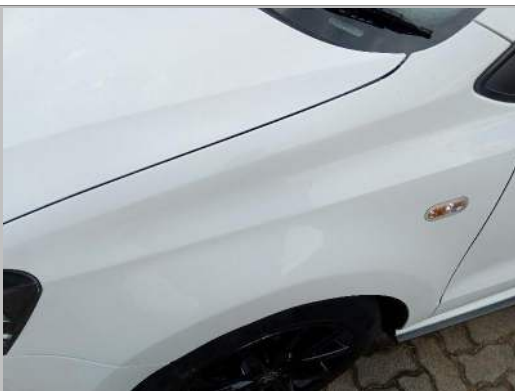
| Front Fender Left Residual Traces of Repair | Repair |

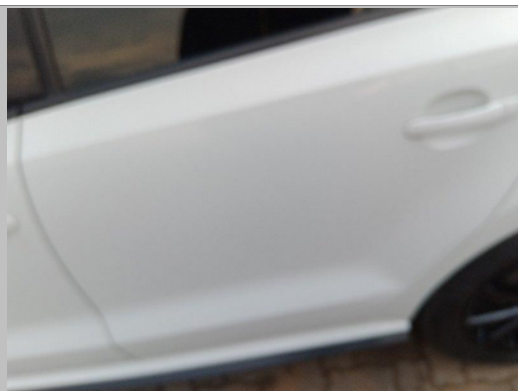
| Door Rear Left Damaged | Repair |

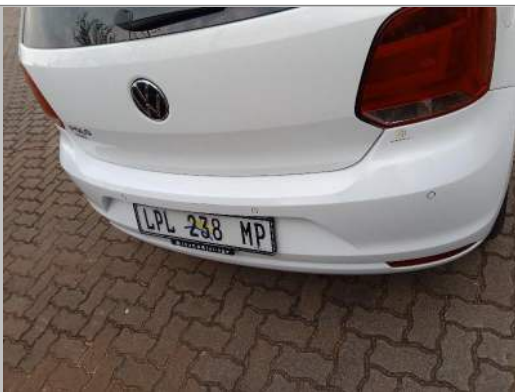
| Rear bumper Paintwork • Scratched | Repair |
