## CONDITION REPORT

Report No:  
2017303555  
DATE  
25/09/2026

| Manufacturer | VOLKSWAGEN | Registration Number | FVW163L |
| Model | POLO 1.0 TSI COMFORTLINE 70KW 5-DR [2018-2019] | Register Number | |

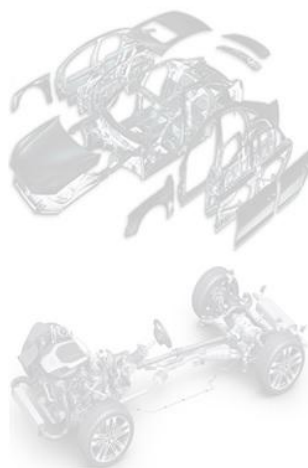
Engine Management Lights Set  
 Tail Light Left Damaged  
 Headlight Left Damaged  
 Headlight Right Damaged  
 Seat Front Right Damaged  
 Front Bumper Damaged  
 Bonnet Damaged  
 Front Fender Left Damaged  
 Rear Fender Left Damaged  
 Door Front Left Damaged  
 Door Front Right Damaged  
 Door Rear Left Damaged  
 Door Rear Right Damaged  
 Rear bumper Damaged  
 Roof Damaged  
 Windscreen Damaged

Repair  
 Replace  
 Replace  
 Replace  
 Repair  
 Repair  
 Repair  
 Repair  
 Repair  
 Repair  
 Repair  
 Repair  
 Repair  
 Repair  
 Repair

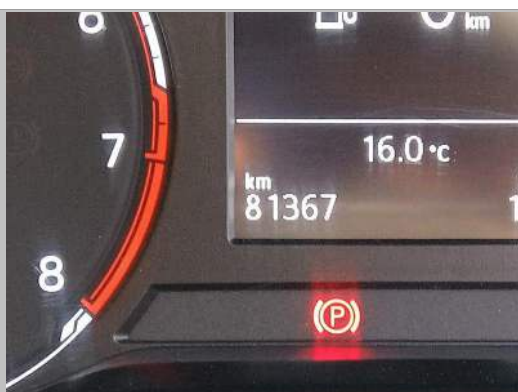
ODOMETER

| Km Reading | 81,367 KM | Transmission | MANUAL |

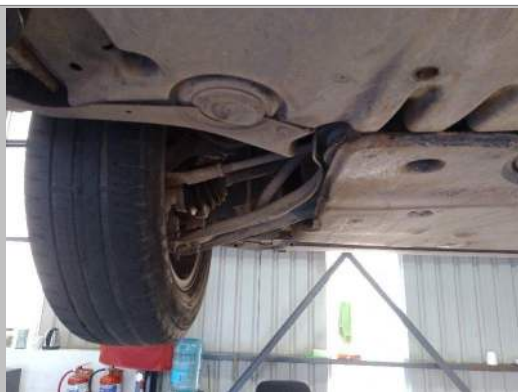
LF TYRE TREAD

| | Size | Load/Speed Index | Manufacture | Model | Type* | Production Date | Tread Depth (mm) |
|---|---|---|---|---|---|---|---|
| Front Left | 185/65R15 | 88H | Falken | Radial | V | 1718 | 1 mm |

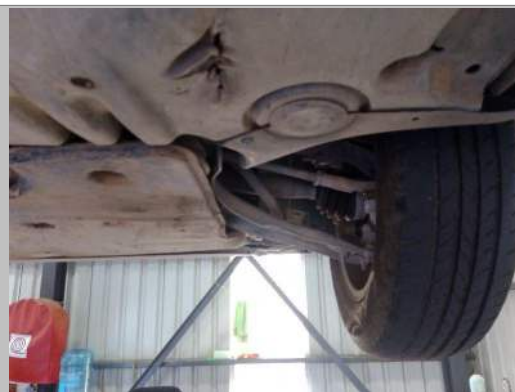
RF TYRE TREAD

| | Size | Load/Speed Index | Manufacture | Model | Type* | Production Date | Tread Depth (mm) |
|---|---|---|---|---|---|---|---|
| Front Right | 185/65R15 | 88H | Symmetry | Radial | V | 2124 | 2 mm |

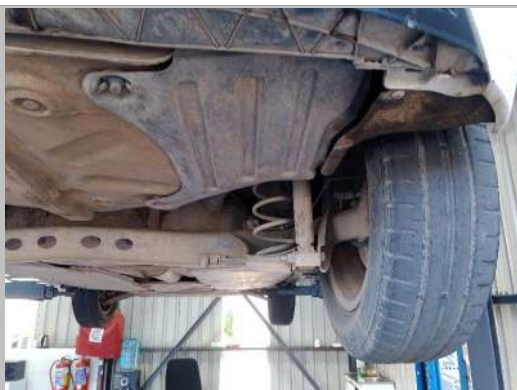
RR TYRE TREAD

| | Size | Load/Speed Index | Manufacture | Model | Type* | Production Date | Tread Depth (mm) |
|---|---|---|---|---|---|---|---|
| Rear Right | 185/65R15 | 88H | Falken | Radial | V | 1618 | 2 mm |

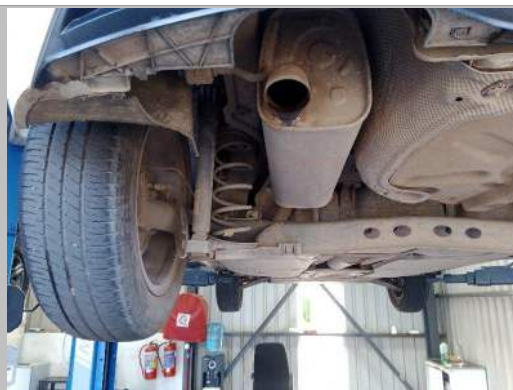
LR TYRE TREAD

| | Size | Load/Speed Index | Manufacture | Model | Type* | Production Date | Tread Depth (mm) |
|---|---|---|---|---|---|---|---|
| Rear Left | 175/65R15 | 84S | Toyo | Radial | V | 1723 | 2 mm |

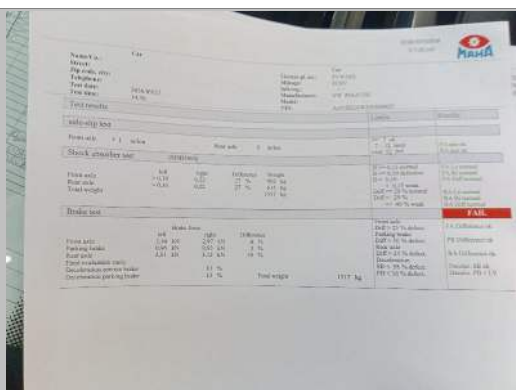
BRAKE TEST REPORT

| | Left | Right | | |
| | Braking Force [KN] | Braking Force [KN] | Axle Weight [KG] | Deceleration [m/s <sup>2</sup> ] |
| Front | 3.14 | 2.97 | - | |
| Rear | 2.81 | 3.12 | - | |
| Emergency / Parking | 0.96 | 0.93 | - | |

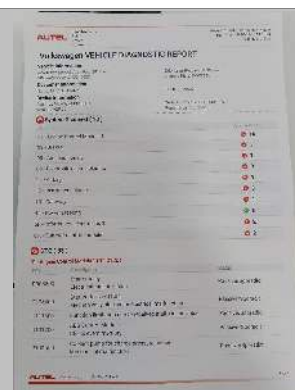
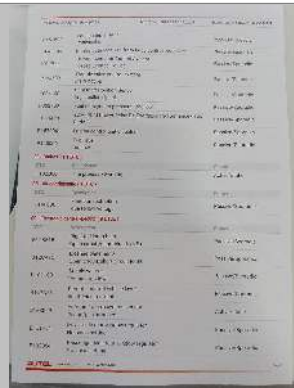
DIAGNOSTIC REPORT PAGE 1

During the diagnostic no active error messages were detected. (See also attached Diagnostic Report. For more information regarding the Fault Codes (DTC) and the recommended rectifications please contact the workshops of the vehicle manufacture).
