CONDITION REPORT

Report No: 2016217479

Vehicle Type	PASSENGER VEHICLE	Registered Owner	MFC
Manufacturer	VOLKSWAGEN	Registration Number	KC78GDGP
Model	POLO TSI	Register Number	
VIN	AAVZZAWZLU023769	Date Of First Licensing	
Engine Number		Last COR	
Doors	5	License Expiry Date	04/01/2024
Color	WHITE	Power / Displacement	
Year Model		Paint Finish	TWO COAT UNI
Km Reading	110,068 KM	Fuel	PETROL
Cab / Body Type	HATCHBACK	Transmission	MANUAL

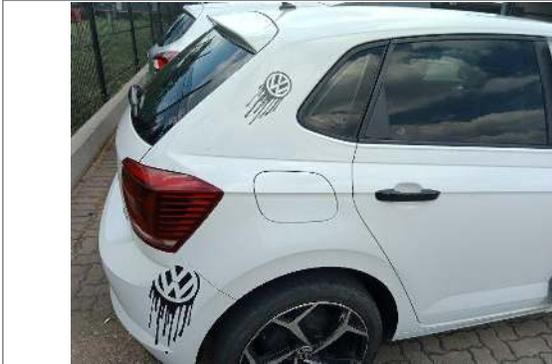
Damage	Repair Way
Rear Fender Left Dented	Repair
Rear Fender Right Paintwork • Scratched	Repair
Door Front Left Dented	Repair
Door Front Right Paintwork • Scratched	Repair
Door Rear Left Dented	Repair
Door Rear Right Paintwork • Scratched	Repair
Boot Lid / Hatch door Paintwork • Scratched	Repair
Rear bumper Paintwork • Scratched	Repair
Sill Panel Left Paintwork • Scratched	Repair
Sill Panel Right Paintwork • Scratched	Repair
Rocker Panel Left Damaged	Repair
Roof Dented	Repair
Windscreen Chipped	Repair
Caliper 1. Axle right Defective	Repair
Service Brake Performance Front Axle Left / Right Difference out of legal range	Repair
Service Brake Performance Rear Axle Left / Right Difference out of legal range	Repair
Parking Brake Performance Left / Right Difference out of legal range	Repair
Shock Absorber Front Left Defective	Repair
Shock Absorber Front Right Leak	Replace
Control Arm Bush(es) Front Axle Left Cracked	Replace

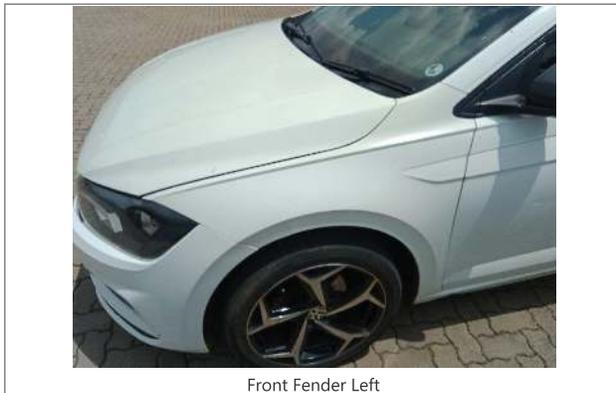
Front Fender Left Paintwork • Scratched	Repair
Front Fender Right Paintwork • Scratched	Repair

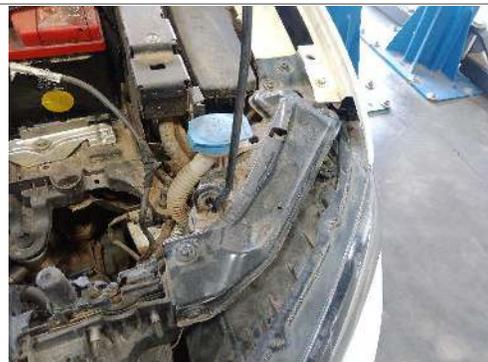
Damage	Repair Way
Engine Wiring Defective	Repair
Caps Defective	Replace
Hoses Defective	Repair
Battery clamps Defective	Repair
Air conditioner pipes Defective	Repair
Air cleaner Damaged	Replace
Bonnet safety caps Damaged	Replace
Engine Oil Sweat	Repair
Switch Electrical Window Winder front left Missing	Replace
Switch Electrical Window Winder front right Missing	Replace
Air Conditioner Insufficient	Replace
Tail Light Left Defective	Repair
Headlight Right Defective	Replace
Seat Front Left Dirty	Repair
Seat Front Right Damaged	Repair
Seat Rear Dirty	Repair
Seat Belt Front Left Defective	Replace
Seat Belt Front Right Defective	Replace
Hood Lining Dirty	Repair
Door Sealing Rubber Front Right Damaged	Replace
Door Sealing Rubber Rear Left Torn / Cut	Replace
Steering Wheel Trim Defective	Repair
Side Mirror Left Damaged	Repair
Front Bumper Damaged	Repair
Grill Damaged	Replace
Bonnet Damaged	Replace
Bonnet slam plate (Shock tower/ Inner tray) Damaged	Replace

General Comments: VEHICLE LICENSE DISC MISSING.SHOCK ABSORBER TEST COULD NOT BE PERFORMED.
 Engine Compartment: Engine bay dirty. Brake fluid level ok. Bonnet release handle damaged. Bonnet slam plate cover missing. Fan Cowley damaged.
 Electrical Components and Instruments: Front right electrical window switch mechanism missing.
 Lights: Front left and right daytime running lights not working.
 Interior: Vehicle interior dirty and some interior panels scratched.
 Body • Exterior: Dents and scratches on some body panels. Spray work on some body panels. Some body panels misaligned. Stone chips on some body panels.
 Residual traces of repair on some body panels. Front number plate missing. Bonnet struggles to open. Signs of impact damage to front of vehicle.
 Axle and Suspension: Abnormal noise coming from front and rear suspension. Front suspension faulty. Wire strapped onto front left shock absorber and brake caliper. Nut missing on front left ball joint. Signs of vehicle grabbing.

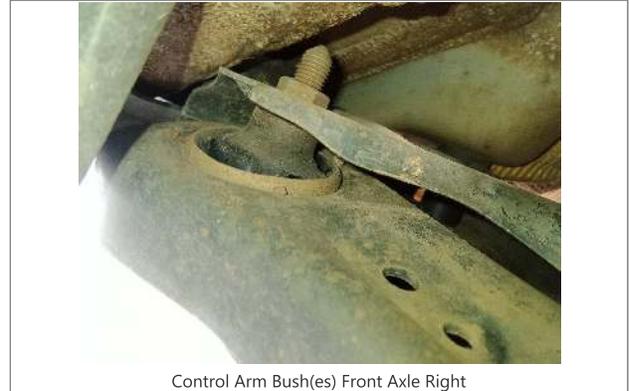
Control Arm Bush(es) Front Axle Right Cracked	Replace
Ball Joint(s) Front Axle Left Defective	Repair
Tyre Front Left Damaged	Replace
Tyre Rear Right Damaged	Replace
Belly plates Defective	Repair
Steering Noisy	Repair
Engine Performance Insufficient	Repair
Engine Noise Excessive	Repair
Warning lights illuminated on dashboard	Repair

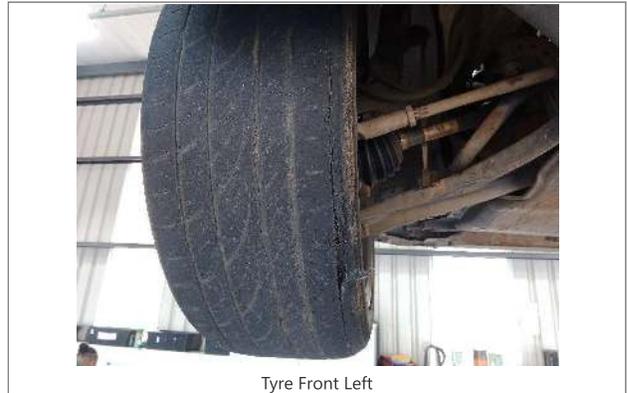
Tyre Front Left

Size	Load/Speed Index	Manufacture	Model	Type*	Production Date	Tread Depth (mm)
Front Left	215/45Z R17	87Y	Sumitomo	HTR Z	V	5020	0 mm
Front Right	185/60 R15	82H	Sumitomo	HTR	V	1622	5 mm
Rear Left	185/70 R14	88H	Falken	Sincera	V	2619	5 mm
Rear Right	215/45Z R17	87Y	Sumitomo	HTRZ	V	5020	0 mm

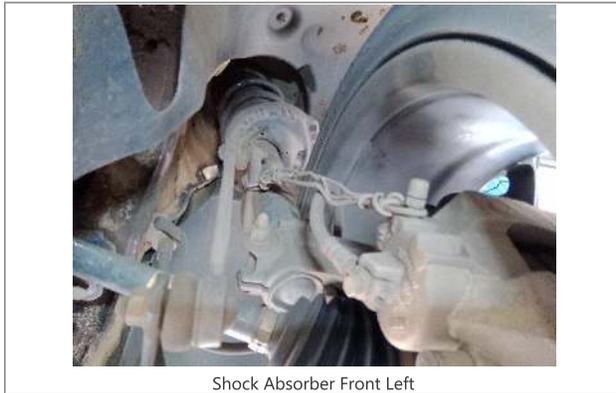
Shock Absorber Front Left

Tyres and Rims: Alloy and steel rims scratched. Front and rear tyre sizes different. Spare wheel missing.
 Undercarriage: Vehicle undercarriage dirty. Bottom of engine and gearbox fully covered. Exhaust heat shields damaged. Fuel tank scratched. Rear exhaust cross member bracket dented.
 Road Test: Vehicle unsafe to drive due steel wire strapped on front left shock absorber and brake caliper.
