CONDITION REPORT

Report No: 2016781244

DATE  
28/02/2025

Vehicle Type	PASSENGER VEHICLE	Registered Owner	
Manufacturer	VOLKSWAGEN	Registration Number	KS69PBG
Model	POLO 1.0 TSI 85KW R-LINE 5-DR DSG [2022-2023]	Register Number	
VIN	AAVZZAWZNU092544	Date Of First Licensing	
Engine Number		Last COR	
Doors	5	License Expiry Date	30/11/2024
Color	WHITE	Power / Displacement	
Year Model	2022	Paint Finish	C - COMMON
Km Reading	63,799 KM	Fuel	PETROL
Cab / Body Type	HATCHBACK	Transmission	AUTOMATIC

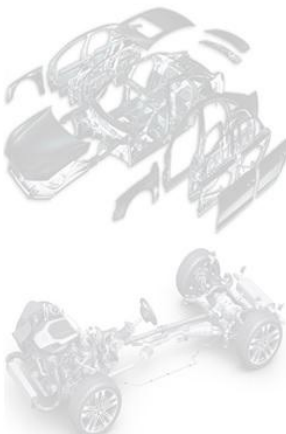
Damage	Repair Way
Seat Front Right Torn / Cut	Repair
Bonnet Paintwork • Scratched	Repair
Rear Fender Left Dented	Repair
Door Front Right Paintwork • Scratched	Repair
Door Rear Left Dented	Repair
Boot Lid / Hatch door Dented	Repair
Rear bumper Paintwork • Scratched	Repair
Windscreen Cracked	Replace
Body exterior	Vehicle got minor scratches, stone chips and dents

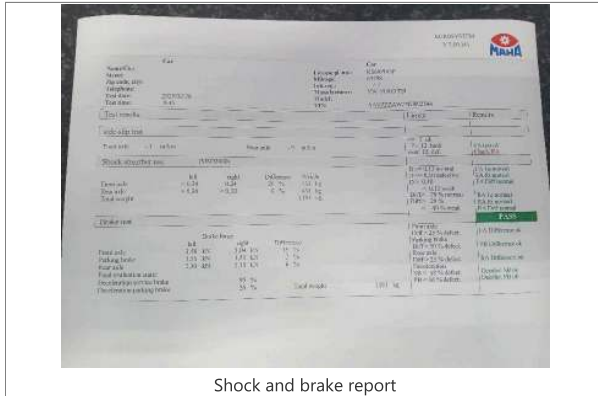
Shock and brake report

Left	Right	Axle Weight [KG]	Deceleration [m/s <sup>2</sup> ]
	Braking Force [KN]	Braking Force [KN]		
Front	3.5	3.0	-	
Rear	2.3	2.1	-	
Emergency / Parking	1.5	1.5	-

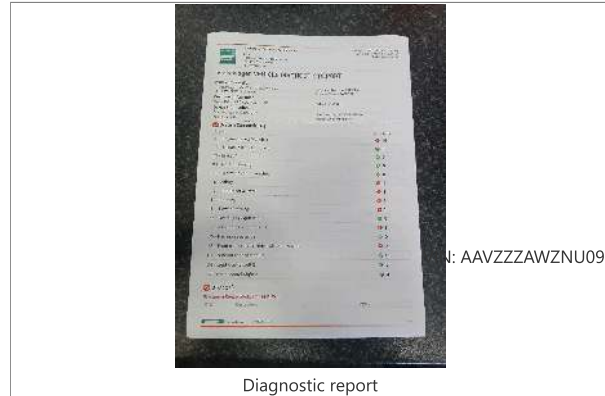
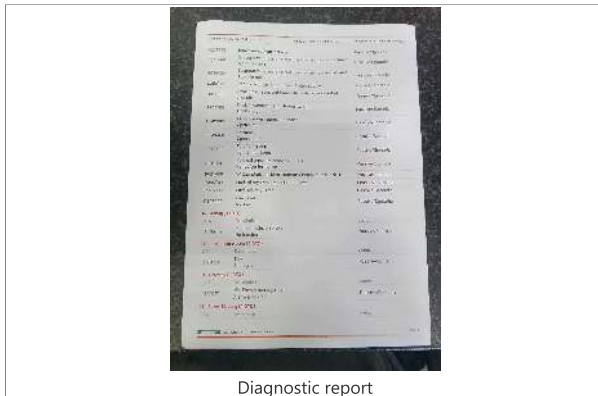
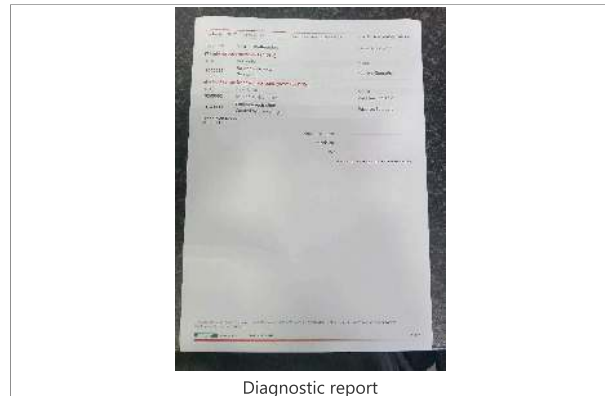
Diagnostic report

During the diagnostic the following error messages were detected: (See also attached Diagnostic Report. For more information regarding the Fault Codes (DTC) and the recommended rectifications please contact the workshops of the vehicle manufacture).

No	System	Code	Description	Status
1	PASSIVE/ SPORADIC	P125000	FUEL LEVEL TOO LOW

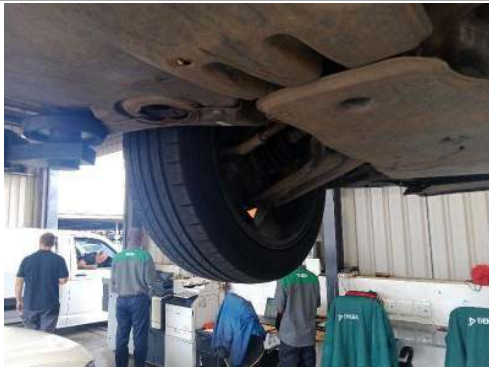
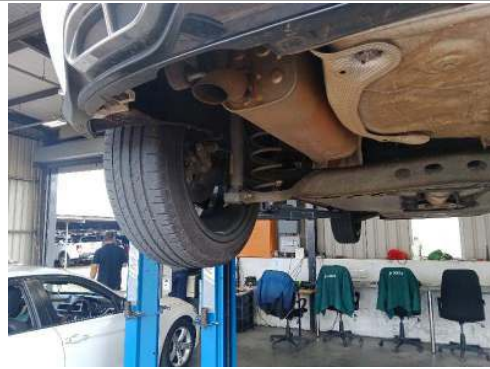
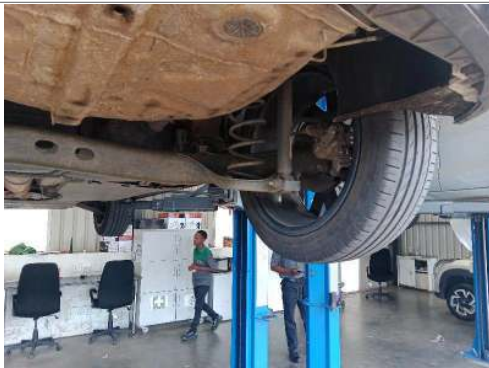
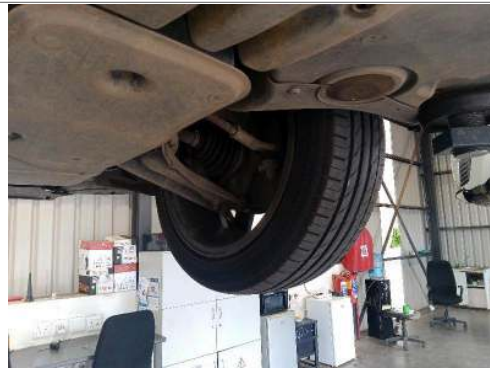
Size	Load/Speed Index	Manufacture	Model	Type*	Production Date	Tread Depth (mm)
Front Left	215/45R17	91W	Continental	Contact	V	1924	4 mm
Front Right	215/45R17	91W	Continental	Contact	V	3724	4 mm
Rear Left	215/45R17	91W	Continental	Contact	V	2022	4 mm
Rear Right	215/45R17	91W	Continental	Contact	V	2022	4 mm
Spare	185/65R15	88H	Continental	Contact	V	0000	5 mm
