CONDITION REPORT

Report No:  
2017304622  
DATE  
29/09/2026

| Manufacturer | VOLKSWAGEN | Registration Number | KX94ZYG |
| Model | POLO 1.0 TSI 70KW 5-DR [2022-2024] | Register Number | |

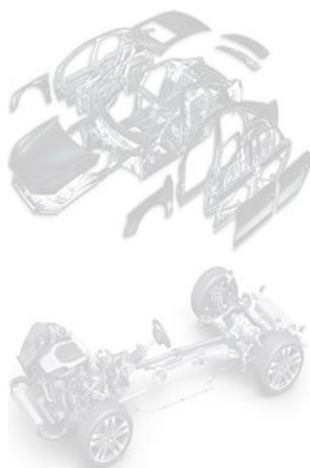
Front Bumper Paintwork • Scratched  
 Rear Fender Left Paintwork • Scratched  
 Rear bumper Paintwork • Scratched

Repair  
 Repair  
 Repair

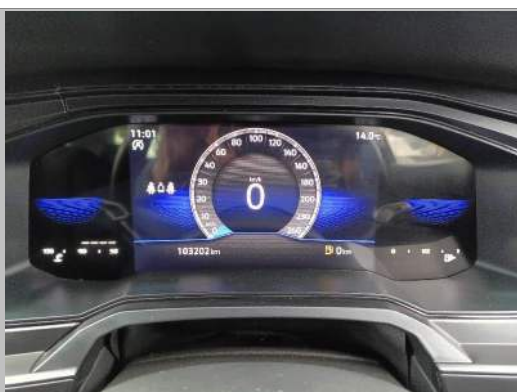
DASHBOARD (W/ ENGINE RUNNING)

| No | System | Code | Description | Status |
|---|---|---|---|---|
| 1 | INSTRUMENT | U111000 | FUNCTION RESTRICTION DUE TO COMMUNICATIONS | |

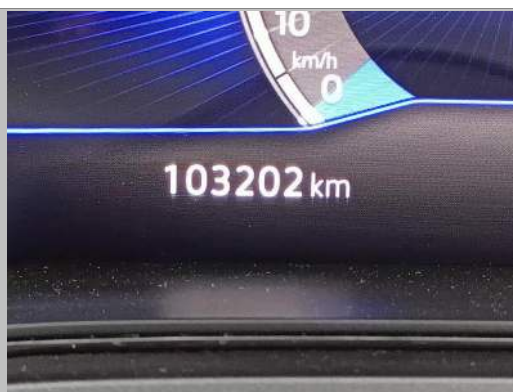
ODOMETER

| Km Reading | 103,202 KM | Fuel | PETROL |

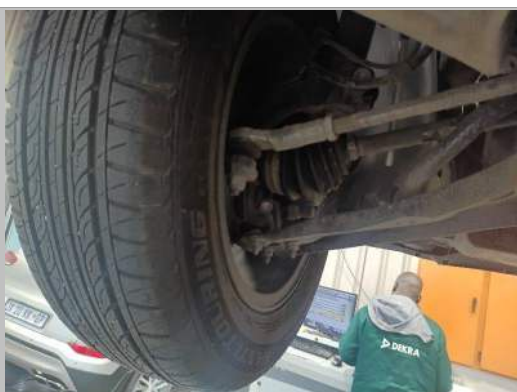
LF TYRE TREAD

| | Size | Load/Speed Index | Manufacture | Model | Type* | Production Date | Tread Depth (mm) |
|---|---|---|---|---|---|---|---|
| Front Left | 185/65R15 | 88H | Centara | Vanti tourin | V | 0226 | 5 mm |

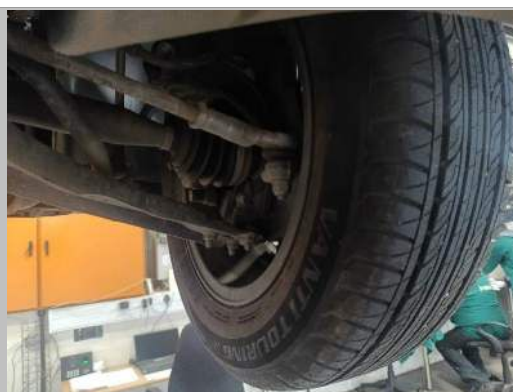
RF TYRE TREAD

| | Size | Load/Speed Index | Manufacture | Model | Type* | Production Date | Tread Depth (mm) |
|---|---|---|---|---|---|---|---|
| Front Right | 185/65R15 | 88H | Centara | Vanti tourin | V | 0226 | 6 mm |

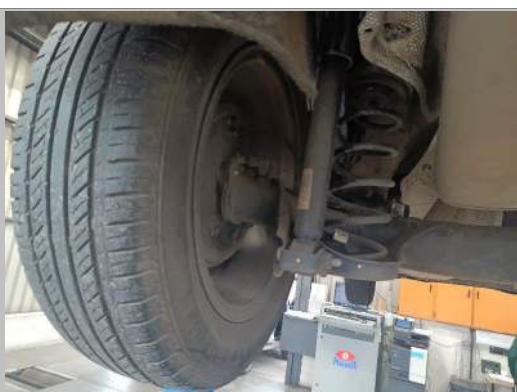
LR TYRE TREAD

| | Size | Load/Speed Index | Manufacture | Model | Type* | Production Date | Tread Depth (mm) |
|---|---|---|---|---|---|---|---|
| Rear Left | 185/65R15 | 88H | Sailun | Atrezzo | V | 0125 | 4 mm |

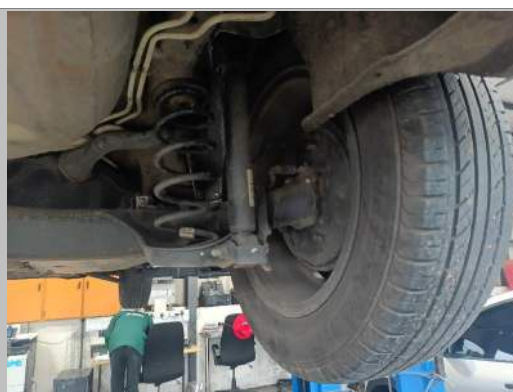
RR TYRE TREAD

| | Size | Load/Speed Index | Manufacture | Model | Type* | Production Date | Tread Depth (mm) |
|---|---|---|---|---|---|---|---|
| Rear Right | 185/65R15 | 88H | Sailun | Atrezzo | V | 0125 | 5 mm |

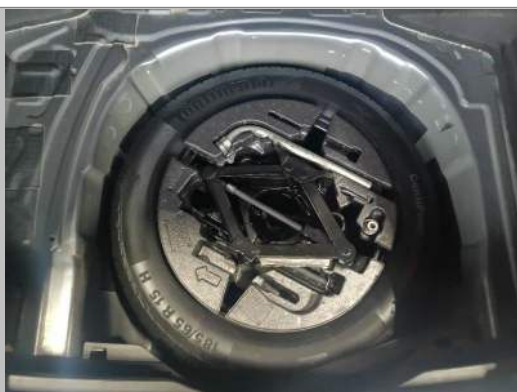
Sparewheel

| | Size | Load/Speed Index | Manufacture | Model | Type* | Production Date | Tread Depth (mm) |
|---|---|---|---|---|---|---|---|
| Spare | 185/65R15 | 88H | Continental | Contact | V | 0000 | 6 mm |

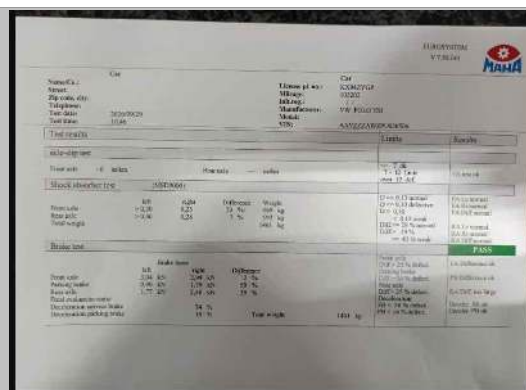
Shock and brake report

| | Left | Right | | |
|---|---|---|---|---|
| Front | 3.0 | 2.9 | - | |
| Rear | 1.7 | 2.8 | - | |
| Emergency / Parking | 0.9 | 1.7 | - | |
