CONDITION REPORT

Report No:  
2017296433  
DATE  
09/09/2026

| Manufacturer | ISUZU | Registration Number | KVB205MP |
| Model | D-MAX 3.0 DDI 4X4 LSE DSL D-CAB PU AT [2022-2023] | Register Number | |

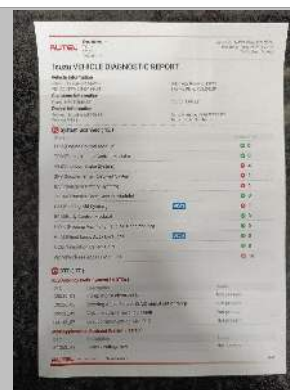
Diagnostics report

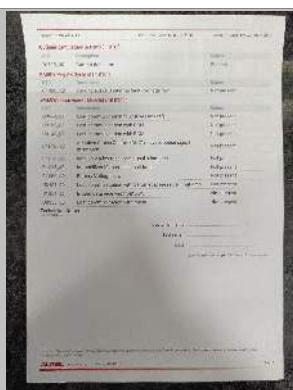
| No | System | Code | Description | Status |
|---|---|---|---|---|
| 1 | ABS | C0020_01 | PUMP MOTOR ELECTRICAL FAULT | |

Diagnostics report

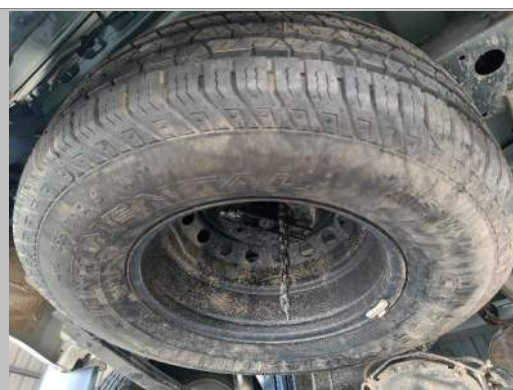
| | Size | Load/Speed Index | Manufacture | Model | Type* | Production Date | Tread Depth (mm) |
|---|---|---|---|---|---|---|---|
| Spare | 255/70R16 | 111T | Continental | Contact | V | 0000 | 10 mm |

Sparewheel

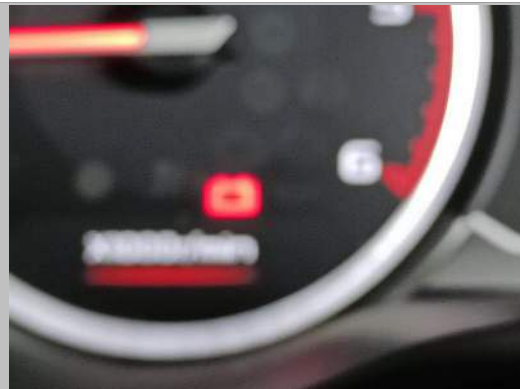
| Damage | Repair Way |
|---|---|
| Warning lights illuminated | Repair |

Warning lights illuminated

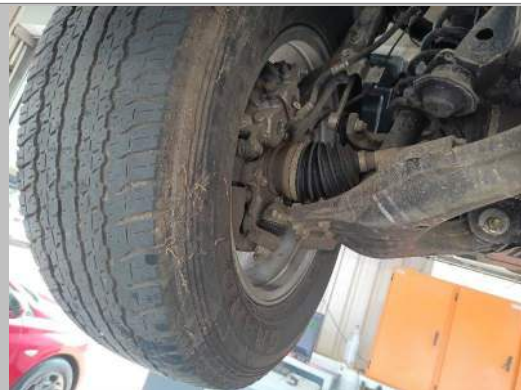
| | Size | Load/Speed Index | Manufacture | Model | Type* | Production Date | Tread Depth (mm) |
|---|---|---|---|---|---|---|---|
| Front Left | 255/65R17 | 110H | Dunlop | Grandtrek | V | 0523 | 1 mm |

LF TYRE TREAD

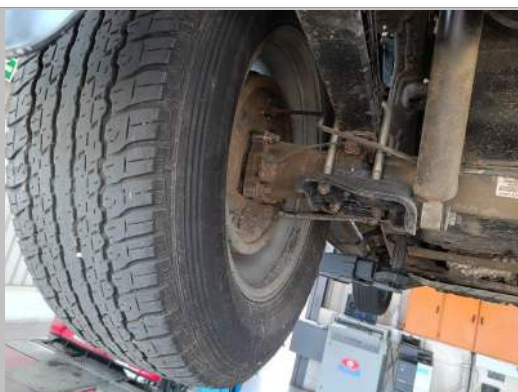
| | Size | Load/Speed Index | Manufacture | Model | Type* | Production Date | Tread Depth (mm) |
|---|---|---|---|---|---|---|---|
| Rear Left | 255/65R17 | 110H | Dunlop | Grandtrek | V | 0523 | 3 mm |

LR TYRE TREAD

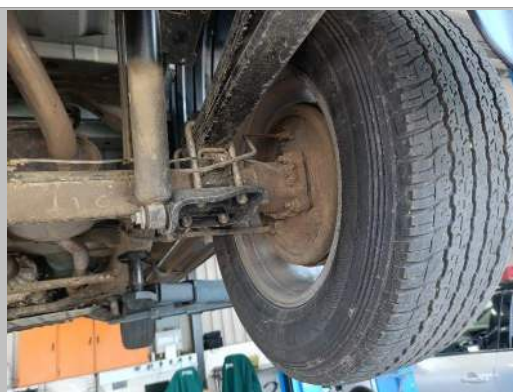
| | Size | Load/Speed Index | Manufacture | Model | Type* | Production Date | Tread Depth (mm) |
|---|---|---|---|---|---|---|---|
| Rear Right | 255/65R17 | 110H | Dunlop | Grandtrek | V | 0523 | 2 mm |

RR TYRE TREAD

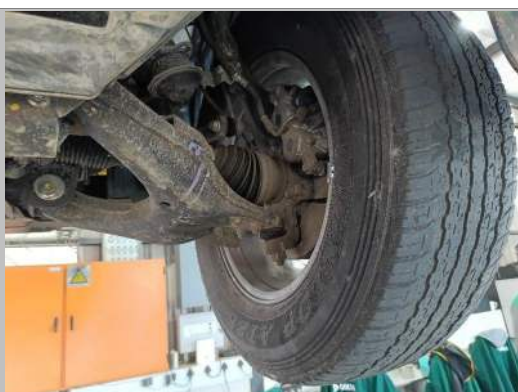
| | Size | Load/Speed Index | Manufacture | Model | Type* | Production Date | Tread Depth (mm) |
|---|---|---|---|---|---|---|---|
| Front Right | 255/65R17 | 110H | Dunlop | Grandtrek | V | 0523 | 1 mm |

RF TYRE TREAD

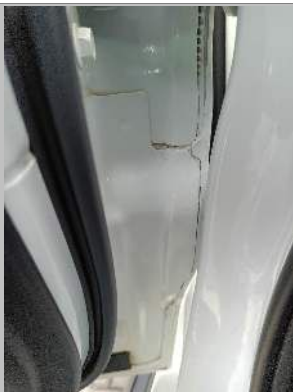
| Damage | Repair Way |
|---|---|
| Door Rear Left Cracked | Repair |

Door Rear Left

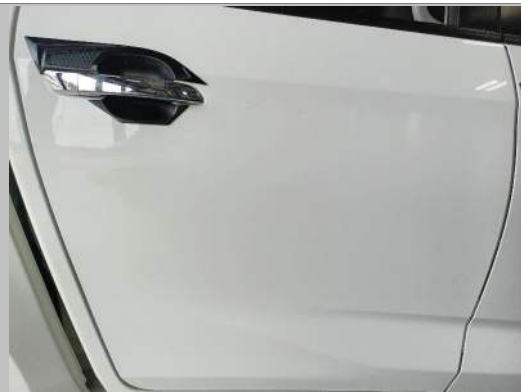
| Damage | Repair Way |
|---|---|
| Door Rear Right Paintwork • Scratched | Repair |

Door Rear Right

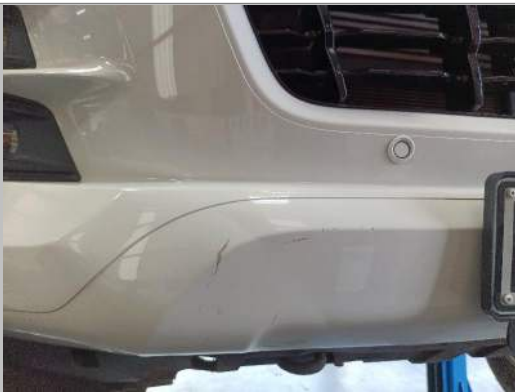
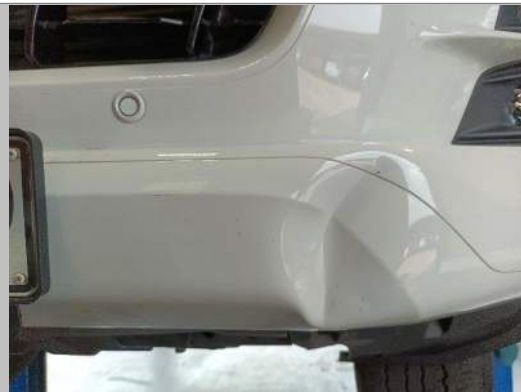
| Damage | Repair Way |
|---|---|
| Front Bumper Paintwork • Scratched | Repair |

Front Bumper
