CONDITION REPORT

Report No: 2016183465

DATE  
29/11/2023

Vehicle Type	LIGHT LOAD VEHICLE	Registered Owner	MFC
Manufacturer	NISSAN	Registration Number	FBR024L
Model	NP300 HARD BODY	Register Number	
VIN	ADNCPGD22ZR115185	Date Of First Licensing	
Engine Number		Last COR	
Doors	4	License Expiry Date	31/12/2023
Color	WHITE	Power / Displacement	
Year Model		Paint Finish	C - COMMON
Km Reading	210,096 KM	Fuel	DIESEL
Cab / Body Type	DOUBLE CAB	Transmission	MANUAL

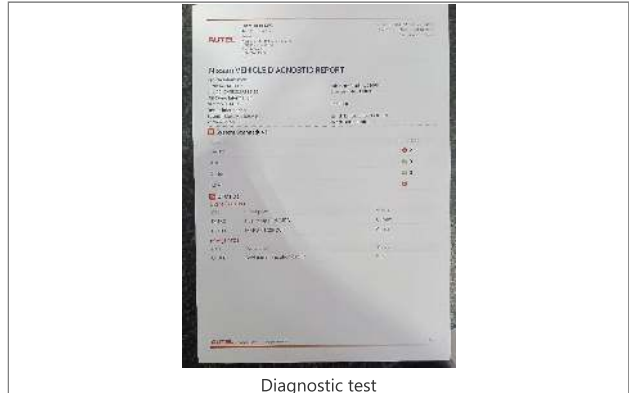
Diagnostic test

During the diagnostic no active error messages were detected. (See also attached Diagnostic Report. For more information regarding the Fault Codes (DTC) and the recommended rectifications please contact the workshops of the vehicle manufacture).

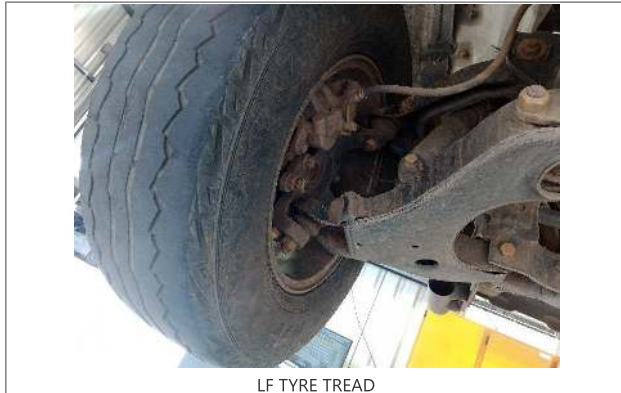
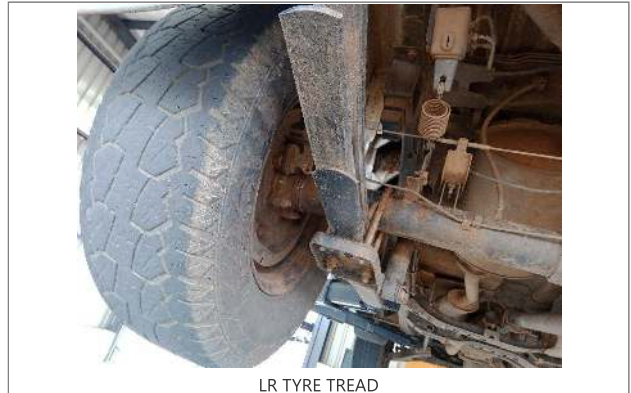
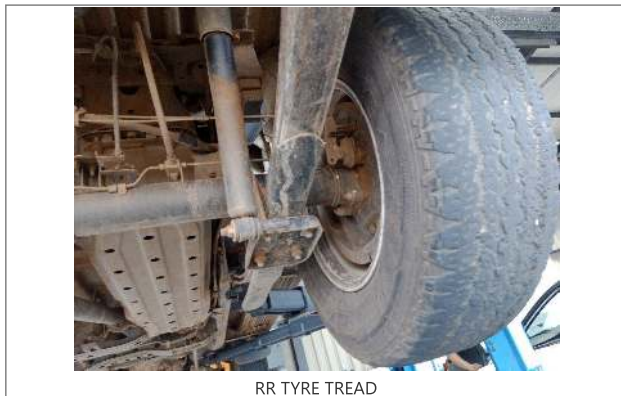
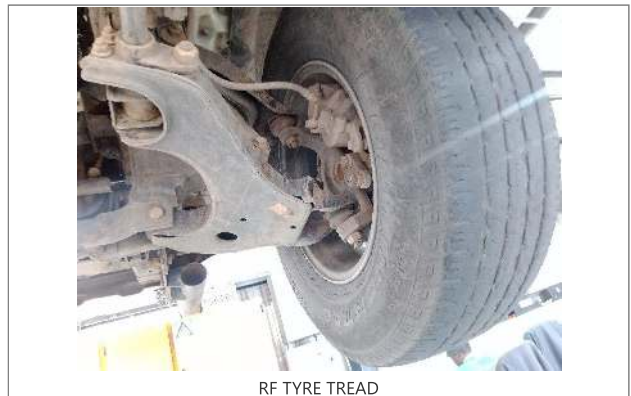
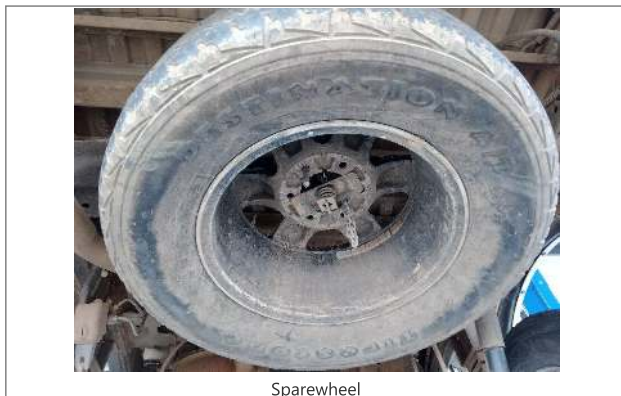
Size	Load/Speed Index	Manufacture	Model	Type*	Production Date	Tread Depth (mm)
Front Left	245/70R16	107S	Falken	Wildpeak	V	3919	0 mm
Front Right	255/70R16	111T	Continental	Contact	V	3522	1 mm
Rear Left	255/70R16	111T	Habilead	Practice	V	2018	0 mm
Rear Right	245/70R16	111/109T	Goodyear	Wrangler	V	1618	0 mm
Spare	245/70R16	107S	Firestone	Destination	V	///////	1 mm

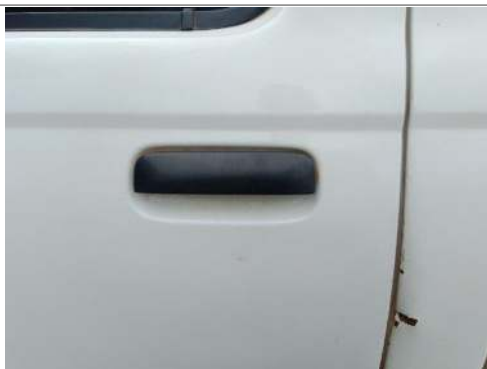
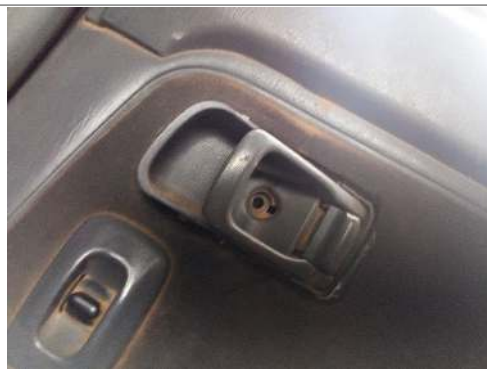
Damage	Repair Way
Tail Light Right Broken	Replace
Headlight Left Broken	Replace
Seat Front Left Torn / Cut	Repair
Seat Front Right Torn / Cut	Replace
Door Handle Rear Left Damaged	Replace
Carpet Front Torn / Cut	Repair
Front Lower Valance Corrosion	Replace
Front Bumper Paintwork • Scratched	Repair
C • Pillar Left Damaged	Repair
Door Rear Right Dented	Repair
Tailgate Hinge Left Defective	Repair
Fuel Flap Defective	Repair
Windscreen Cracked	Replace
Brake disc 1. Axle right Damaged	Replace
Stabilizer Mounting Front Right Damaged	Replace
Ball Joint(s) Front Axle Left Cracked	Replace
Spring Shackle Bush Rear Axle Left Damaged	Replace
Spring Shackle Bush Rear Axle Right Damaged	Replace
Tyre Rear Left Smooth	Replace

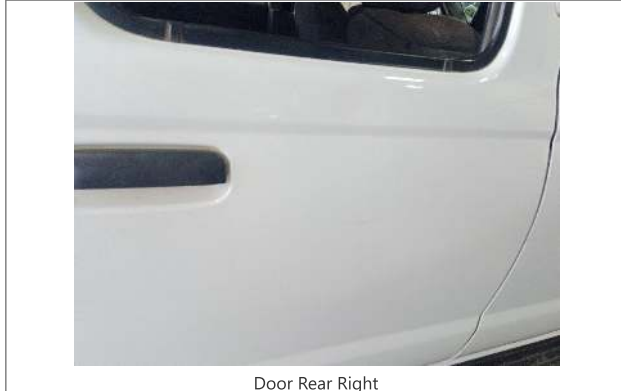
Door Rear Right

Body • Exterior: Minor dents scratches and stone chips on some body panels. Signs of spray work done on some body panels. L/R door not working.
