## CONDITION REPORT

Report No:  
2017295698  
DATE  
08/09/2026

| Manufacturer | FORD | Registration Number | LPH569MP |
| Model | RANGER 2.2 TDCI XL DSL PU OPT PLAN [2021-2023] | Register Number | |

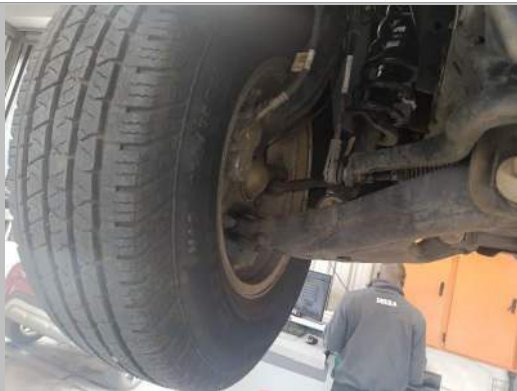
LF TYRE TREAD

| | Size | Load/Speed Index | Manufacture | Model | Type* | Production Date | Tread Depth (mm) |
|---|---|---|---|---|---|---|---|
| Front Left | 255/70R16 | 111T | Continental | Contact | V | 2019 | 5 mm |

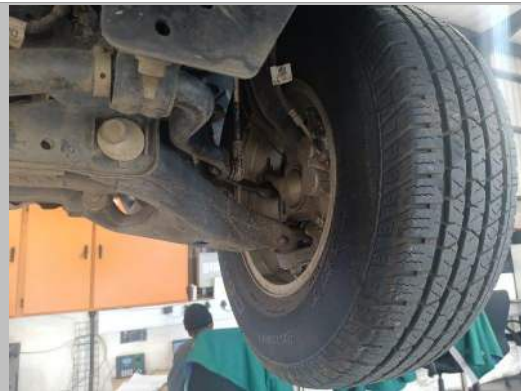
RF TYRE TREAD

| | Size | Load/Speed Index | Manufacture | Model | Type* | Production Date | Tread Depth (mm) |
|---|---|---|---|---|---|---|---|
| Front Right | 255/70R16 | 111T | Continental | Contact | V | 2016 | 5 mm |

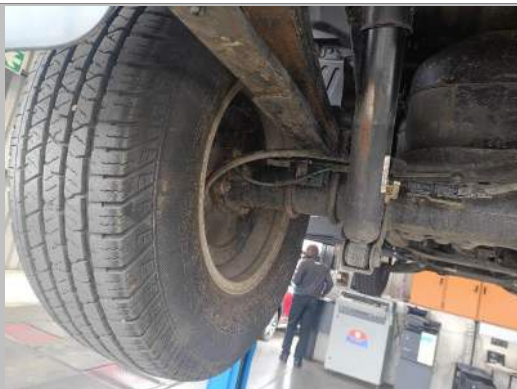
LR TYRE TREAD

| | Size | Load/Speed Index | Manufacture | Model | Type* | Production Date | Tread Depth (mm) |
|---|---|---|---|---|---|---|---|
| Rear Left | 255/70R16 | 111T | Continental | Contact | V | 2019 | 5 mm |

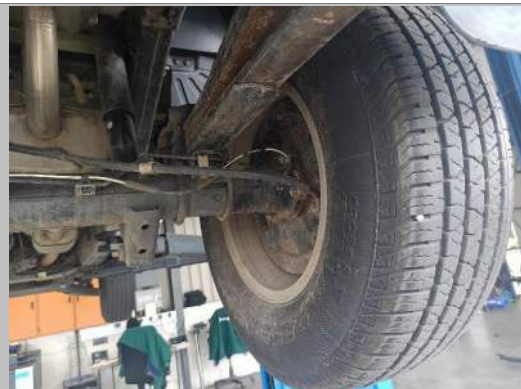
RR TYRE TREAD

| | Size | Load/Speed Index | Manufacture | Model | Type* | Production Date | Tread Depth (mm) |
|---|---|---|---|---|---|---|---|
| Rear Right | 255/70R16 | 111T | Continental | Contact | V | 2019 | 5 mm |

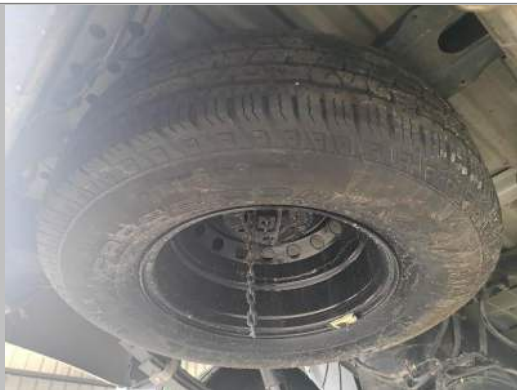
### Sparewheel

| | Size | Load/Speed Index | Manufacture | Model | Type* | Production Date | Tread Depth (mm) |
|---|---|---|---|---|---|---|---|
| Spare | 255/70R16 | 111T | Continental | Contact | V | 0000 | 4 mm |

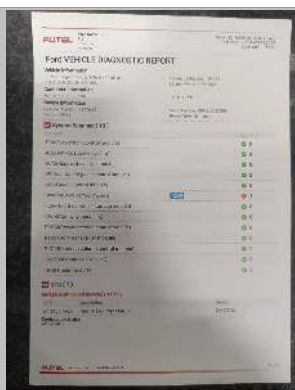
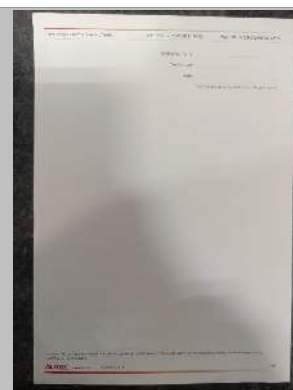
Diagnostic Report page 1

During the diagnostic the following error messages were detected: (See also attached Diagnostic Report. For more information regarding the Fault Codes (DTC) and the recommended rectifications please contact the workshops of the vehicle manufacture).

| No | System | Code | Description | Status |
|---|---|---|---|---|
| 1 | BODY CONTROL MODULE | B1313:15-0A | INTERIOR LIGHTING OUTPUT | |

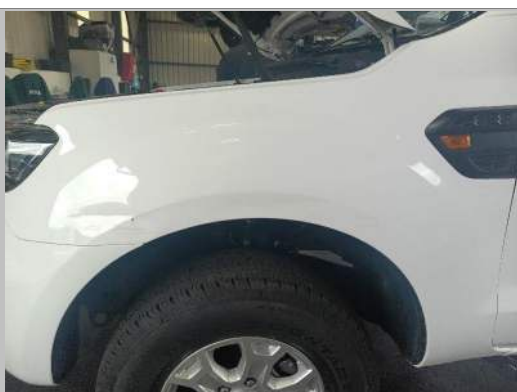
| Damage | Repair Way |
|---|---|
| Front Fender Left Paintwork • Scratched | Repair |

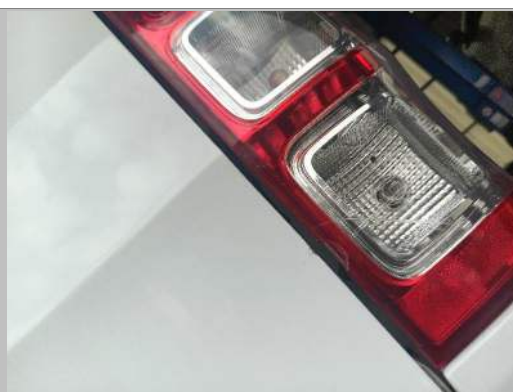
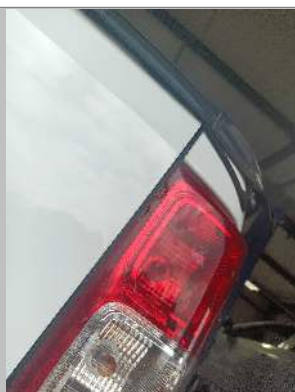
| Damage | Repair Way |
|---|---|
| Tail Light Right Cracked | Replace |

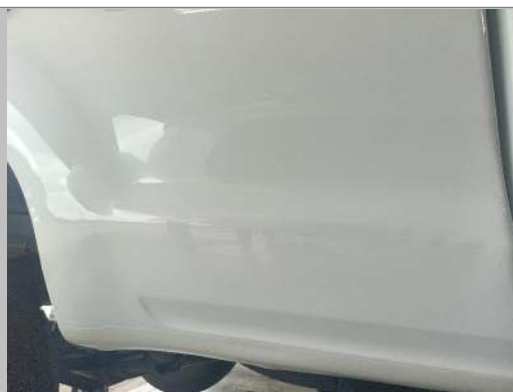
| Damage | Repair Way |
|---|---|
| Load Body Dented | Repair |

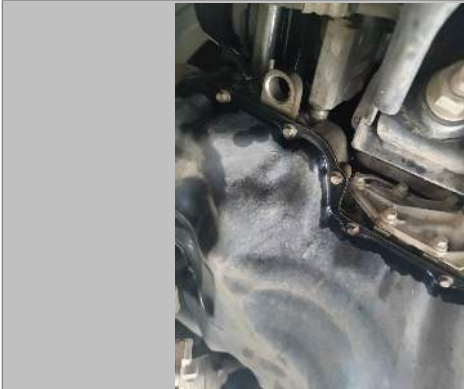
| Damage | Repair Way |
|---|---|
| Engine Oil Sweat | Repair |
