## CONDITION REPORT

Report No: 2016865061

| Model | RANGER 3.2 TDCI XLT D-CAB 4X4 DSL PU AT [2017-2020] | Register Number | |

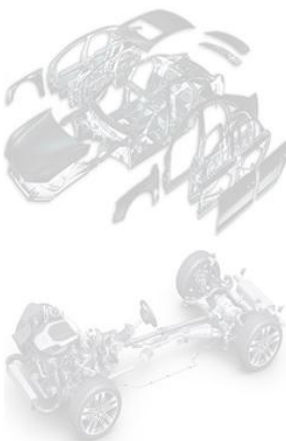
## VEHICLE INSPECTION

| Damage | Repair Way |
| Front Bumper Paintwork • Chipmarks | Repair |
| Bonnet Paintwork • Chipmarks | Repair |
| Front Fender Right Paintwork • Scratched | Repair |
| Rear Fender Left Paintwork • Chipmarks | Repair |
| Door Front Right Paintwork • Chipmarks | Repair |
| Tailgate Paintwork • Scratched | Repair |
| Both number plates missing | Replace |
| No license disc | Replace |

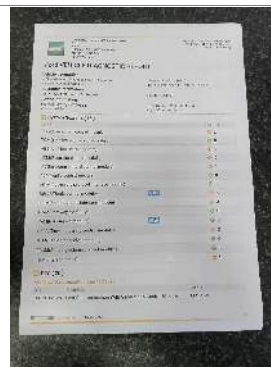
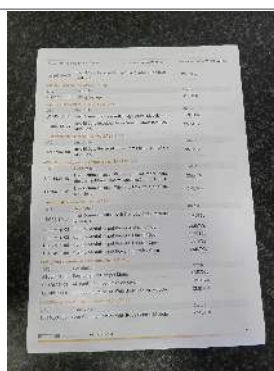
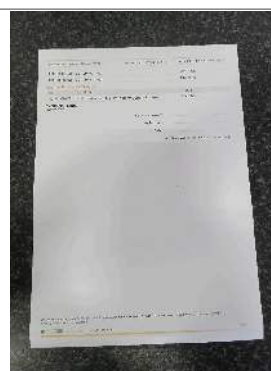
Diagnostic report

| No | System | Code | Description | Status |
|---|---|---|---|---|
| 1 | CMDTCS | U0140:00-08 | LOST COMMUNICATION WITH BODY CONTROL MODULE | |

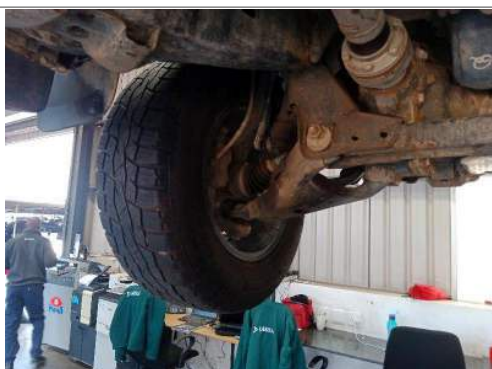
LF TYRE TREAD

| | Size | Load/Speed Index | Manufacture | Model | Type* | Production Date | Tread Depth (mm) |
|---|---|---|---|---|---|---|---|
| Front Left | 265/65R17 | 112T | Sun full | Mont-pro | V | 2921 | 6 mm |

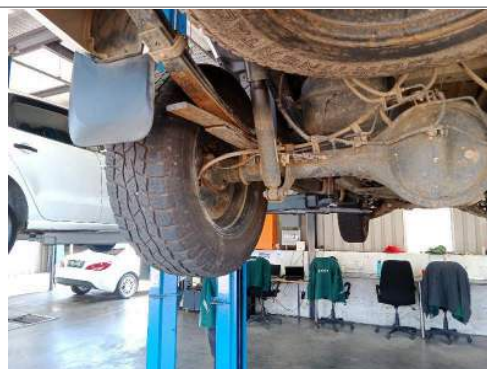
LR TYRE TREAD

| | Size | Load/Speed Index | Manufacture | Model | Type* | Production Date | Tread Depth (mm) |
|---|---|---|---|---|---|---|---|
| Rear Left | 265/65R17 | 112T | Sun full | Mont-pro | V | 2921 | 6 mm |

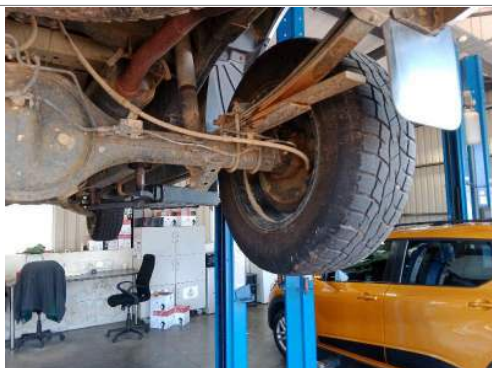
RR TYRE TREAD

| | Size | Load/Speed Index | Manufacture | Model | Type* | Production Date | Tread Depth (mm) |
|---|---|---|---|---|---|---|---|
| Rear Right | 265/65R17 | 112T | Sun full | Mont-pro | V | 2921 | 6 mm |

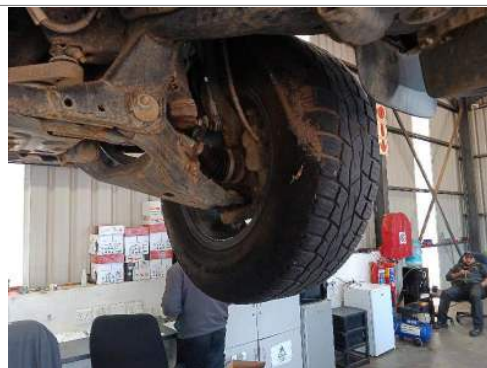
RF TYRE TREAD

| | Size | Load/Speed Index | Manufacture | Model | Type* | Production Date | Tread Depth (mm) |
|---|---|---|---|---|---|---|---|
| Front Right | 265/65R17 | 112T | Sun full | Mont-pro | V | 2921 | 6 mm |

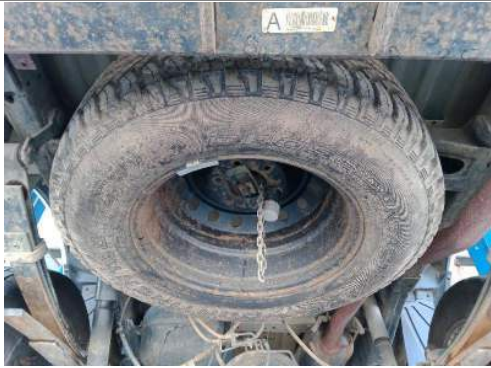
Spare wheel

| | Size | Load/Speed Index | Manufacture | Model | Type* | Production Date | Tread Depth (mm) |
|---|---|---|---|---|---|---|---|
| Spare | 255/65R17 | 112T | Continental | Contact | V | 0000 | 7 mm |

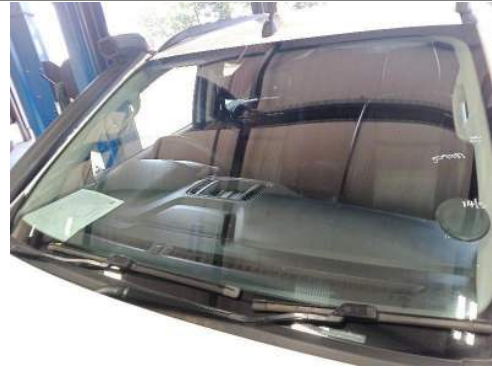
No license disc
