CONDITION REPORT

Report No:  
2017302455  
DATE  
23/09/2026

| Manufacturer | TOYOTA | Registration Number | LBX860MP |
| Model | FORTUNER 2.4 GD-6 RB DSL AT [2023-2024] | Register Number | |

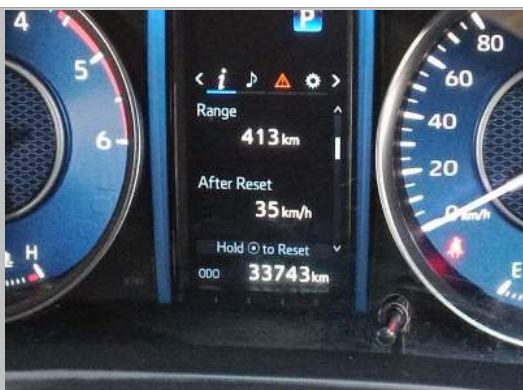
ODOMETER

| Km Reading | 33,743 KM | Fuel | DIESEL |

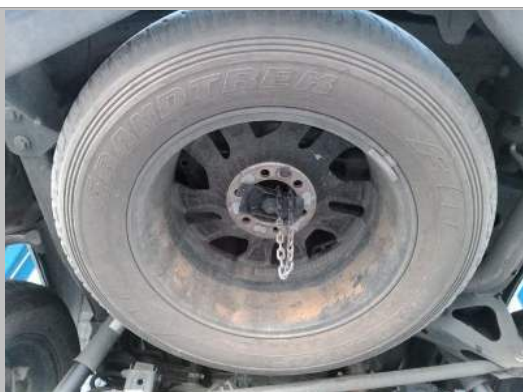
Spare wheel

| | Size | Load/Speed Index | Manufacture | Model | Type* | Production Date | Tread Depth (mm) |
|---|---|---|---|---|---|---|---|
| Spare | 265/60R18 | 110H | Dunlop | Grandtrek | V | //// | 5 mm |

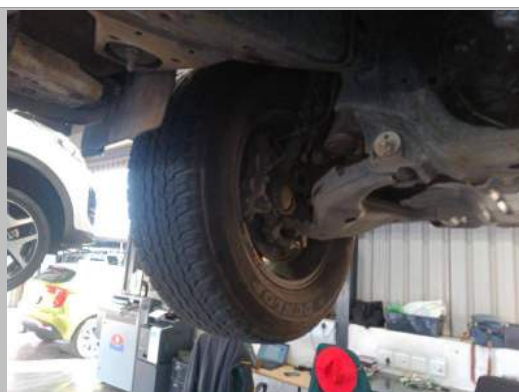
LF TYRE TREAD

| | Size | Load/Speed Index | Manufacture | Model | Type* | Production Date | Tread Depth (mm) |
|---|---|---|---|---|---|---|---|
| Front Left | 265/60R18 | 110H | Dunlop | Grandtrek | V | 4323 | 4 mm |

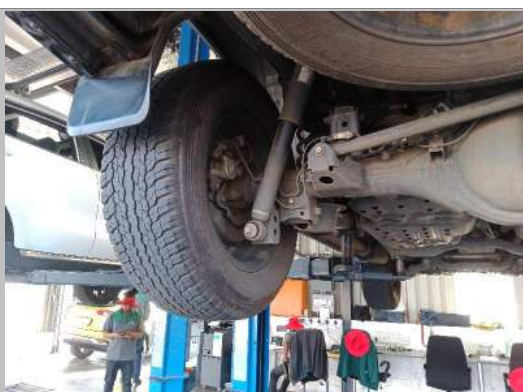
LR TYRE TREAD

| | Size | Load/Speed Index | Manufacture | Model | Type* | Production Date | Tread Depth (mm) |
|---|---|---|---|---|---|---|---|
| Rear Left | 265/60R18 | 110H | Dunlop | Grandtrek | V | 4323 | 4 mm |

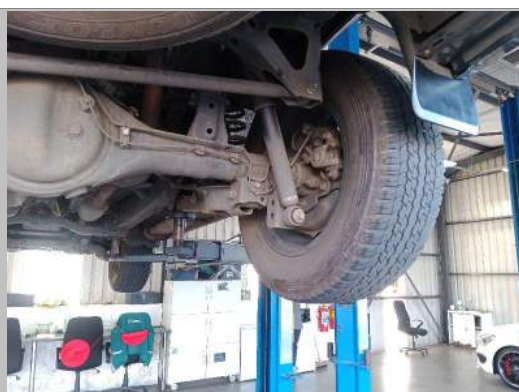
RR TYRE TREAD

| | Size | Load/Speed Index | Manufacture | Model | Type* | Production Date | Tread Depth (mm) |
|---|---|---|---|---|---|---|---|
| Rear Right | 265/60R18 | 110H | Dunlop | Grandtrek | V | 4323 | 4 mm |

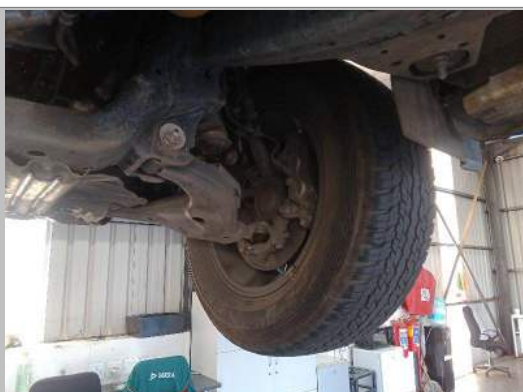
RF TYRE TREAD

| | Size | Load/Speed Index | Manufacture | Model | Type* | Production Date | Tread Depth (mm) |
|---|---|---|---|---|---|---|---|
| Front Right | 265/60R18 | 110H | Dunlop | Grandtrek | V | 4323 | 4 mm |

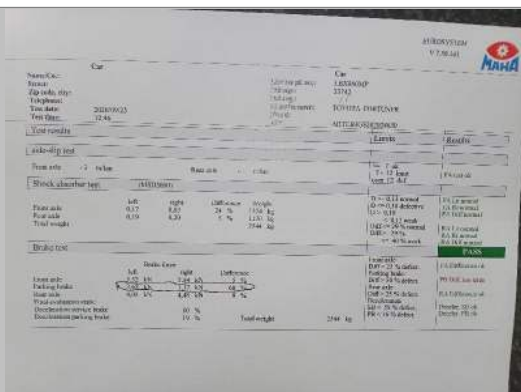
Shock and brake report

| Parking Brake Performance Left / Right Difference out of legal range | Repair |

| | Left | Right | | |
|---|---|---|---|---|
| Emergency / Parking | 3.6 | 1.1 | - | |

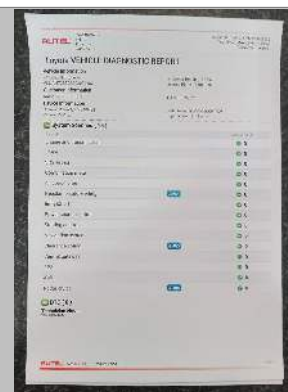
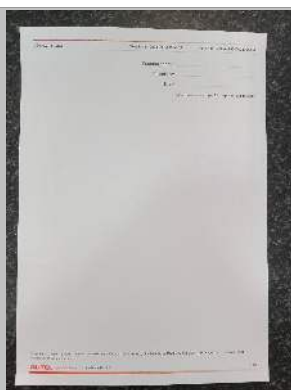
DIAGNOSTIC REPORT PAGE 1

During the diagnostic no active error messages were detected. (See also attached Diagnostic Report. For more information regarding the Fault Codes (DTC) and the recommended rectifications please contact the workshops of the vehicle manufacture).

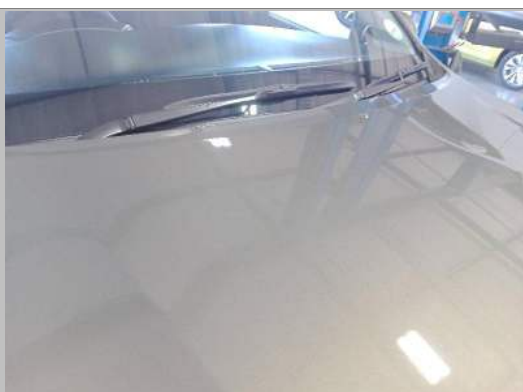
| Bonnet Dented | Repair |

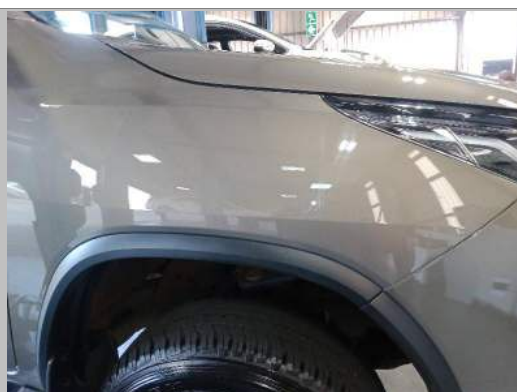
| Front Fender Right Paintwork • Scratched | Repair |

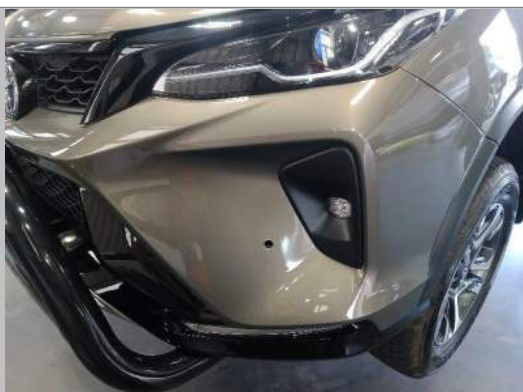
| Front Bumper Damaged | Repair |

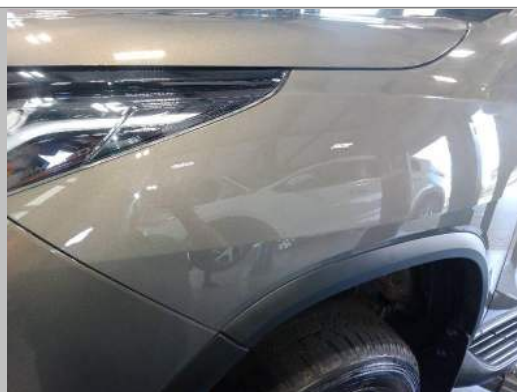
| Front Fender Left Paintwork • Scratched | Repair |
