## CONDITION REPORT

Report No:  
2016977595  
DATE  
13/08/2025

| Manufacturer | TOYOTA | Registration Number | FVL735L |
| Model | HILUX 2.4 GD-6 RAIDER 4X4 DSL D-CAB PU AT [2021-2023] | Register Number | |

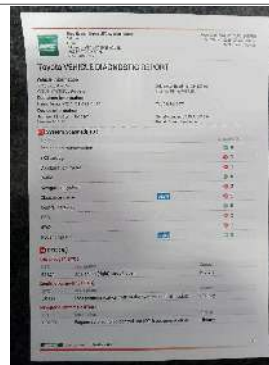
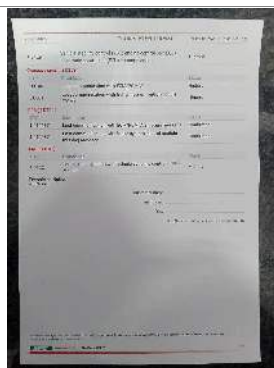
Diagnostic test

During the diagnostic no active error messages were detected. (See also attached Diagnostic Report. For more information regarding the Fault Codes (DTC) and the recommended rectifications please contact the workshops of the vehicle manufacture).

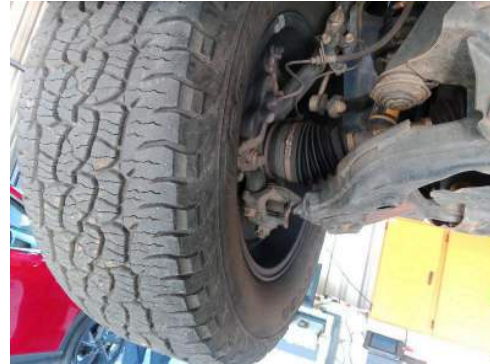
LF TYRE TREAD

| | Size | Load/Speed Index | Manufacture | Model | Type* | Production Date | Tread Depth (mm) |
|---|---|---|---|---|---|---|---|
| Front Left | 265/65R17 | 112T | BF Goodrich | Trail | V | 3824 | 5 mm |

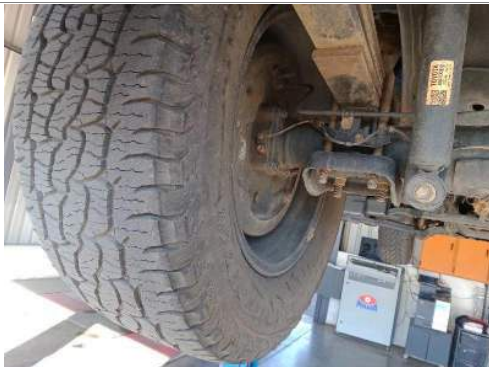
LR TYRE TREAD

| | Size | Load/Speed Index | Manufacture | Model | Type* | Production Date | Tread Depth (mm) |
|---|---|---|---|---|---|---|---|
| Rear Left | 265/65R17 | 112T | BF Goodrich | Trail | V | 3824 | 6 mm |

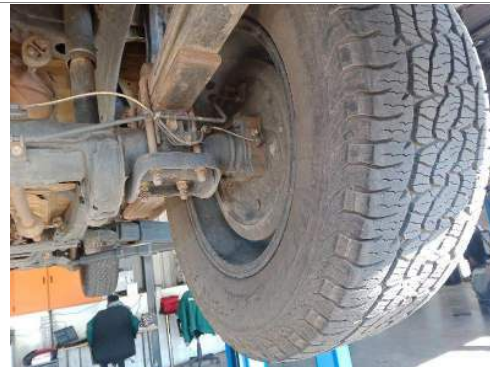
RR TYRE TREAD

| | Size | Load/Speed Index | Manufacture | Model | Type* | Production Date | Tread Depth (mm) |
|---|---|---|---|---|---|---|---|
| Rear Right | 265/65R17 | 112T | BF Goodrich | Trail | V | 3824 | 5 mm |

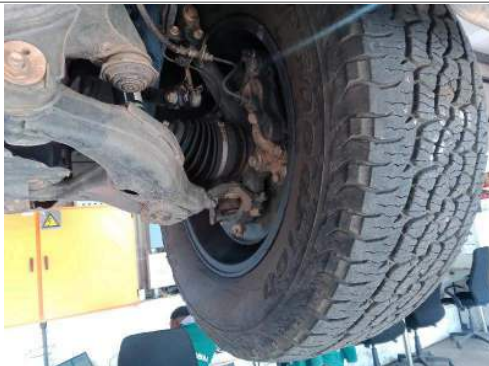
RF TYRE TREAD

| | Size | Load/Speed Index | Manufacture | Model | Type* | Production Date | Tread Depth (mm) |
|---|---|---|---|---|---|---|---|
| Front Right | 265/65R17 | 112T | BF Goodrich | Trail | V | 3821 | 4 mm |

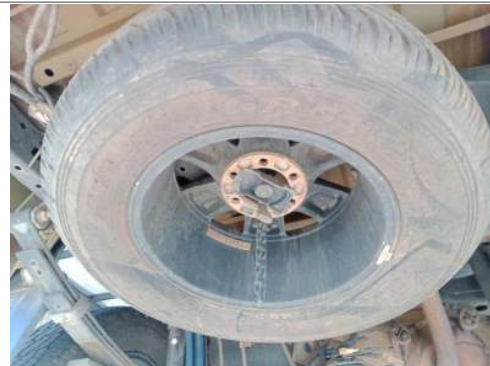
Sparewheel

| | Size | Load/Speed Index | Manufacture | Model | Type* | Production Date | Tread Depth (mm) |
|---|---|---|---|---|---|---|---|
| Spare | 265/65R17 | 112S | Dunlop | Grandtrek | V | 0000 | 5 mm |

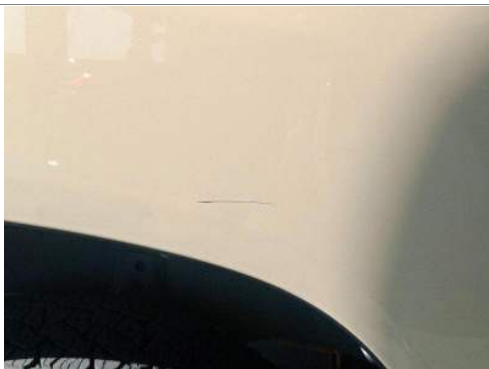
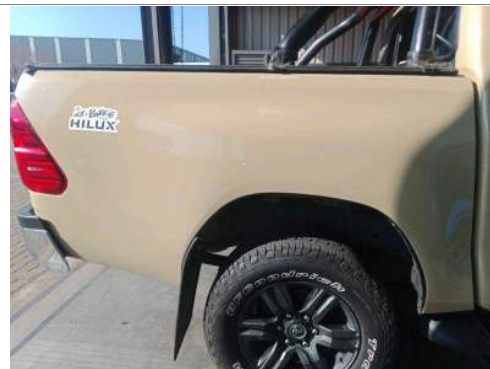
| Damage | Repair Way |
|---|---|
| Load Body Paintwork • Scratched | Repair |

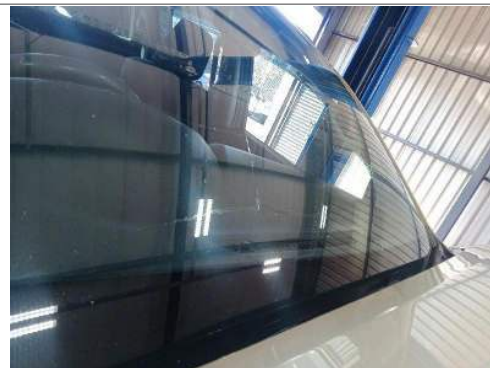
| Damage | Repair Way |
|---|---|
| Windscreen Cracked | Replace |

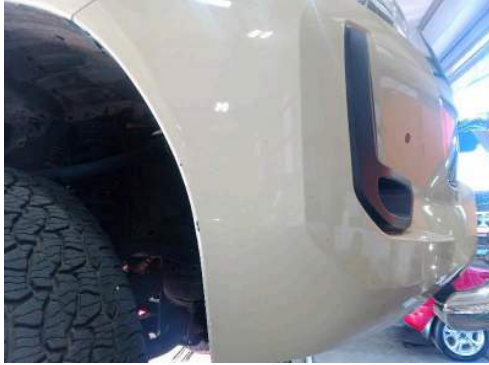
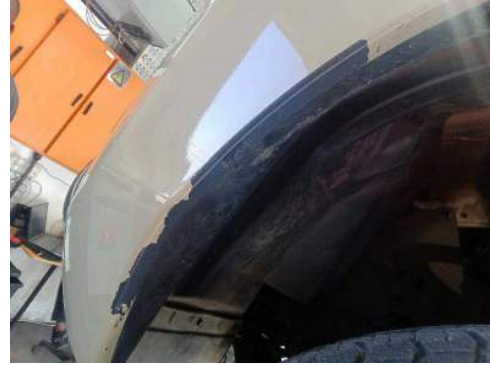
| Damage | Repair Way |
|---|---|
| Front Bumper Paintwork • Scratched | Repair |
