CONDITION REPORT

Report No: 2016866871

Vehicle Type	LIGHT LOAD VEHICLE	Registered Owner	
Manufacturer	TOYOTA	Registration Number	HBJ289L
Model	HILUX 2.4 GD-6 SRX 4X4 D-CAB DSL PU AT [2019-2021]	Register Number	
VIN	AHTKB8CD702975246	Date Of First Licensing	
Engine Number		Last COR	
Doors	4	License Expiry Date	31/12/2025
Color	WHITE	Power / Displacement	
Year Model	2019	Paint Finish	C - COMMON
Km Reading	198,902 KM	Fuel	DIESEL
Cab / Body Type	DOUBLE CAB	Transmission	AUTOMATIC

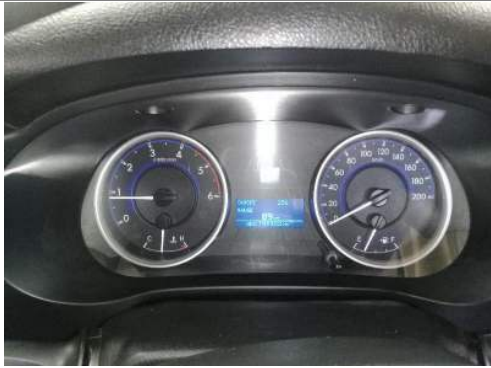
DASHBOARD (W/ ENGINE RUNNING)

No	System	Code	Description	Status
1	CURRENT	P1605	ROUGH IDLING

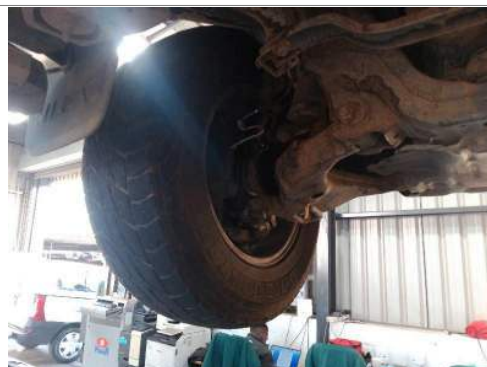
LF TYRE TREAD

Size	Load/Speed Index	Manufacture	Model	Type*	Production Date	Tread Depth (mm)
Front Left	265/65R17	112S	Bridgestone	Dueler	V	0723	2 mm
Front Right	265/65R17	112S	Bridgestone	Dueler	V	4121	2 mm
Rear Left	265/65R17	112S	Bridgestone	Dueler	V	1423	3 mm
Rear Right	265/65R17	112S	Bridgestone	Dueler	V	1323	4 mm
Spare	265/65R17	120/117P	Nk sport	Conqueror	V	1122	7 mm
