CONDITION REPORT

Report No:
2016958195
DATE
25/07/2025

Vehicle Type	PASSENGER VEHICLE	Registered Owner	
Manufacturer	TOYOTA	Registration Number	KWD527NW
Model	HI-ACE 2.5 SESFIKILE 16-S DSL MINIBUS [2021-2024]	Register Number	
		Date Of First Licensing	
VIN	AHTSS22P207140442	Last COR	
Engine Number		License Expiry Date	
Doors	4	Power / Displacement	
Color	WHITE	Paint Finish	TWO COAT UNI
Year Model	2022	Fuel	DIESEL
Km Reading	228,122 KM	Transmission	MANUAL
Cab / Body Type	STATION WAGON

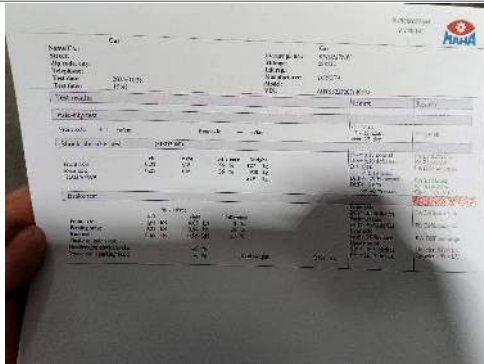
Brake and shock absorber

Left	Right		
	Braking Force [KN]	Braking Force [KN]	Axle Weight [KG]	Deceleration [m/s ²]
Front	4.04	4.05	-	
Rear	0.65	0.89	-	
Emergency / Parking	0.35	0.54	-

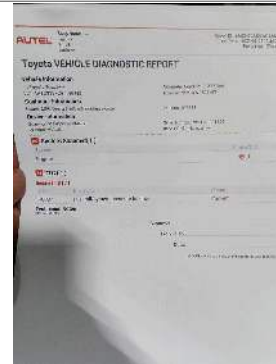
Diagnostic report

No	System	Code	Description	Status
1	ENGINE	P0087	FUEL RAIL/ SYSTEM PRESSURE TO LOW

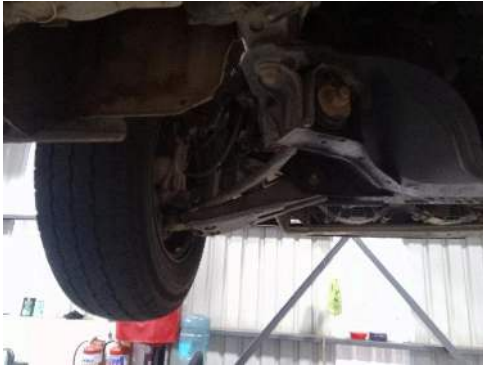
LF TYRE TREAD

Size	Load/Speed Index	Manufacture	Model	Type*	Production Date	Tread Depth (mm)
Front Left	195R15C	104R	Autogrip	Radial	V	1025	2 mm
Front Right	195R15C	104R	Autogrip	Radial	V	1025	1 mm
Rear Left	195R15C	104R	Autogrip	Radial	V	1025	2 mm
Rear Right	195R15C	104R	Autogrip	Radial	V	0125	2 mm

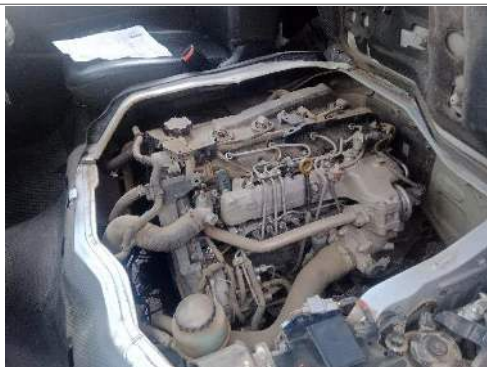
ENGINE 1

Damage	Repair Way
	Engine Oil Leak	Repair
	Seat Front Left Damaged	Repair
	Seat Front Right Damaged	Repair
	Seat Rear Damaged	Repair
	Seat Rear (2. Row) Damaged	Repair
	Door Sealing Rubber Rear Left Damaged	Repair
	Front Bumper Damaged	Repair
	Bonnet Damaged	Repair
	Rear Fender Left Damaged	Repair
	Rear Fender Right Damaged	Repair
	Door Rear Left Damaged	Repair
	Wheel Cylinder / Caliper 2. Axle left Leak	Replace
	Service Brake Performance Rear Axle Left / Right	Roadworthy Relevant
	Difference out of legal range	
	Brakes Insufficient	Repair
