CONDITION REPORT

Report No: 2016450460

Vehicle Type	PASSENGER VEHICLE	Registered Owner	MFC AUCTION HOUSE
Manufacturer	TOYOTA	Registration Number	LF74ZHGP
Model	QUANTUM	Register Number	
VIN	AHTSS22P507149555	Date Of First Licensing	
Engine Number		Last COR	
Doors	4	License Expiry Date	28/02/2025
Color	WHITE	Power / Displacement	
Year Model		Paint Finish	TWO COAT UNI
Km Reading	84,267 KM	Fuel	DIESEL
Cab / Body Type	STATION WAGON	Transmission	MANUAL

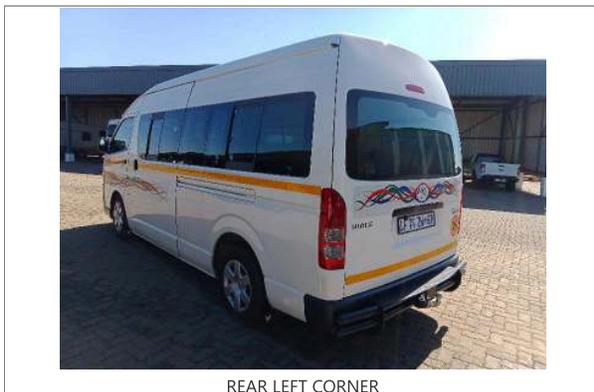
REAR LEFT CORNER

Body and Exterior	Vehicle is a cut and joint
Body and Exterior	Dents and scratches on some body panels
Body and Exterior	Signs of impact damage to rear of vehicle .
Body and Exterior	Stone chips and spray work on some body panels
Body and Exterior	Some body panels misaligned
Interior	Rear left door side step damaged

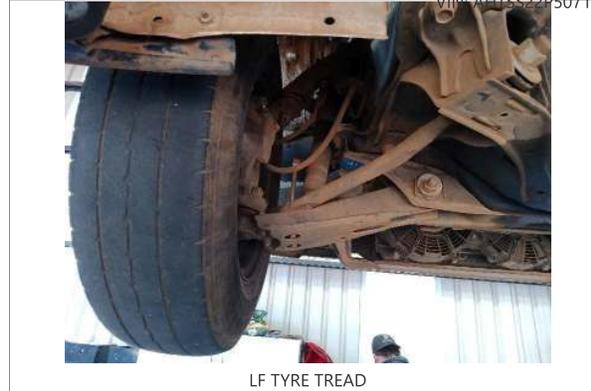
LF TYRE TREAD

Size	Load/Speed Index	Manufacture	Model	Type*	Production Date	Tread Depth (mm)
Front Left	195R15C	106S	Toyo	H07	V	5019	1 mm
Front Right	195R15C	106S	Bridgestone	Taxi	V	4321	3 mm
Rear Left	195R15C	106R	Windforce	Touring	V	1519	0 mm
Rear Right	195R15C	106R	Toyo	HO7	V	1423	0 mm

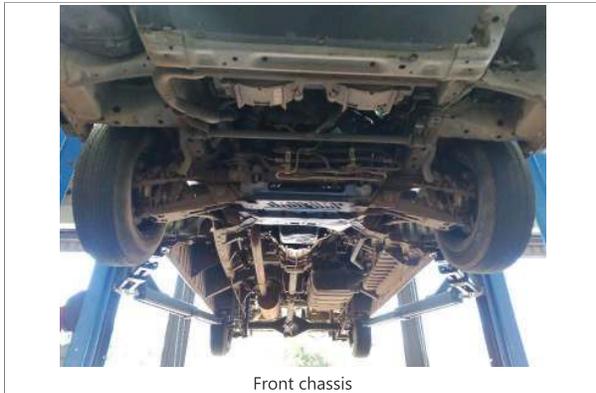
Front chassis

Damage	Repair Way
Main Beam Right Welded	Repair
Chassis Welded	Repair
Sub Frame Dented	Repair
Engine mountings Loose / Excessive Play	Replace
Gearbox Defective	Repair
Radiator Cradle Dented	Repair
Differential Oil Sweat	Repair
Steering Malfunction	Repair
Brakes Insufficient	Repair
Engine Noise Excessive	Repair
Jack Missing	Replace
Wheel Spanner Missing	Replace
Triangle Missing	Replace
Warning lights illuminated on dashboard	Repair
Road test	Vehicle struggles to start
Interior	Interior boot panel damaged.
Engine	Engine bay dirty
Body and Exterior	Jig marks on left and right sill panles
Tyres and rims	Front and rear hubcaps scratched
Tyres and rims	Spare wheel missing
Engine	Engine oil sump dented
Undercarriage	Left and right engine brackets missing
Undercarriage	Gearbox dust plate missing
Undercarriage	Rear right leaf spring bracket damaged
Road test	Vehicle unsafe to drive
Body and Exterior	Vehicle safety integrity compromised

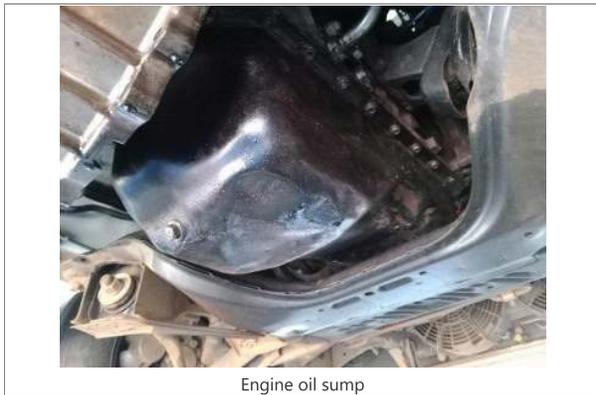
Engine oil sump

Damage	Repair Way
Engine Oil Leak	Repair
Brake Light Centre Cracked	Replace
Number Plate Light Left Defective	Replace
Number Plate Light Right Damaged	Replace
Seat Rear Damaged	Repair
Dash Padding Defective	Repair
Front Bumper Paintwork • Scratched	Repair
Grill Paintwork • Scratched	Repair
Bonnet Paintwork • Chipmarks	Repair
C • Pillar Right Residual Traces of Repair	Repair
Rear Fender Left Damaged	Repair
Rear Fender Right Residual Traces of Repair	Repair
Rear Fender Left / Inner Tray Welded	Repair
Rear Fender Right / Inner Tray Damaged	Repair
Door Front Right Dented	Repair
Door Rear Left Dented	Repair
Rear bumper Paintwork • Scratched	Repair
Inner Boot Floor Pan and Spare Wheel Well Residual Traces of Repair	Repair
Sill Panel Left Paintwork • Scratched	Repair
Sill Panel Right Paintwork • Scratched	Repair
Windscreen Cracked	Replace
Brake Drum 2. Axle left Defective	Repair
Parking Brake Performance Insufficient	Repair

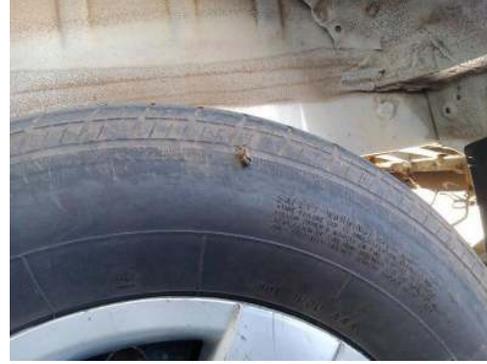
Shock Absorber Rear Left Loose / Excessive Play	Repair
Tyre Front Left Damaged	Replace
Tyre Rear Left Damaged	Replace
Tyre Rear Right Damaged	Replace
Main Beam Left Dented	Repair
