MFC Auction House
M57 Pretoria Rd, Glenmarais, KEMPTON PARK
Gauteng

Vehicle Type	PASSENGER VEHICLE	Registered Owner	
Manufacturer	MITSUBISHI	Registration Number	KZ53RWGP
Model	ASX 2.0 GLS CVT [2014-2018]	Register Number	
VIN	JMYXTGA2WFZC00803	Date Of First Licensing	
Engine Number		Last COR	
Doors	5	License Expiry Date	31/05/2025
Color	GREY	Power / Displacement	
Year Model	2015	Paint Finish	M - METALLIC
Km Reading	170,681 KM	Fuel	PETROL
Cab / Body Type	STATION WAGON	Transmission	AUTOMATIC

VEHICLE INSPECTION

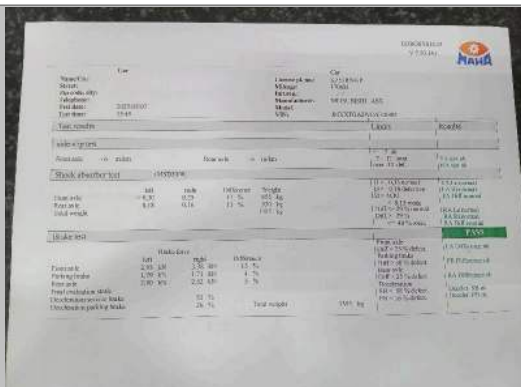
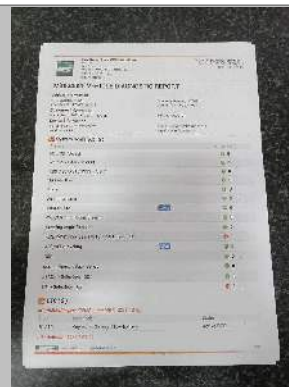
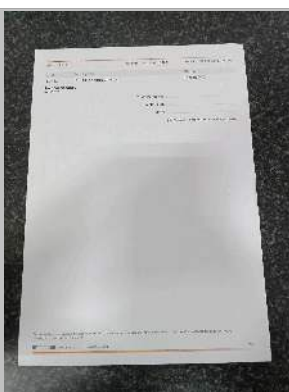
Diagnostic report

No	System	Code	Description	Status
1	ACTIVE DTC	B1A10	KEYLESS/KOS KEY1 LOW BATTERY

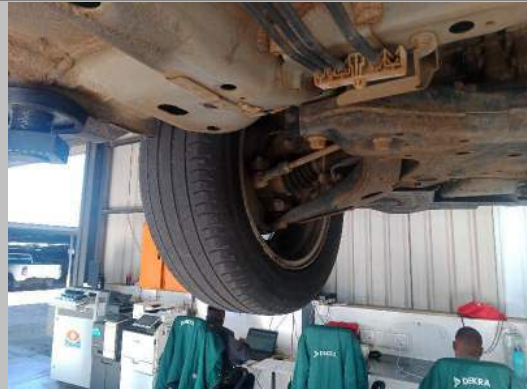
LF TYRE TREAD

Size	Load/Speed Index	Manufacture	Model	Type*	Production Date	Tread Depth (mm)
Front Left	215/60R17	96H	Michelin	Primacy	V	5021	3 mm
Front Right	215/60R17	100V	Kumho	Crugen	V	1818	4 mm
Rear Left	215/60R17	96H	Rovelo	Road quest	V	2022	4 mm
Rear Right	215/60R17	96H	Rovelo	Road quest	V	2022	4 mm
Spare	215/60R17	96H	Lanvigator	Performax	V	0000	2 mm

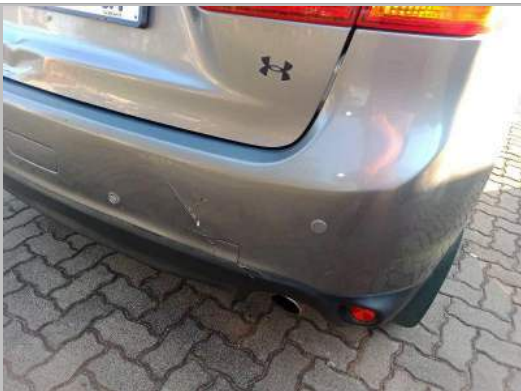
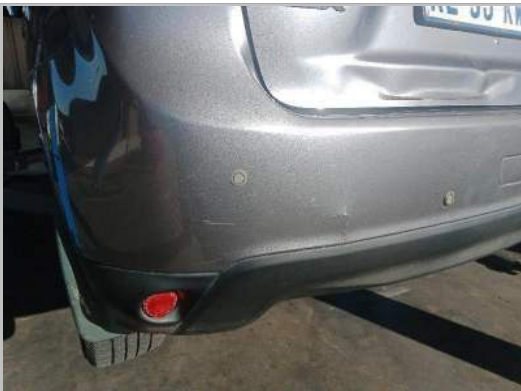
Damage	Repair Way
Side Mirror Right Damaged	Repair
Front Bumper Damaged	Repair
Bonnet Paintwork • Scratched	Repair
Front Fender Right Paintwork • Scratched	Repair
Rear Fender Right Paintwork • Scratched	Repair
Door Front Left Dented	Repair
Door Front Right Paintwork • Scratched	Repair
Door Rear Left Paintwork • Scratched	Repair
Door Rear Right Paintwork • Scratched	Repair
Boot Lid / Hatch door Dented	Repair
Rear bumper Cracked	Repair
Body exterior	Vehicle got minor scratches, stone chips and dents
