## CONDITION REPORT

Report No:  
2017302494  
DATE  
23/09/2026

| Manufacturer | NISSAN | Registration Number | LD30PDGP |
| Model | X-TRAIL 2.5 ACENTA AWD 7-S CVT [2017-2021] | Register Number | |

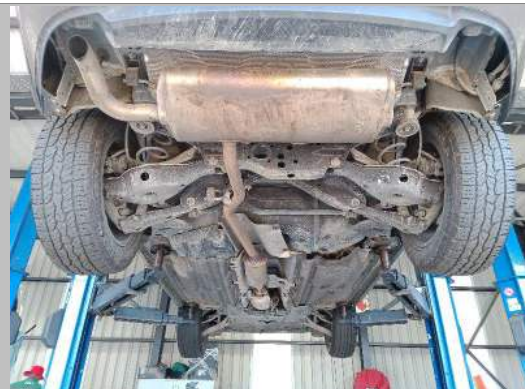
Rear chassis

Undercarriage: Bottom of engine and gearbox fully covered. Vehicle undercarriage dirty

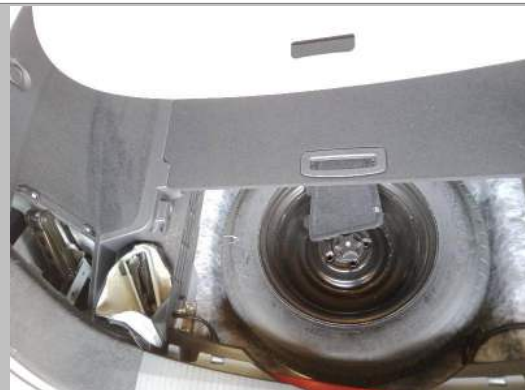
### Spare Wheel and Accessories

| | Size | Load/Speed Index | Manufacture | Model | Type* | Production Date | Tread Depth (mm) |
|---|---|---|---|---|---|---|---|
| Spare | T165/90 D17 | 105M | Falken | Temporary | V | 3722 | 3 mm |

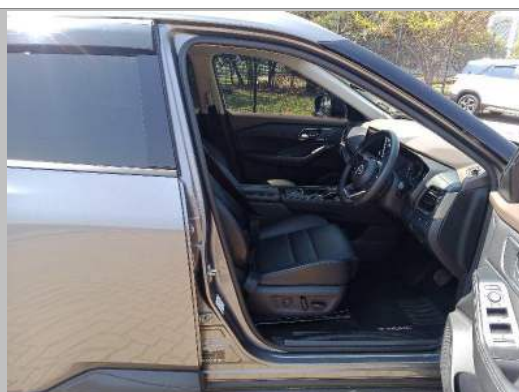
INTERIOR (FRONT DRIVER DOOR)

General Comments: ACCORDING TO THE AGE AND MILEAGE OF THE VEHICLE, NORMAL WEAR AND TEAR MARKS ARE VISIBLE ON THE INTERIOR, EXTERIOR, ELECTRICAL AND MECHANICAL PARTS. Interior: Vehicle interior dirty and panels scratched.

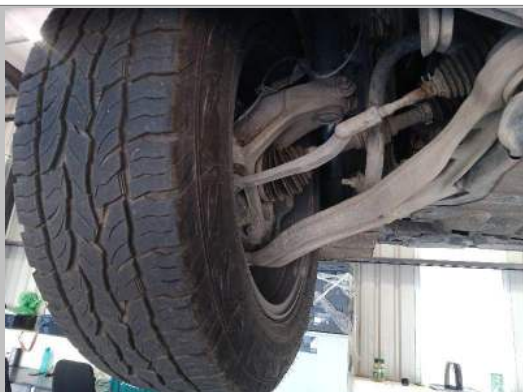
LF TYRE TREAD

| | Size | Load/Speed Index | Manufacture | Model | Type* | Production Date | Tread Depth (mm) |
|---|---|---|---|---|---|---|---|
| Front Left | 235/60 R18 | 103H | Dunlop | Grandtrek | V | 3824 | 5 mm |

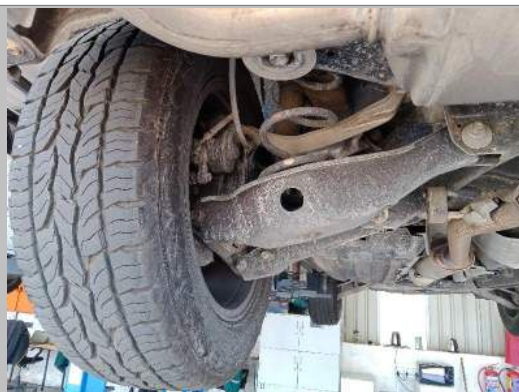
LR TYRE TREAD

| | Size | Load/Speed Index | Manufacture | Model | Type* | Production Date | Tread Depth (mm) |
|---|---|---|---|---|---|---|---|
| Rear Left | 235/60 R18 | 103H | Dunlop | Grandtrek | V | 3824 | 5 mm |

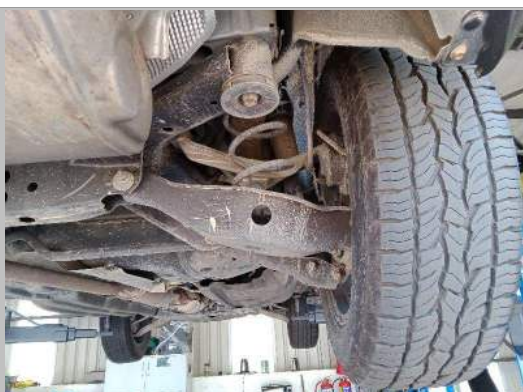
RR TYRE TREAD

| | Size | Load/Speed Index | Manufacture | Model | Type* | Production Date | Tread Depth (mm) |
|---|---|---|---|---|---|---|---|
| Rear Right | 235/60 R18 | 103H | Dunlop | Grandtrek | V | 3824 | 6 mm |

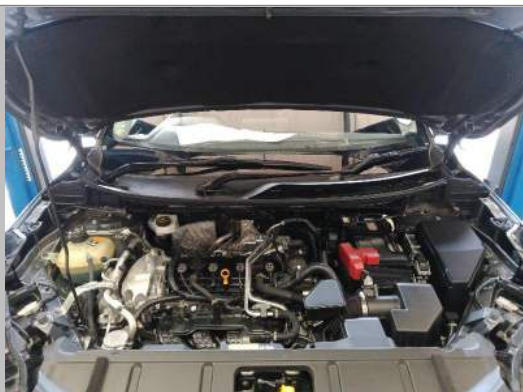
ENGINE 1

Engine number – not possible to verify engine number (not visible without dismantling)

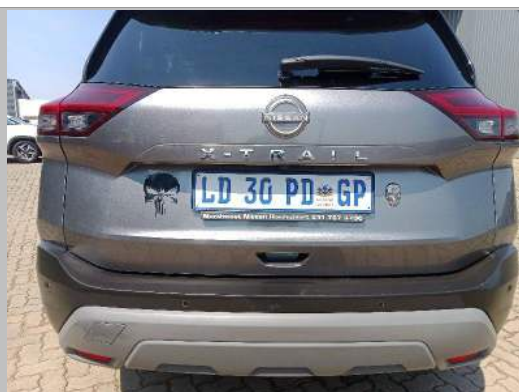
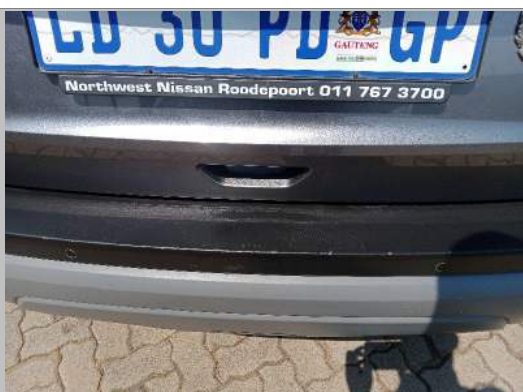
Front Bumper Damaged  
 C • Pillar Left Dented  
 Door Rear Left Residual Traces of Repair  
 Rear bumper Paintwork • Scratched  
 Roof Dented  
 Belly plates Damaged

Repair  
 Repair  
 Repair  
 Repair  
 Repair  
 Repair
