CONDITION REPORT

Report No: 2016205657

Vehicle Type	PASSENGER VEHICLE	Registered Owner	MFC
Manufacturer	TOYOTA	Registration Number	KM98CLGP
Model	URBAN CRUISER	Register Number	
VIN	JTDPYGJ1S00902202	Date Of First Licensing	
Engine Number		Last COR	
Doors	5	License Expiry Date	31/03/2023
Color	GREY	Power / Displacement	
Year Model		Paint Finish	M - METALLIC
Km Reading	58,442 KM	Fuel	PETROL
Cab / Body Type	STATION WAGON	Transmission	MANUAL

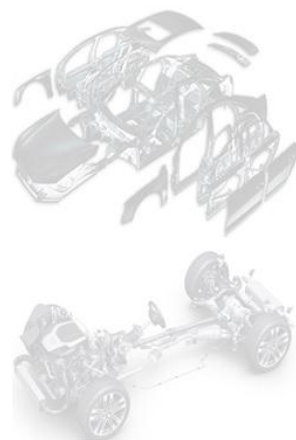
Damage	Repair Way
Front Bumper Paintwork • Scratched	Repair
Rear Fender Right Damaged	Repair
Door Front Right Damaged	Repair
Door Rear Left Paintwork • Scratched	Repair
Door Rear Right Damaged	Repair
Rear bumper Paintwork • Scratched	Repair
Windscreen Cracked	Replace

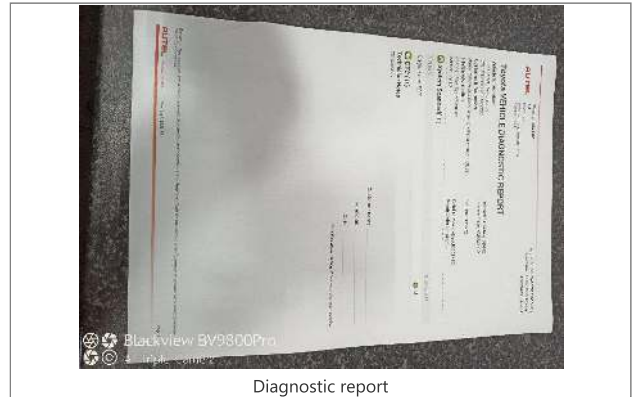
Diagnostic report

During the diagnostic no active error messages were detected. (See also attached Diagnostic Report. For more information regarding the Fault Codes (DTC) and the recommended rectifications please contact the workshops of the vehicle manufacture).

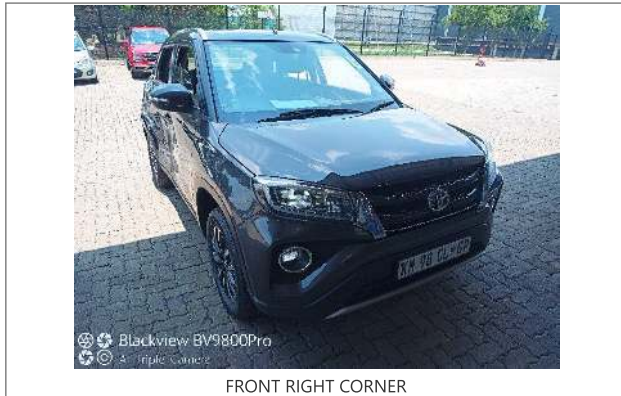
FRONT RIGHT CORNER

Body • Exterior: Vehicle got some scratches, stone chips and dents on some body panels. Impact damage at right side of vehicle

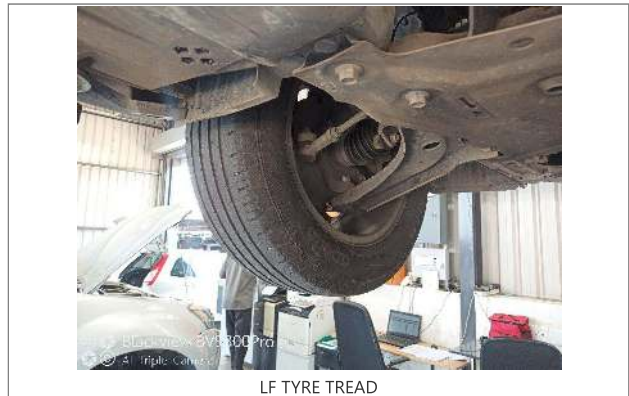
LF TYRE TREAD

Size	Load/Speed Index	Manufacture	Model	Type*	Production Date	Tread Depth (mm)
Front Left	215/60R16	95H	Apollo	Alnac	V	0222	3 mm
Front Right	215/60R16	95H	Apollo	Alnac	V	0322	3 mm
Rear Left	215/60R16	95H	Apollo	Alnac	V	0322	4 mm
Rear Right	215/60R16	95H	Apollo	Alnac	V	0322	4 mm
Spare	215/60R16	95H	Apollo	Alnac	V	////	5 mm
