CONDITION REPORT

Report No:
2016950947
DATE
18/07/2025

Vehicle Type	MINI BUS	Registered Owner	MFC AUCTION HOUSE
Manufacturer	TOYOTA	Registration Number	KH00WFGP
Model	QUANTUM 2.8 GL DSL LWB BUS 11-S [2021-2024]	Register Number	
		Date Of First Licensing	
VIN	JTFPA9AP208022697	Last COR	
Engine Number		License Expiry Date	
Doors	5	Power / Displacement	
Color	WHITE	Paint Finish	C - COMMON
Year Model	2021	Fuel	DIESEL
Km Reading	185,660 KM	Transmission	MANUAL
Cab / Body Type	OTHERS

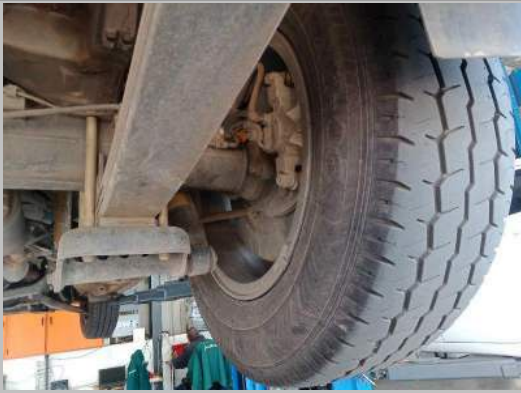
RR TYRE TREAD

Size	Load/Speed Index	Manufacture	Model	Type*	Production Date	Tread Depth (mm)
Front Left	235/65R15	115/113R	Aplus	A807	V	4323	5 mm
Front Right	235/65R16	115/113R	Aplus	A867	R	4323	5 mm
Rear Left	235/65R16	115/113R	Aplus	A867	V	4323	5 mm
Rear Right	235/65R15	115/113R	Aplus	A867	V	4323	6 mm
Spare	235/65R16	115/113T	Bridgestone	Duragrip	V	0000	5 mm

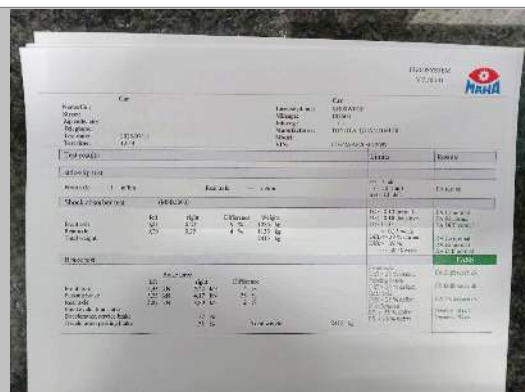
SHOCK AND BRAKE REPORT

Left	Right		
	Braking Force [KN]	Braking Force [KN]	Axle Weight [KG]	Deceleration [m/s ²]
Front	5.4	5.2	-	
Rear	3.8	3.8	-	
Emergency / Parking	3.2	4.1	-

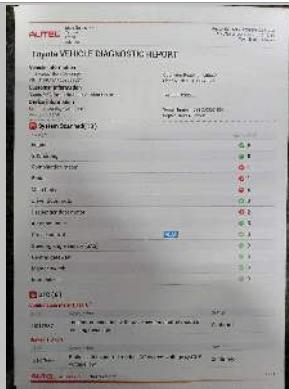
DIAGNOSTIC REPORT PAGE 1

No	System	Code	Description	Status
1	PASSENGER DOOR MOTOR	B2313	GLASS POSITION INITIALIZATION INCOMPLETE
