## CONDITION REPORT

Report No:  
2016999444  
DATE  
02/09/2025

| Manufacturer | TOYOTA | Registration Number | HW17YFGP |
| Model | RAV4 2.0 GX CVT [2017-2019] | Register Number | |

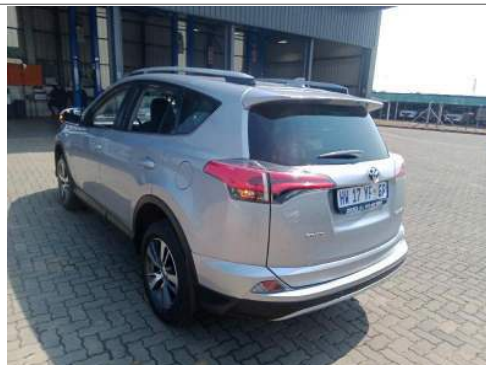
REAR LEFT CORNER

| | Damage | Repair Way |
|--|---|---|
| | Front Bumper Paintwork • Scratched<br>Door Rear Left Paintwork • Scratched<br>Door Rear Right Paintwork • Scratched<br>Rear bumper Damaged<br>Spare Tyre Smooth<br>Body exterior | Repair<br>Repair<br>Repair<br>Repair<br>Replace<br>Signs of spray work done on some body panels |

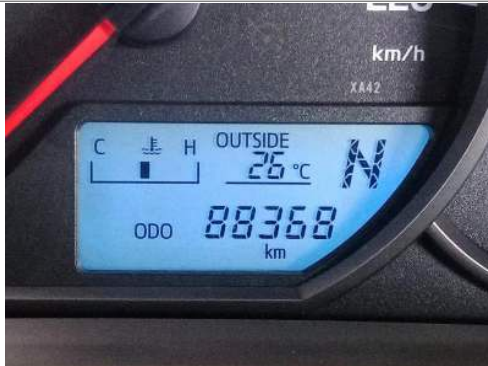
ODOMETER

| Km Reading | 88,368 KM | Fuel | PETROL |

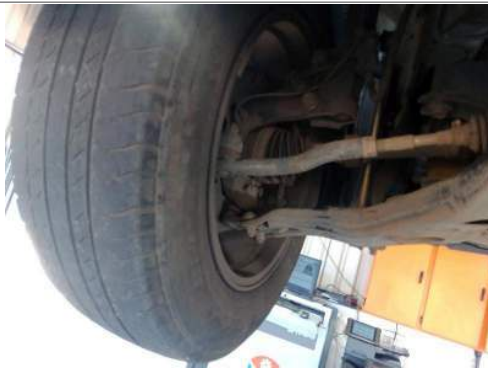
LF TYRE TREAD

| | Size | Load/Speed Index | Manufacture | Model | Type* | Production Date | Tread Depth (mm) |
|---|---|---|---|---|---|---|---|
| Front Left | 225/65R17 | 102H | Michelin | Latitude | V | 3318 | 0 mm |

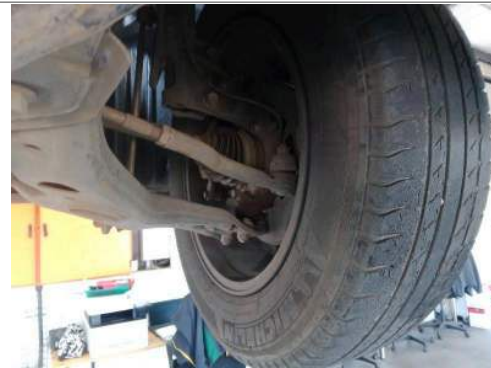
RF TYRE TREAD

| | Size | Load/Speed Index | Manufacture | Model | Type* | Production Date | Tread Depth (mm) |
|---|---|---|---|---|---|---|---|
| Front Right | 225/65R17 | 102H | Michelin | Latitude | V | 3318 | 2 mm |

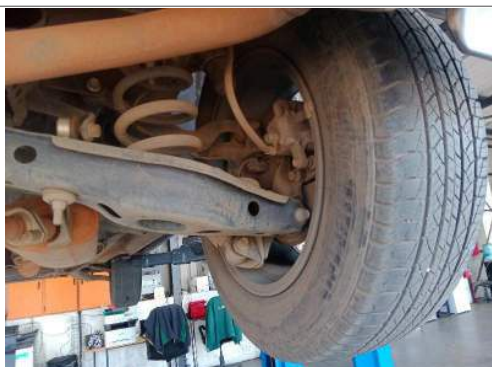
RR TYRE TREAD

| | Size | Load/Speed Index | Manufacture | Model | Type* | Production Date | Tread Depth (mm) |
|---|---|---|---|---|---|---|---|
| Rear Right | 225/65R17 | 102H | Michelin | Latitude | V | 3318 | 5 mm |

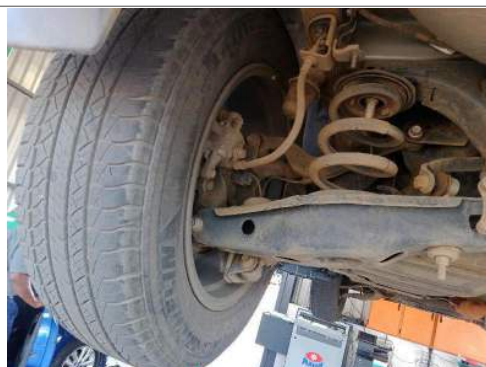
LR TYRE TREAD

| | Size | Load/Speed Index | Manufacture | Model | Type* | Production Date | Tread Depth (mm) |
|---|---|---|---|---|---|---|---|
| Rear Left | 225/65R17 | 102H | Michelin | Latitude | V | 3318 | 5 mm |

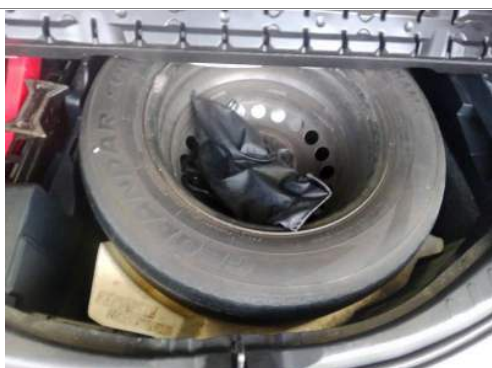
Sparewheel

| | Size | Load/Speed Index | Manufacture | Model | Type* | Production Date | Tread Depth (mm) |
|---|---|---|---|---|---|---|---|
| Spare | 215/65R16 | 98H | Yokohama | Geolandar | V | //////// | 0 mm |

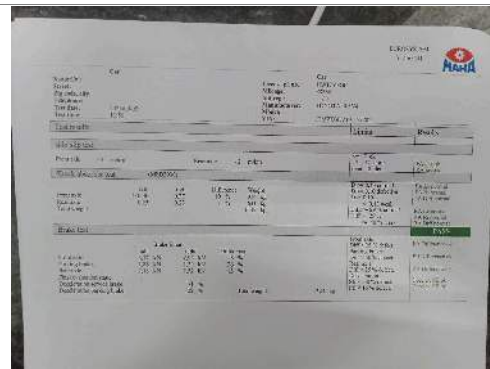
SHOCK AND BRAKE REPORT

| | Left | Right | Axle Weight [KG] | Deceleration [m/s²] |
|---|---|---|---|---|
| Front | 3.1 | 2.9 | - | |
| Rear | 2.1 | 2.5 | - | |
| Emergency / Parking | 1.8 | 1.3 | - | |

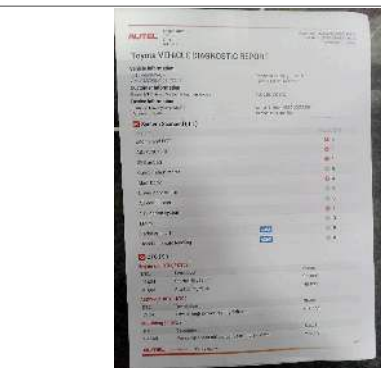
DIAGNOSTIC REPORT PAGE 1

| No | System | Code | Description | Status |
|---|---|---|---|---|
| 1 | ENGINE AND ECT | P1604 | STARTABILITY FAULT | |

During the diagnostic the following error messages were detected: (See also attached Diagnostic Report. For more information regarding the Fault Codes (DTC) and the recommended rectifications please contact the workshops of the vehicle manufacture).
