CONDITION REPORT

Report No:
2017026797
DATE
30/09/2025

Vehicle Type	LIGHT LOAD VEHICLE	Registered Owner	MFC
Manufacturer	HYUNDAI	Registration Number	HH96JKGP
Model	H-1	Register Number	
VIN	KMFWBX7KMJU974099	Date Of First Licensing	
Engine Number		Last COR	
Doors	5	License Expiry Date	28/02/2025
Color	WHITE	Power / Displacement	
Year Model		Paint Finish	TWO COAT UNI
Km Reading	228,583 KM	Fuel	DIESEL
Cab / Body Type	PANEL VAN	Transmission	AUTOMATIC

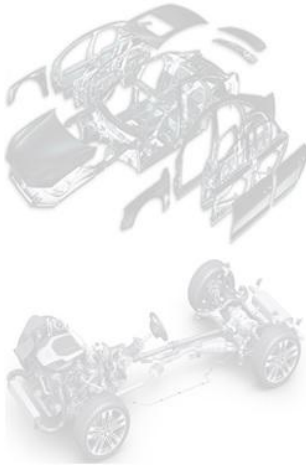
Damage	Repair Way
Front Bumper Damaged	Repair
Front Fender Left Damaged	Repair
Rear Fender Left Damaged	Repair
Door Rear Left Damaged	Repair
Boot Lid / Hatch door Damaged	Repair
Windscreen Scratched	Replace

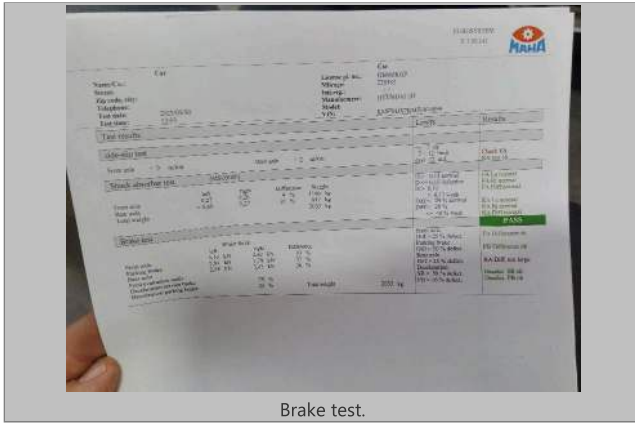
Brake test.

Left	Right	Axle Weight [KG]	Deceleration [m/s ²]
	Braking Force [KN]	Braking Force [KN]		
Front	5.16	4.62	-	
Rear	2.55	3.47	-	
Emergency / Parking	2.84	1.79	-

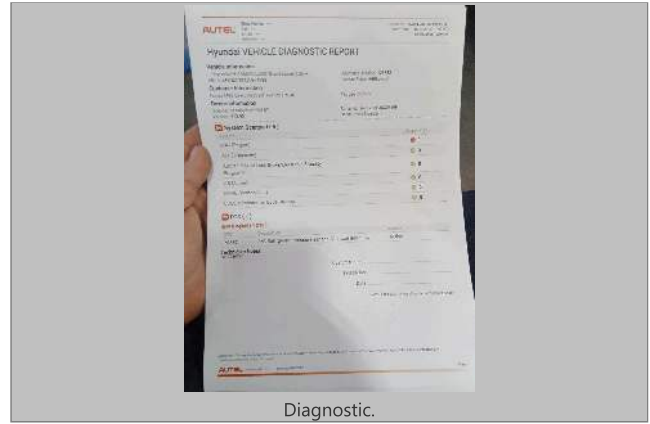
Diagnostic.

During the diagnostic no active error messages were detected. (See also attached Diagnostic Report. For more information regarding the Fault Codes (DTC) and the recommended rectifications please contact the workshops of the vehicle manufacture).

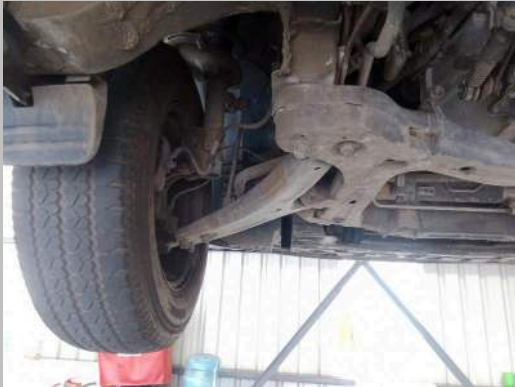
LF TYRE TREAD

Size	Load/Speed Index	Manufacture	Model	Type*	Production Date	Tread Depth (mm)
Front Left	215/70R16	106R	Royal black	Radial	V	3923	1 mm
Front Right	215/70R16	106R	Royal black	Radial	V	3923	1 mm
Rear Left	215/70R16	106R	Royal black	Radial	V	4323	2 mm
Rear Right	215/70R16	106R	Royal black	Radial	V	3923	3 mm
Spare	215/70R16	106R	Hilo	Radial	V	0000	4 mm
