## CONDITION REPORT

Report No:  
2017298425  
DATE  
14/09/2026

| Manufacturer | HYUNDAI | Registration Number | MC45BBGP |
| Model | H-100 | Register Number | |

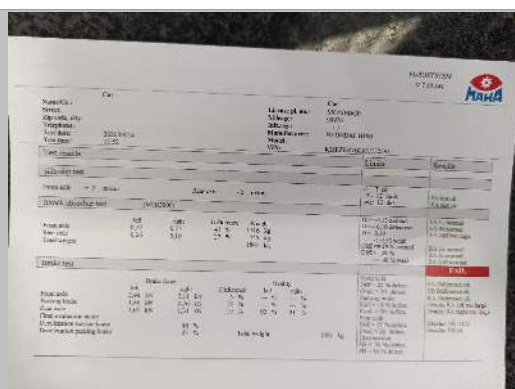
Shock and brake report

| | Left | Right | | |
|---|---|---|---|---|
| Front | 2.9 | 3.1 | - | |
| Rear | 1.6 | 1.3 | - | |
| Emergency / Parking | 1.8 | 2.2 | - | |

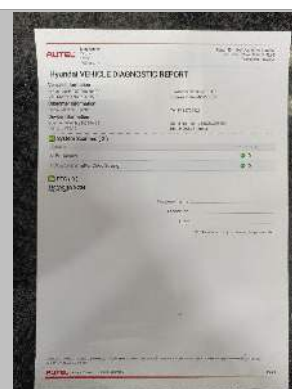
Diagnostics report

During the diagnostic no active error messages were detected. (See also attached Diagnostic Report. For more information regarding the Fault Codes (DTC) and the recommended rectifications please contact the workshops of the vehicle manufacture).

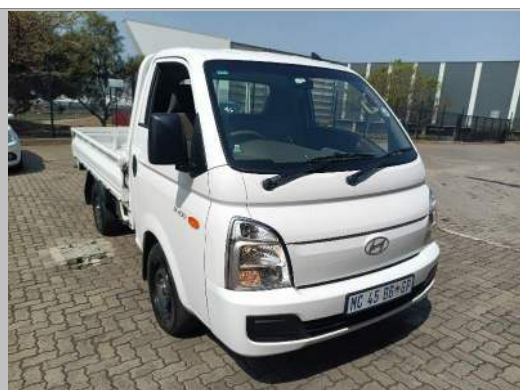
FRONT RIGHT CORNER

Bonnet Paintwork • Chipmarks  
 Door Front Right Paintwork • Scratched  
 Load Body Paintwork • Scratched  
 Windscreen Cracked  
 Tyre Front Right Excessive Wear & Tear

Repair  
 Repair  
 Repair  
 Replace  
 Replace

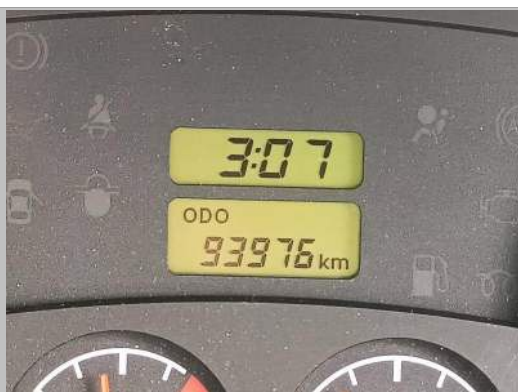
ODOMETER

| Km Reading | 93,976 KM | Fuel | DIESEL |

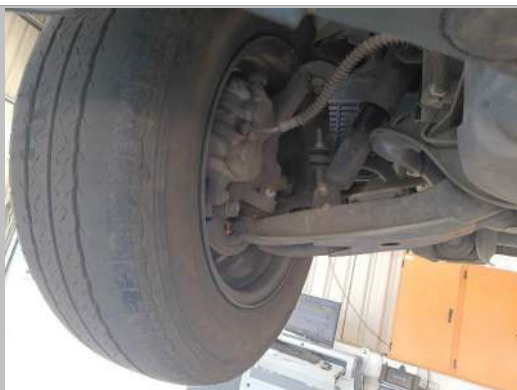
LF TYRE TREAD

| | Size | Load/Speed Index | Manufacture | Model | Type* | Production Date | Tread Depth (mm) |
|---|---|---|---|---|---|---|---|
| Front Left | 195/70R15 | 104/102S | Nexen | CP321 | V | 0000 | 0 mm |

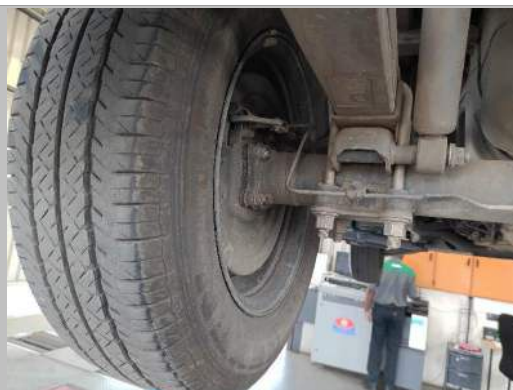
LR TYRE TREAD

| | Size | Load/Speed Index | Manufacture | Model | Type* | Production Date | Tread Depth (mm) |
|---|---|---|---|---|---|---|---|
| Rear Left | 195/70R15 | 104/102S | Nexen | CP321 | V | 0524 | 6 mm |

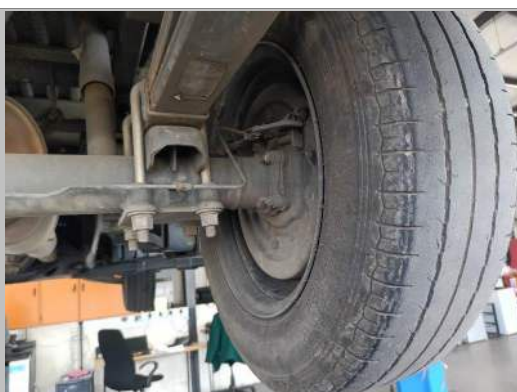
RR TYRE TREAD

| | Size | Load/Speed Index | Manufacture | Model | Type* | Production Date | Tread Depth (mm) |
|---|---|---|---|---|---|---|---|
| Rear Right | 195/70R15 | 104/102S | Nexen | 321 | V | 0524 | 3 mm |

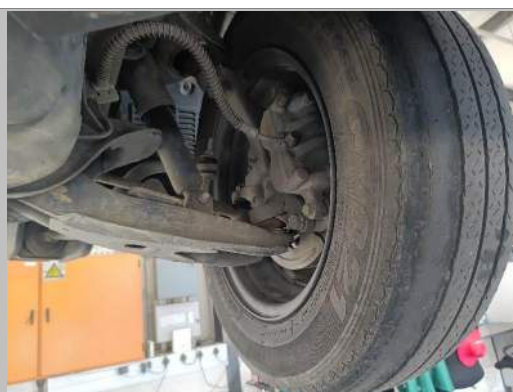
RF TYRE TREAD

| | Size | Load/Speed Index | Manufacture | Model | Type* | Production Date | Tread Depth (mm) |
|---|---|---|---|---|---|---|---|
| Front Right | 195/70R15 | 104/102S | Nexen | CP321 | V | 0524 | 0 mm |

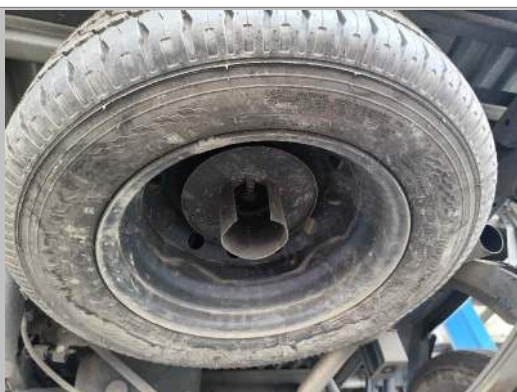
Sparewheel

| | Size | Load/Speed Index | Manufacture | Model | Type* | Production Date | Tread Depth (mm) |
|---|---|---|---|---|---|---|---|
| Spare | 195/70R15 | 104/102R | Royal black | Commerical | V | 0000 | 9 mm |

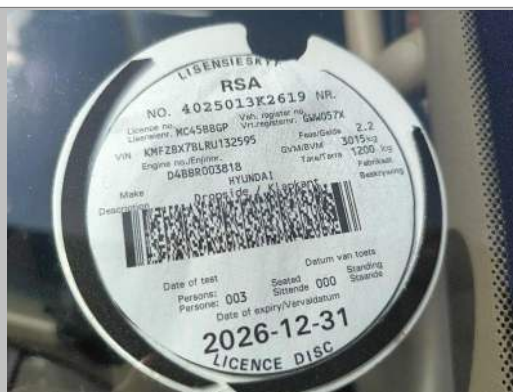
LICENSE DISC

| Doors | 2 | License Expiry Date | 31/12/2026 |

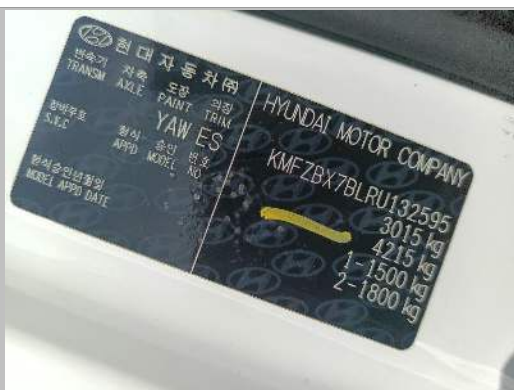
VIN PLATE OR STICKER

| VIN | KMFZBX7BLRU132595 | Date Of First Licensing | |

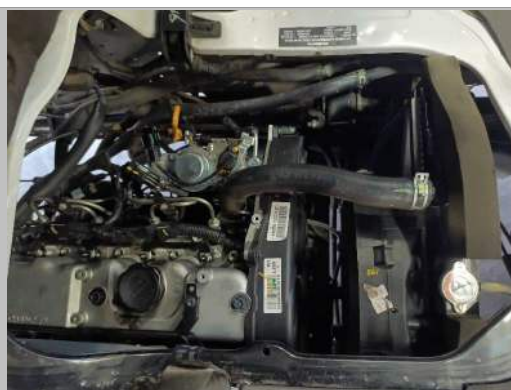
ENGINE 1

Engine number – not possible to verify engine number (not visible without dismantling)

General Comments: ACCORDING TO THE AGE AND MILEAGE OF THE VEHICLE, NORMAL WEAR AND TEAR MARKS ARE VISIBLE ON THE INTERIOR, EXTERIOR, ELECTRICAL AND MECHANICAL PARTS. Engine Compartment: Bottom of engine is fully covered.
