CONDITION REPORT

Report No: 2016258236

Vehicle Type	PASSENGER VEHICLE	Registered Owner	MFC AUCTION HOUSE
Manufacturer	HYUNDAI	Registration Number	JZ82SXGP
Model	TUCSON	Register Number	
VIN	KMHJ381AMMU406072	Date Of First Licensing	
Engine Number		Last COR	
Doors	5	License Expiry Date	31/05/2024
Color	WHITE	Power / Displacement	
Year Model		Paint Finish	TWO COAT UNI
Km Reading	93,330 KM	Fuel	DIESEL
Cab / Body Type	STATION WAGON	Transmission	AUTOMATIC

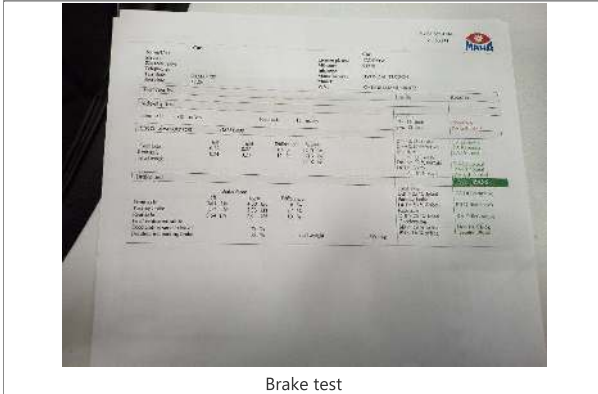
Brake test

Left	Right	Axle Weight [KG]	Deceleration [m/s ²]
	Braking Force [KN]	Braking Force [KN]		
Front	3.64	4.33	-	
Rear	2.64	2.94	-	
Emergency / Parking	2.77	3.33	-

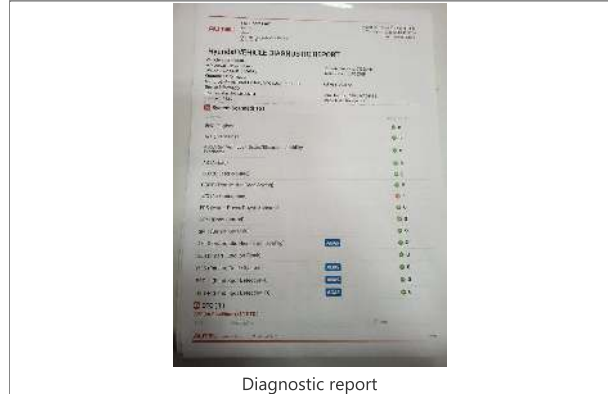
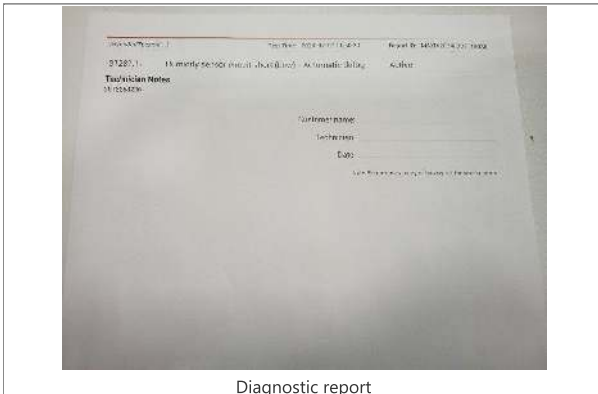
Diagnostic report

During the diagnostic no active error messages were detected. (See also attached Diagnostic Report. For more information regarding the Fault Codes (DTC) and the recommended rectifications please contact the workshops of the vehicle manufacture).

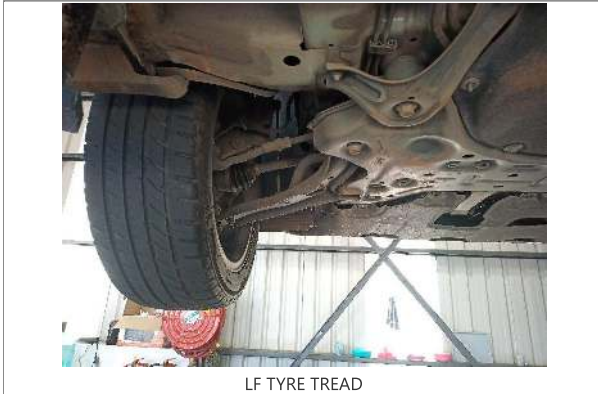
LF TYRE TREAD

Size	Load/Speed Index	Manufacture	Model	Type*	Production Date	Tread Depth (mm)
Front Left	245/45R19	102W	Royalblack	Radial	V	1822	3 mm
Front Right	245/45R19	102W	Royalblack	Radial	V	1822	3 mm
Rear Left	245/45R19	98H	Hankook	Radial	V	4520	0 mm
Rear Right	245/45R19	98H	Hankook	Radial	V	4520	1 mm

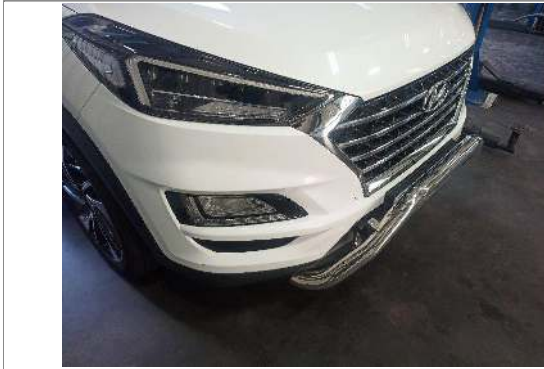
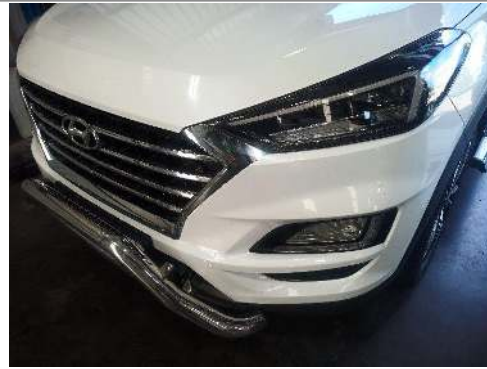
Damage	Repair Way
Front Bumper Damaged	Repair
Bonnet Damaged	Repair
Front Fender Left Damaged	Repair
Door Front Left Damaged	Repair
Door Front Right Damaged	Repair
Door Rear Left Damaged	Repair
Door Rear Right Damaged	Repair
Boot Lid / Hatch door Damaged	Repair
Rear bumper Damaged	Repair
Tyre Rear Left Worn	Replace

General Comments: Body • Exterior: Minor dents and scratches and stone chips to some body panels. Signs of repair work done to some body panels. Poor alignment to some body panels. Signs of hail damage to some body panels.
