MFC Auction House
M57 Pretoria Rd, Glenmarais, KEMPTON PARK
Gauteng

DEKRA MFC
M57 Pretoria Rd - 1619
KEMPTON PARK - GT
08610 33572

VEHICLE INSPECTION

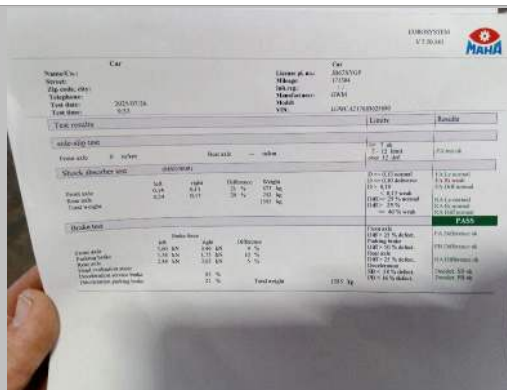
Brake test.

Left	Right		
	Braking Force [KN]	Braking Force [KN]	Axle Weight [KG]	Deceleration [m/s ²]
Front	3.6	3.46	-	
Rear	2.88	3.03	-	
Emergency / Parking	1.58	1.75	-

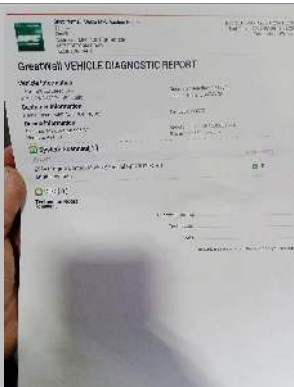
Diagnostic.

During the diagnostic no active error messages were detected. (See also attached Diagnostic Report. For more information regarding the Fault Codes (DTC) and the recommended rectifications please contact the workshops of the vehicle manufacture).

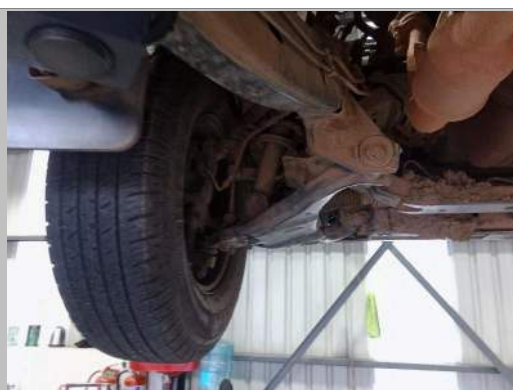
LF TYRE TREAD

Size	Load/Speed Index	Manufacture	Model	Type*	Production Date	Tread Depth (mm)
Front Left	215/75R15	100S	Giti	Radial	V	1818	2 mm
Front Right	195R15C	104S	Dunlop	Sp	V	0620	0 mm
Rear Left	195R15C	104S	Dunlop	Sp	V	0620	0 mm
Rear Right	205/70R15C	104S	Continental	Worldcontact	V	3722	1 mm

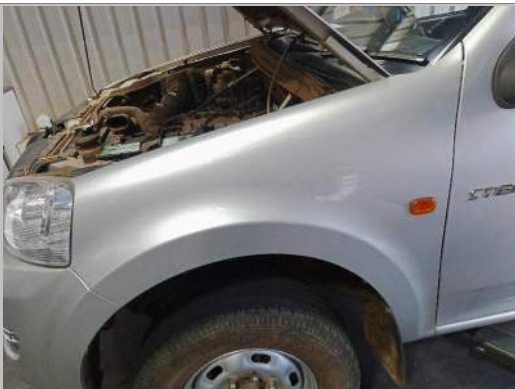
Damage	Repair Way
Engine Oil Leak	Repair
Seat Front Right Damaged	Repair
Front Bumper Damaged	Repair
Bonnet Damaged	Repair
Front Fender Left Damaged	Repair
Front Fender Right Damaged	Repair
Rear Fender Left Damaged	Repair
Rear Fender Right Damaged	Repair
Door Front Left Damaged	Repair
Door Front Right Damaged	Repair
Door Rear Left Damaged	Repair
Door Rear Right Damaged	Repair
Tailgate Damaged	Repair
Windscreen Damaged	Replace
Tyre Front Right Worn	Replace
Tyre Rear Left Worn	Replace
Gearbox Oil Leak	Repair

General Comments: Body • Exterior: Minor dents and scratches and stone chips to some body panels. Signs of repair work done to somebody panels. Poor alignment to somebody panels.
