CONDITION REPORT

Report No: 2016843958

Vehicle Type	PASSENGER VEHICLE	Registered Owner	
Manufacturer	HAVAL	Registration Number	JYF050MP
Model	H2 1.5 CITY [2017-2020]	Register Number	
VIN	LGWEE4A40KH914356	Date Of First Licensing	
Engine Number		Last COR	
Doors	5	License Expiry Date	31/10/2024
Color	WHITE	Power / Displacement	
Year Model	2019	Paint Finish	TWO COAT UNI
Km Reading	99,744 KM	Fuel	PETROL
Cab / Body Type	STATION WAGON	Transmission	MANUAL

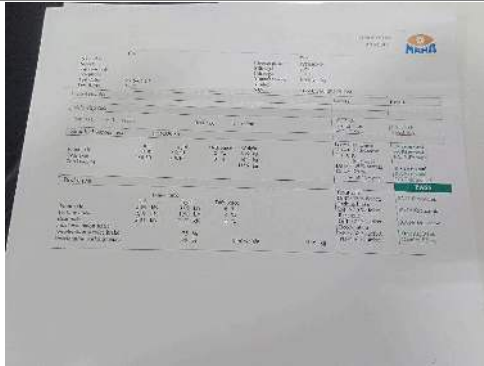
Brake test

Left	Right		
	Braking Force [KN]	Braking Force [KN]	Axle Weight [KG]	Deceleration [m/s <sup>2</sup> ]
Front	2.89	3.08	-	
Rear	2.31	2.42	-	
Emergency / Parking	2.01	1.96	-

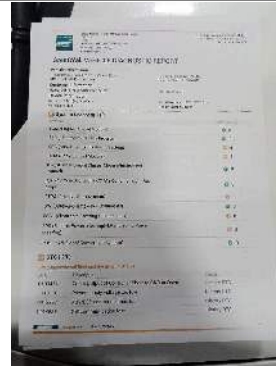
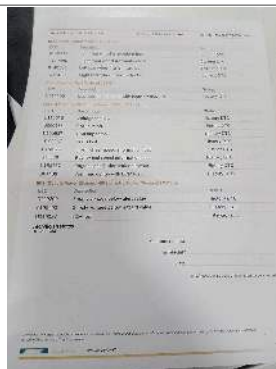
Diagnostics

No	System	Code	Description	Status
1	SRS	B103414	CRASH OUTPUT OF CONTROLLER SHORT TO GND

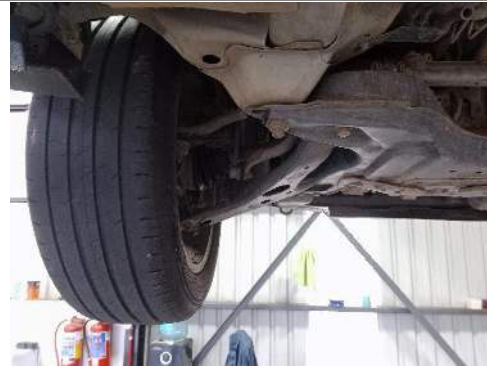
LF TYRE TREAD

Size	Load/Speed Index	Manufacture	Model	Type*	Production Date	Tread Depth (mm)
Front Left	235/55R18	100V	Goodyear	Efficient	V	2321	2 mm
Front Right	235/55R18	100V	Goodyear	Efficient	V	2321	2 mm
Rear Left	235/55R18	100V	Goodyear	Efficient	V	2321	3 mm
Rear Right	235/55R18	100V	Goodyear	Efficient	V	2321	2 mm

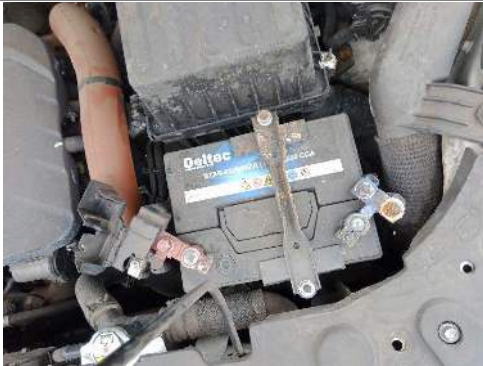
Damage	Repair Way
Battery clamps Corrosion	Repair
Fog Light Front Right Damaged	Replace
Headlight Left Damaged	Replace
Side Mirror Right Damaged	Replace
Front Bumper Damaged	Repair
Grill Damaged	Repair
Front Fender Left Damaged	Repair
Front Fender Right Damaged	Repair
Rear Fender Right Damaged	Repair
Door Front Left Damaged	Repair
Door Front Right Damaged	Repair
Door Rear Left Damaged	Repair
Door Rear Right Damaged	Repair
Rear bumper Damaged	Repair
