## CONDITION REPORT

Report No:  
2016917745  
DATE  
19/06/2025

| Manufacturer | HAVAL | Registration Number | HT86LTGP |
| Model | H2 | Register Number | |

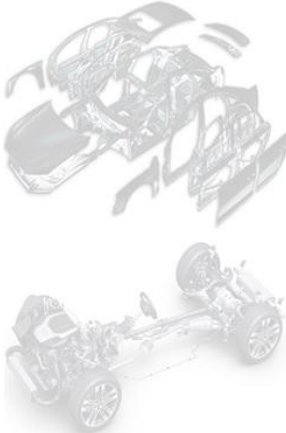
| | Damage | Repair Way |
|---|---|---|
| | Water level Insufficient<br>Fog Light Front Left Malfunction<br>Seat Front Right Torn / Cut<br>Gear Lever Dust Boot Defective<br>Front Bumper Paintwork • Scratched<br>Bonnet Paintwork • Chipmarks<br>Front Fender Left Paintwork • Scratched<br>Front Fender Right Paintwork • Scratched<br>Rear Fender Right Dented<br>Door Front Left Paintwork • Scratched<br>Door Front Right Paintwork • Scratched<br>Door Rear Left Dented<br>Door Rear Right Paintwork • Scratched<br>Rear bumper Damaged<br>Windscreen Chipped<br>Shock Absorber Rear Left Leak<br>Shock Absorber Rear Right Leak<br>Battery loose<br>All four tires deferred name brand | Repair<br>Repair<br>Repair<br>Repair<br>Repair<br>Repair<br>Repair<br>Repair<br>Repair<br>Repair<br>Repair<br>Repair<br>Repair<br>Repair<br>Repair<br>Replace<br>Replace<br>Repair<br>Repair |

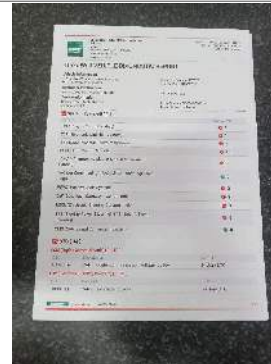
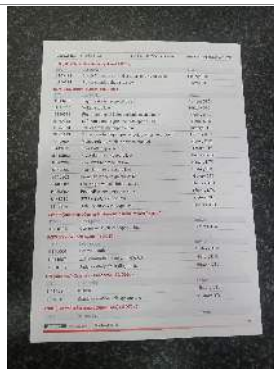
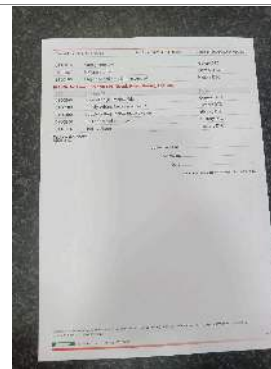
Diagnostic report

| No | System | Code | Description | Status |
|---|---|---|---|---|
| 1 | HISTORY DTC | U110116 | UNDERVOLTAGE | |

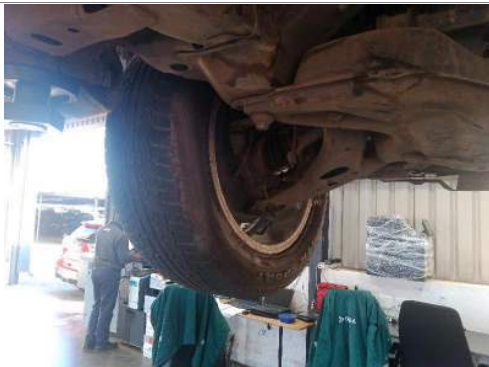
LF TYRE TREAD

| | Size | Load/Speed Index | Manufacture | Model | Type* | Production Date | Tread Depth (mm) |
|---|---|---|---|---|---|---|---|
| Front Left | 235/55R18 | 104V | Desert hawk | Atr sport | V | 4817 | 4 mm |

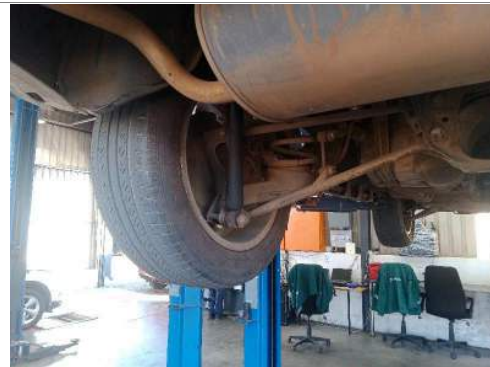
LR TYRE TREAD

| | Size | Load/Speed Index | Manufacture | Model | Type* | Production Date | Tread Depth (mm) |
|---|---|---|---|---|---|---|---|
| Rear Left | 235/55R18 | 100H | Hankook | Optimo | V | 2413 | 4 mm |

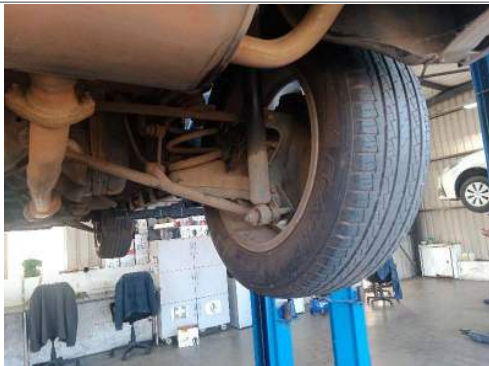
RR TYRE TREAD

| | Size | Load/Speed Index | Manufacture | Model | Type* | Production Date | Tread Depth (mm) |
|---|---|---|---|---|---|---|---|
| Rear Right | 235/55R18 | 103H | Wanli | Flash Asc28 | V | 5114 | 4 mm |

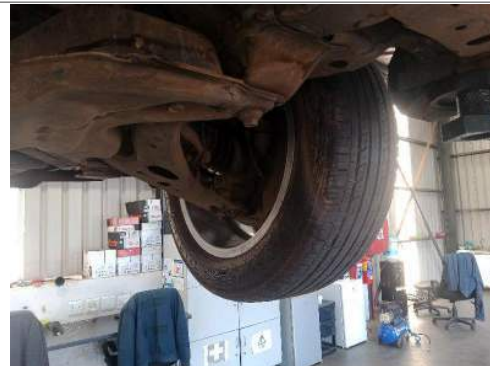
RF TYRE TREAD

| | Size | Load/Speed Index | Manufacture | Model | Type* | Production Date | Tread Depth (mm) |
|---|---|---|---|---|---|---|---|
| Front Right | 235/55R18 | 100H | Kumho | Solus | V | 3920 | 3 mm |

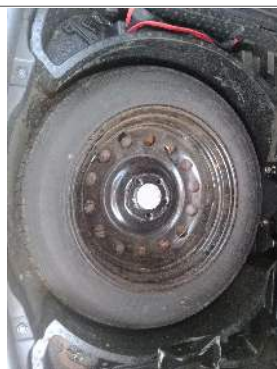
Spare wheel

| | Size | Load/Speed Index | Manufacture | Model | Type* | Production Date | Tread Depth (mm) |
|---|---|---|---|---|---|---|---|
| Spare | T155/85R18 | 115M | Chao yang | Rp03 | V | 0000 | 4 mm |

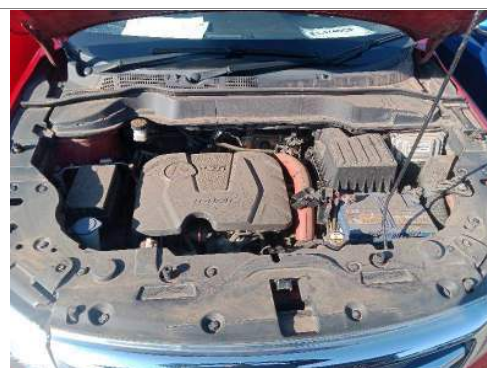
ENGINE 1

Engine number – not possible to verify engine number (not visible without dismantling)

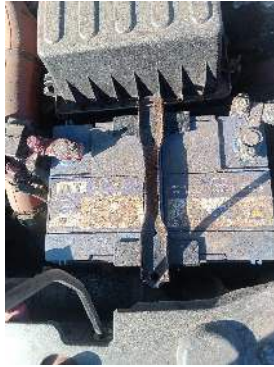
Battery loose
