## CONDITION REPORT

Report No:  
2017302459  
DATE  
23/09/2026

| Manufacturer | HAVAL | Registration Number | LM92YFGP |
| Model | JOLION 1.5T CITY [2021-2024] | Register Number | |

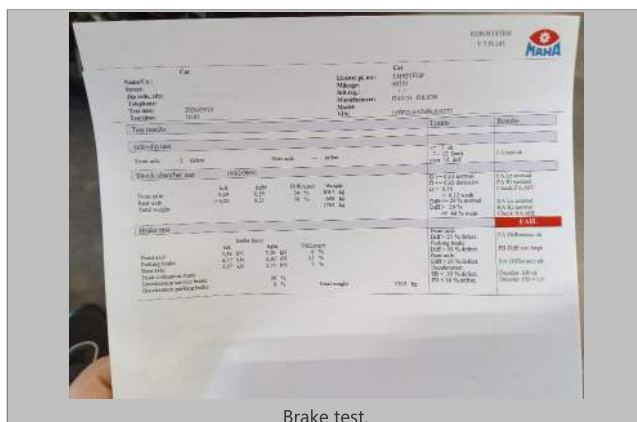
## Brake Test Results

| | Left | Right | | |
|---|---|---|---|---|
| Front | 3.58 | 3.3 | - | |
| Rear | 2.07 | 2.13 | - | |
| Emergency / Parking | 0.77 | 0.3 | - | |

Brake test.

| Parking Brake Performance Left / Right Difference out of legal range | Repair |

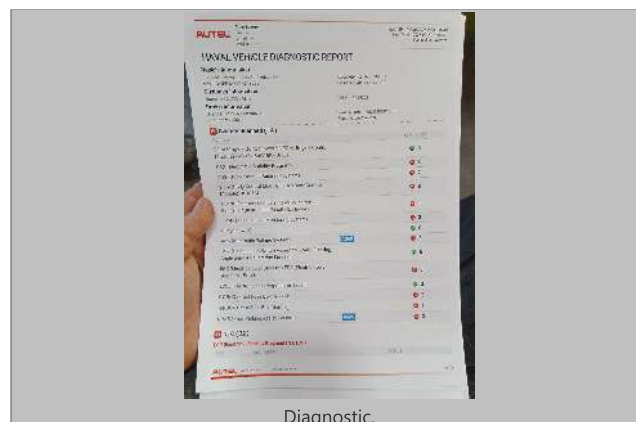
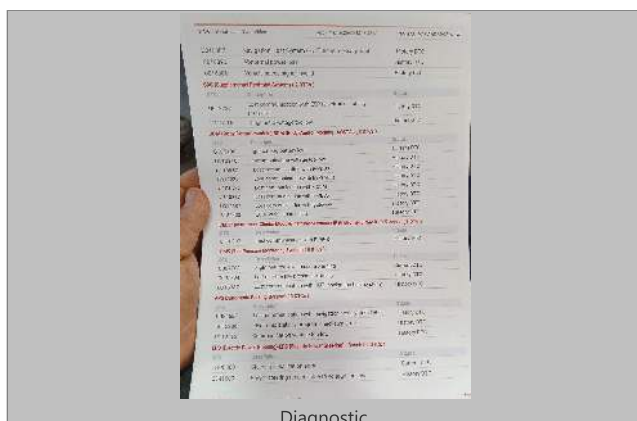
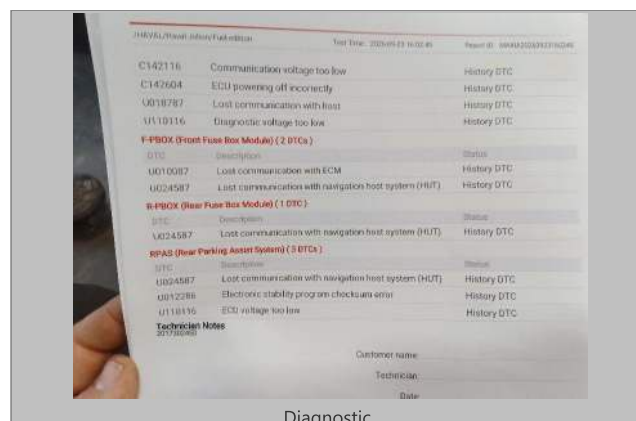
During the diagnostic the following error messages were detected: (See also attached Diagnostic Report. For more information regarding the Fault Codes (DTC) and the recommended rectifications please contact the workshops of the vehicle manufacture).

| No | System | Code | Description | Status |
|---|---|---|---|---|
| 1 | ESP | U016387 | NAVIGATION HOST SYSTEM NODE MESSAGE LOST | |

Diagnostic.

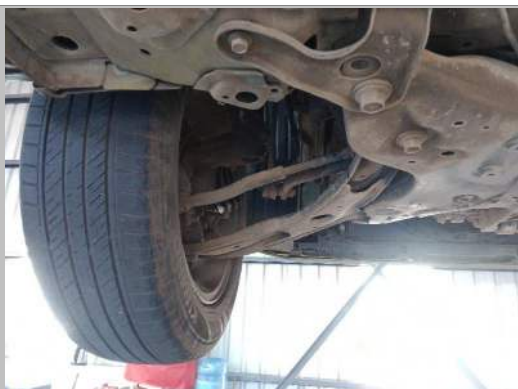
| | Size | Load/Speed Index | Manufacture | Model | Type* | Production Date | Tread Depth (mm) |
|---|---|---|---|---|---|---|---|
| Front Left | 215/60R17 | 96H | Kumho | Radial | V | 4622 | 0 mm |

LF TYRE TREAD

| Tyre Front Left Worn | Replace |

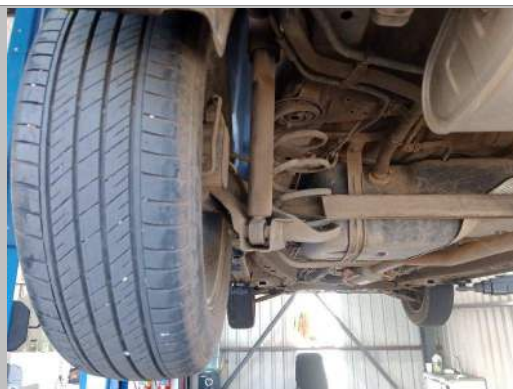
| | Size | Load/Speed Index | Manufacture | Model | Type* | Production Date | Tread Depth (mm) |
|---|---|---|---|---|---|---|---|
| Rear Left | 215/60R17 | 96H | Kumho | Radial | V | 4622 | 2 mm |

LR TYRE TREAD

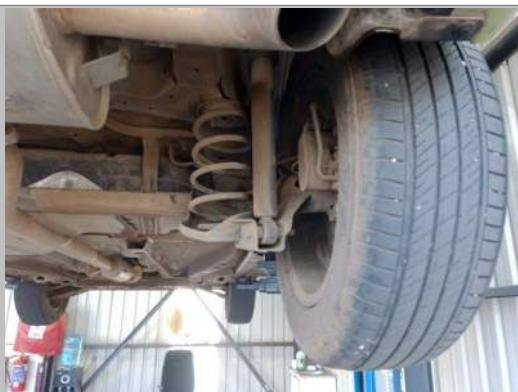
| | Size | Load/Speed Index | Manufacture | Model | Type* | Production Date | Tread Depth (mm) |
|---|---|---|---|---|---|---|---|
| Rear Right | 215/60R17 | 96H | Kumho | Radial | V | 4622 | 2 mm |

RR TYRE TREAD

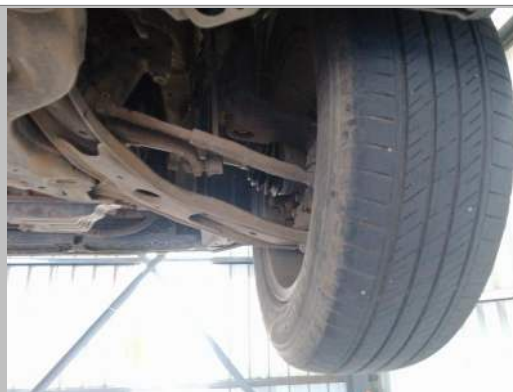
| | Size | Load/Speed Index | Manufacture | Model | Type* | Production Date | Tread Depth (mm) |
|---|---|---|---|---|---|---|---|
| Front Right | 215/60R17 | 96H | Kumho | Radial | V | 4522 | 0 mm |

RF TYRE TREAD

| Tyre Front Right Worn | Replace |

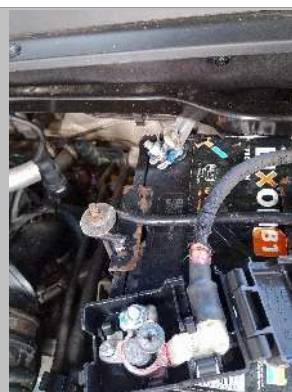
| Battery clamps Damaged | Repair |

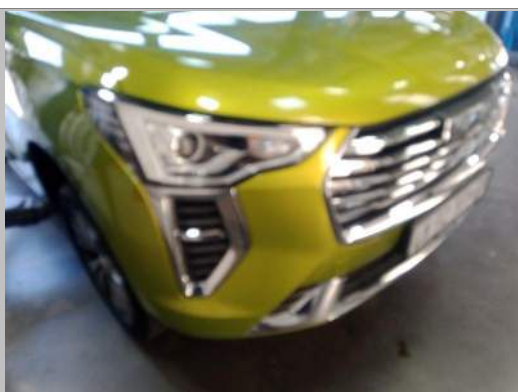
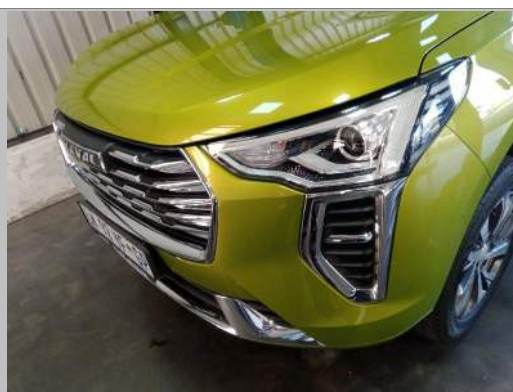
| Front Bumper Damaged | Repair |

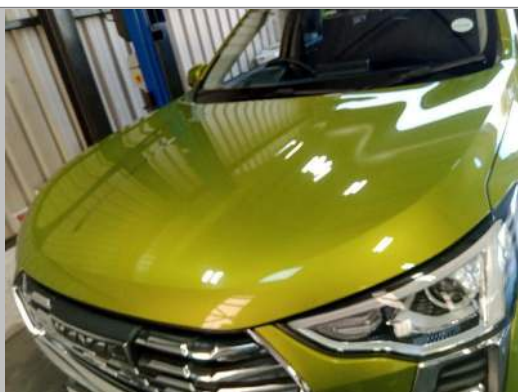
| Bonnet Damaged | Repair |

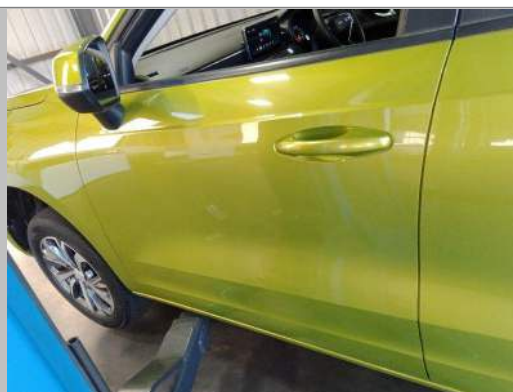
| Door Front Left Damaged | Repair |
