## CONDITION REPORT

2017303177

| Manufacturer | CHERY | Registration Number | ML74GPGP |
| Model | TIGGO 4 PRO 1.5 LIT [2023-ON] | Register Number | |

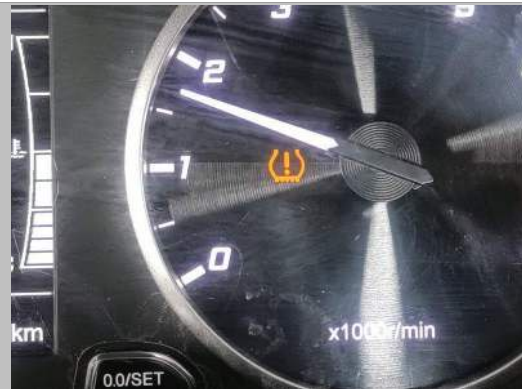
| No | System | Code | Description | Status |
|---|---|---|---|---|
| 1 | TIRE PRESSURE | B103813 | PLEASE REFER TO VEHICLE SERVICE MANUAL | |

Tyre pressure warning lights i

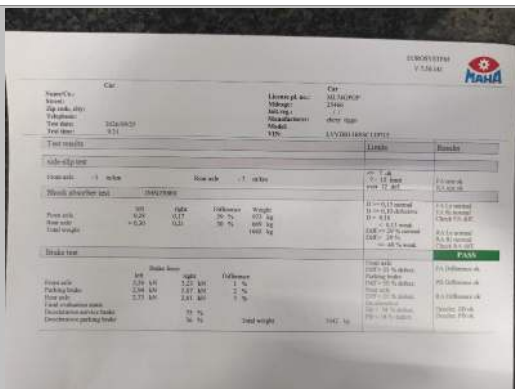
## Shock and brake report

| | Left | Right | | |
| | Braking Force [KN] | Braking Force [KN] | Axle Weight [KG] | Deceleration [m/s <sup>2</sup> ] |
| Front | 3.2 | 3.2 | - | |
| Rear | 2.7 | 2.8 | - | |
| Emergency / Parking | 2.9 | 2.8 | - | |

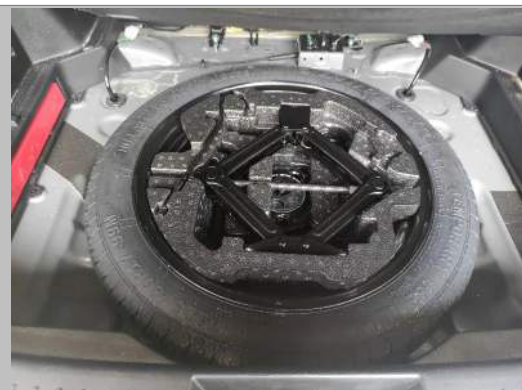
Sparewheel

| | Size | Load/Speed Index | Manufacture | Model | Type* | Production Date | Tread Depth (mm) |
|---|---|---|---|---|---|---|---|
| Spare | 125/80R17 | 99M | Ling long | Temporary | V | 0000 | 3 mm |

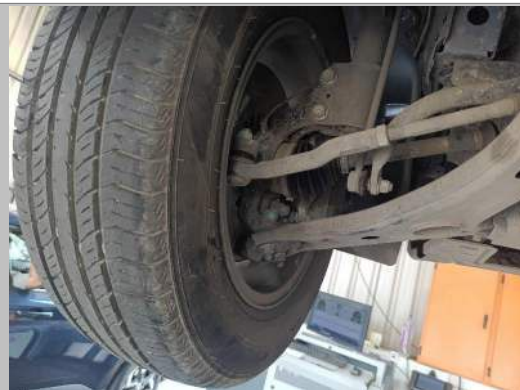
LF TYRE TREAD

| | Size | Load/Speed Index | Manufacture | Model | Type* | Production Date | Tread Depth (mm) |
|---|---|---|---|---|---|---|---|
| Front Left | 215/65R16 | 98H | Chaoyang | SU | V | 0125 | 6 mm |

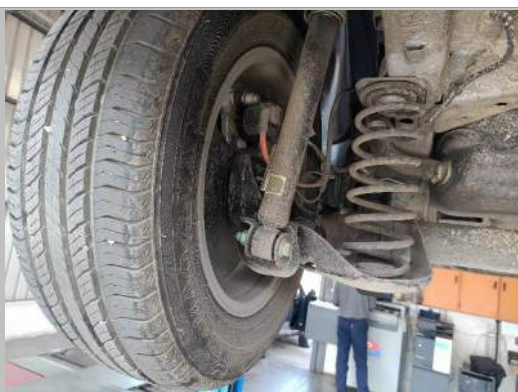
LR TYRE TREAD

| | Size | Load/Speed Index | Manufacture | Model | Type* | Production Date | Tread Depth (mm) |
|---|---|---|---|---|---|---|---|
| Rear Left | 215/65R16 | 98H | Chaoyang | SU | V | 0125 | 6 mm |

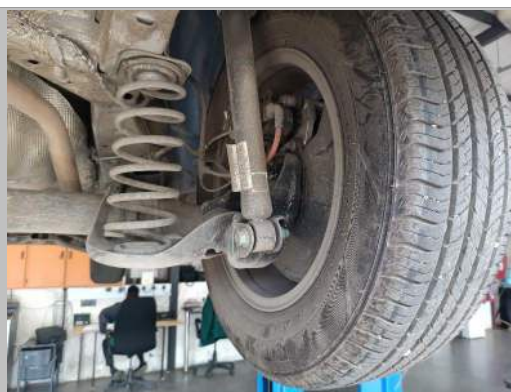
RR TYRE TREAD

| | Size | Load/Speed Index | Manufacture | Model | Type* | Production Date | Tread Depth (mm) |
|---|---|---|---|---|---|---|---|
| Rear Right | 215/65R16 | 98H | Chaoyang | SU | V | 0125 | 6 mm |

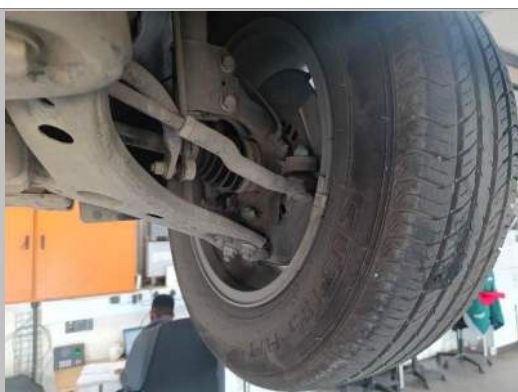
RF TYRE TREAD

| | Size | Load/Speed Index | Manufacture | Model | Type* | Production Date | Tread Depth (mm) |
|---|---|---|---|---|---|---|---|
| Front Right | 215/65R16 | 98H | Chaoyang | SU | V | 0125 | 6 mm |

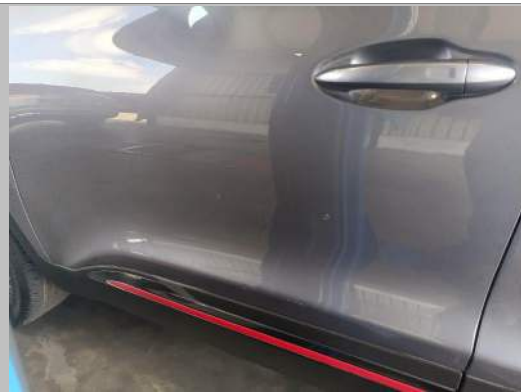
Side Mirror Right Damaged  
 Door Front Left Paintwork • Scratched  
 Windscreen Chipped  
 Body exterior  
 Body exterior  
 Warning lights illuminated

Repair  
 Repair  
 Replace  
 Signs of spray work done on body panels  
 Minor dents scratches stone chips on body panels  
 Repair
