CONDITION REPORT

Report No:  
2017302453  
DATE  
25/09/2026

| Manufacturer | CHERY | Registration Number | MF51CHGP |
| Model | OMEDA | Register Number | |

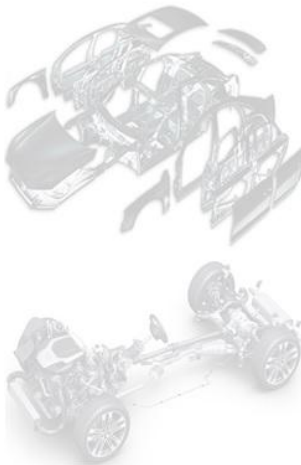
| Damage | Repair Way |
|---|---|
| Front Bumper Paintwork • Scratched | Repair |
| Front Fender Left Paintwork • Scratched | Repair |
| Door Front Left Paintwork • Scratched | Repair |
| Door Rear Left Paintwork • Scratched | Repair |
| Door Rear Right Paintwork • Scratched | Repair |
| Windscreen Chipped | Replace |
| Warning lights illuminated | Repair |
| Body exterior | Signs of spray work done on body panels |

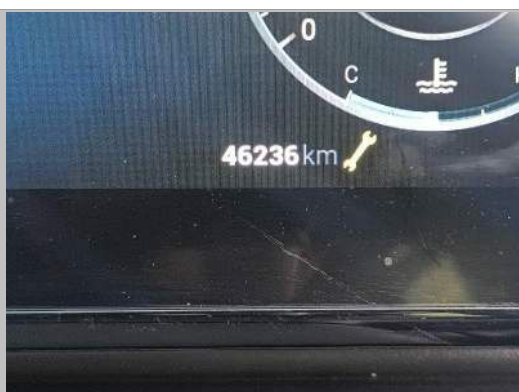
ODOMETER

| Km Reading | 46,236 KM | Fuel | PETROL |

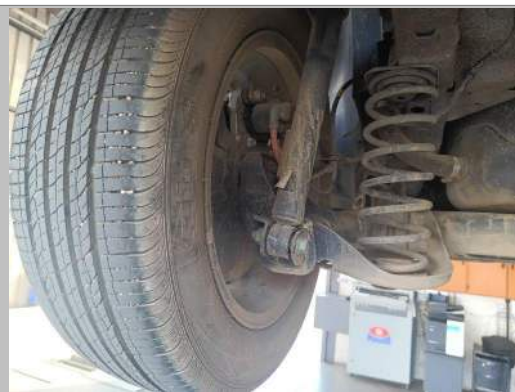
LR TYRE TREAD

| | Size | Load/Speed Index | Manufacture | Model | Type* | Production Date | Tread Depth (mm) |
|---|---|---|---|---|---|---|---|
| Rear Left | 215/60R17 | 96H | Giti | Comfort | V | 4824 | 5 mm |

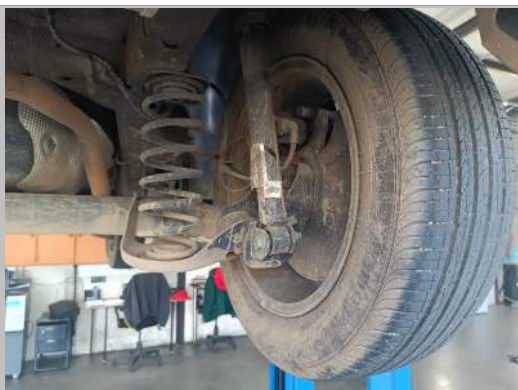
RR TYRE TREAD

| | Size | Load/Speed Index | Manufacture | Model | Type* | Production Date | Tread Depth (mm) |
|---|---|---|---|---|---|---|---|
| Rear Right | 215/60R17 | 96H | Giti | Giti comfort | V | 4824 | 5 mm |

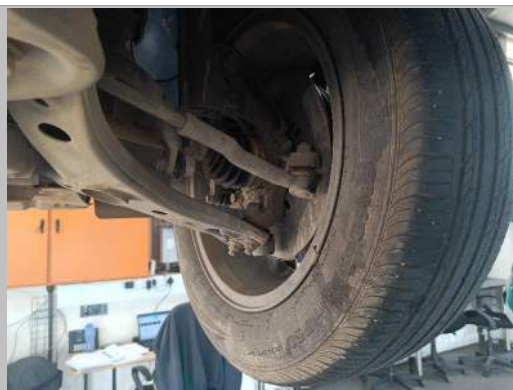
RF TYRE TREAD

| | Size | Load/Speed Index | Manufacture | Model | Type* | Production Date | Tread Depth (mm) |
|---|---|---|---|---|---|---|---|
| Front Right | 215/60R17 | 96H | Giti | Giti comfort | V | 4824 | 3 mm |

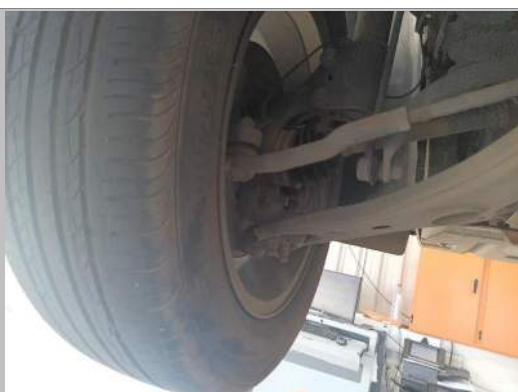
LF TYRE TREAD

| | Size | Load/Speed Index | Manufacture | Model | Type* | Production Date | Tread Depth (mm) |
|---|---|---|---|---|---|---|---|
| Front Left | 215/60R17 | 96H | Giti | Comfort | V | 4824 | 3 mm |

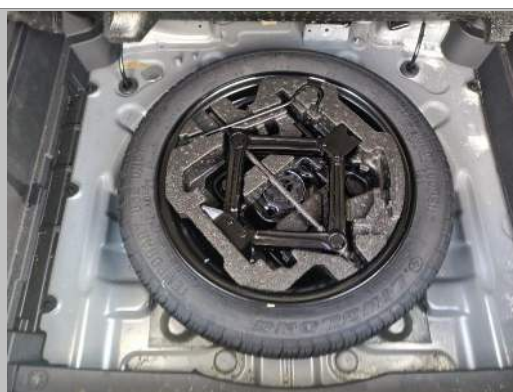
Sparewheel

| | Size | Load/Speed Index | Manufacture | Model | Type* | Production Date | Tread Depth (mm) |
|---|---|---|---|---|---|---|---|
| Spare | T125/80R17 | 99M | Ling long | Temporary | V | /////// | 6 mm |

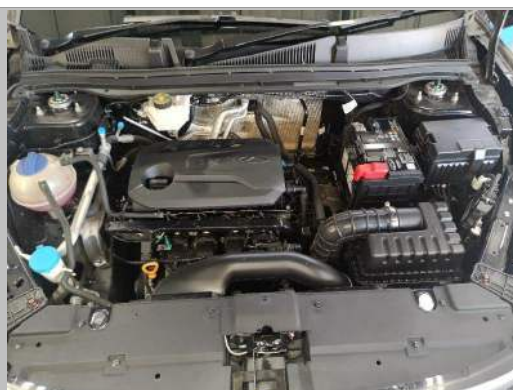
ENGINE 1

General Comments: BOTTOM OF ENGINE IS FULLY COVERED. ACCORDING TO THE AGE AND MILEAGE OF THE VEHICLE, NORMAL WEAR AND TEAR MARKS ARE VISIBLE ON THE INTERIOR, EXTERIOR, ELECTRICAL AND MECHANICAL PARTS.

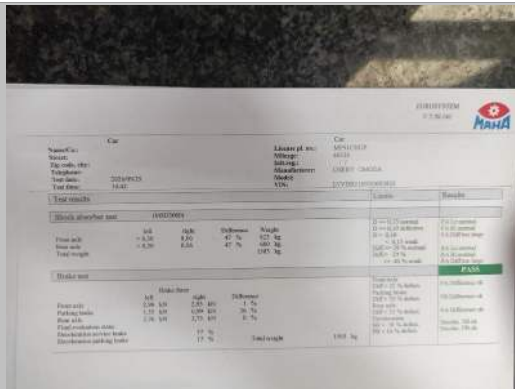
## Shock and brake report

| | Left | Right | | |
|---|---|---|---|---|
| Front | 2.9 | 2.9 | - | |
| Rear | 2.7 | 2.7 | - | |
| Emergency / Parking | 1.5 | 0.9 | - | |

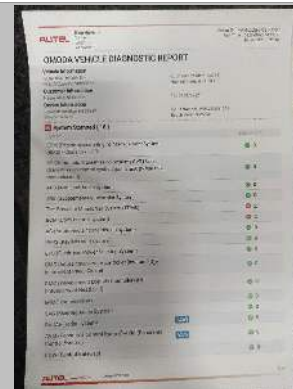
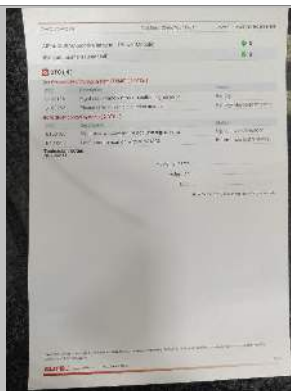
DIAGNOSTIC REPORT PAGE 1

| No | System | Code | Description | Status |
|---|---|---|---|---|
| 1 | TIRE PRESSURE | B103186 | RIGHT REAR WINDOW MOTOR POSITION SIGNAL ERROR | |
