CONDITION REPORT

Report No:  
2017305134  
DATE  
30/09/2026

| Manufacturer | CHERY | Registration Number | LN50VYGP |
| Model | TIGGO 4 PRO 1.5T ELITE CVT [2021-2026] | Register Number | |

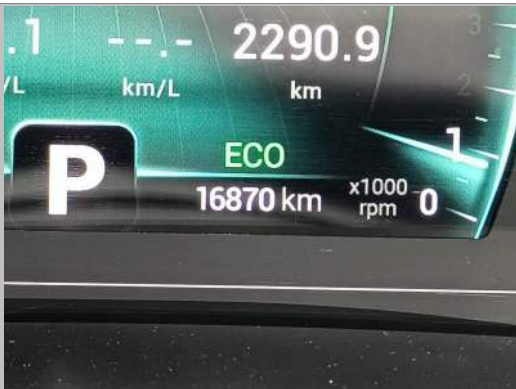
ODOMETER

| Km Reading | 16,870 KM | Fuel | PETROL |

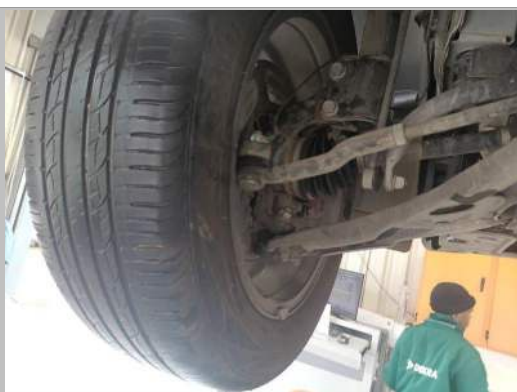
LF TYRE TREAD

| | Size | Load/Speed Index | Manufacture | Model | Type* | Production Date | Tread Depth (mm) |
|---|---|---|---|---|---|---|---|
| Front Left | 215/60R17 | 96H | Giti | Comfort | V | 2523 | 3 mm |

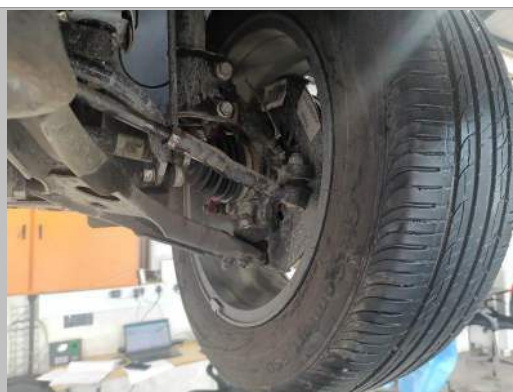
RF TYRE TREAD

| | Size | Load/Speed Index | Manufacture | Model | Type* | Production Date | Tread Depth (mm) |
|---|---|---|---|---|---|---|---|
| Front Right | 215/60R17 | 96H | Giti | Comfort | V | 2523 | 5 mm |

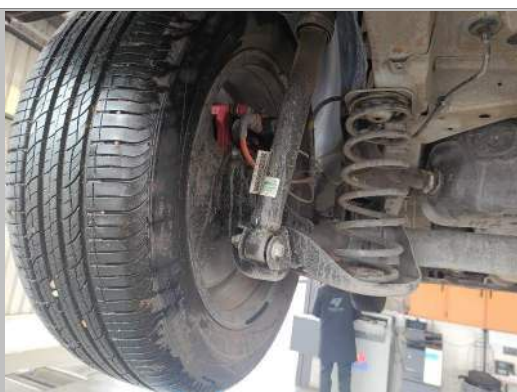
LR TYRE TREAD

| | Size | Load/Speed Index | Manufacture | Model | Type* | Production Date | Tread Depth (mm) |
|---|---|---|---|---|---|---|---|
| Rear Left | 215/60R17 | 96H | Giti | Comfort | V | 2523 | 5 mm |

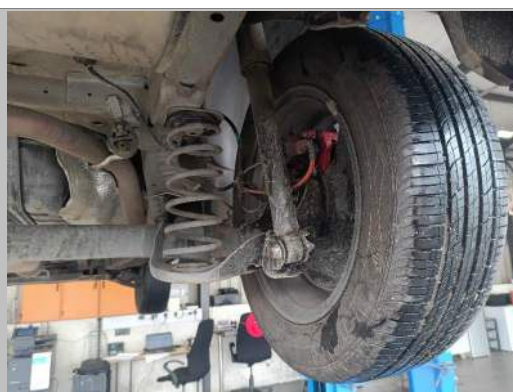
RR TYRE TREAD

| | Size | Load/Speed Index | Manufacture | Model | Type* | Production Date | Tread Depth (mm) |
|---|---|---|---|---|---|---|---|
| Rear Right | 215/60R17 | 96H | Giti | Comfort | V | 2523 | 6 mm |

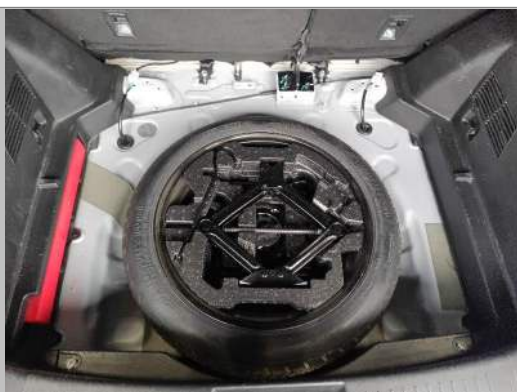
### Sparewheel

| | Size | Load/Speed Index | Manufacture | Model | Type* | Production Date | Tread Depth (mm) |
|---|---|---|---|---|---|---|---|
| Spare | T125/80R17 | 99M | Westlake | Temporary | V | 0000 | 5 mm |

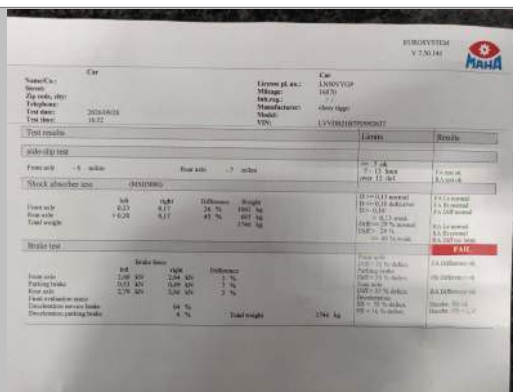
## Shock and brake report

| | Left | Right | | |
|---|---|---|---|---|
| Front | 2.6 | 2.6 | - | |
| Rear | 2.7 | 2.8 | - | |
| Emergency / Parking | 0.5 | 0.4 | - | |

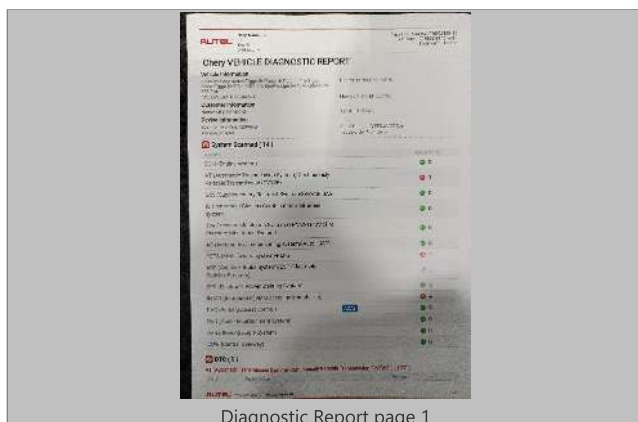
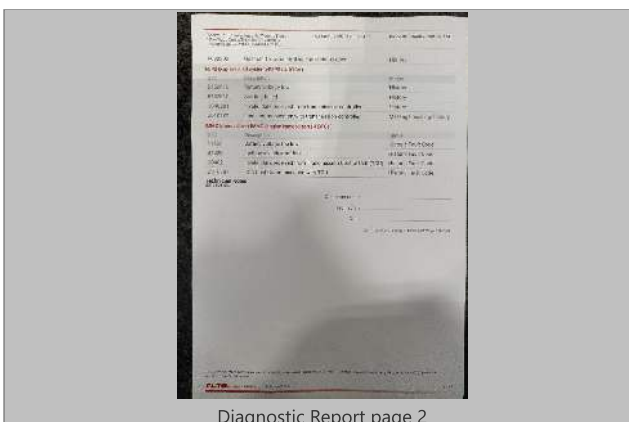
Diagnostic Report page 1

During the diagnostic the following error messages were detected: (See also attached Diagnostic Report. For more information regarding the Fault Codes (DTC) and the recommended rectifications please contact the workshops of the vehicle manufacture).

| No | System | Code | Description | Status |
|---|---|---|---|---|
| 1 | IMMOBILIZER | B152F | BATTERY VOLTAGE TOO LOW | |
