MFC Auction House
M57 Pretoria Rd, Glenmarais, KEMPTON PARK
Gauteng

DEKRA MFC
M57 Pretoria Rd - 1619
KEMPTON PARK - GT
08610 33572

VEHICLE INSPECTION

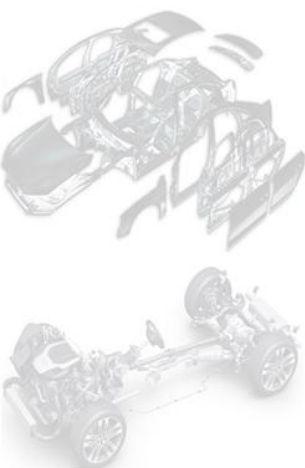
Body exterior
Body exterior

Signs of spray work done on some body panels
Minor dents scratches stone chips on some body pan

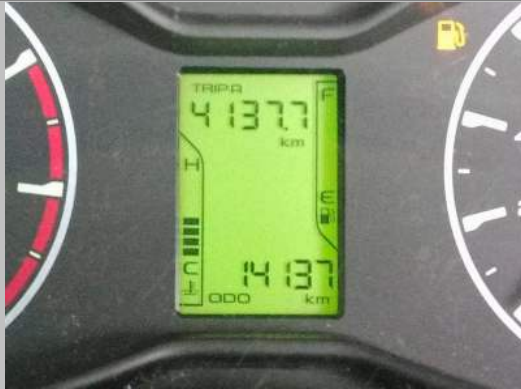
ODOMETER

Vehicle Type	LIGHT LOAD VEHICLE	Registered Owner	MFC AUCTION HOUSE
Manufacturer	MAHINDRA	Registration Number	HGG437L
Model	SCORPIO PIK-UP 2.2 MHAWK S4 DSL [2017-ON]	Register Number	
VIN	MA1RA2VK2R2A13418	Date Of First Licensing	
Engine Number		Last COR	
Doors	2	License Expiry Date	31/07/2025
Color	WHITE	Power / Displacement	
Year Model	2024	Paint Finish	C - COMMON
Km Reading	14,137 KM	Fuel	DIESEL
Cab / Body Type	SINGLE CAB	Transmission	MANUAL

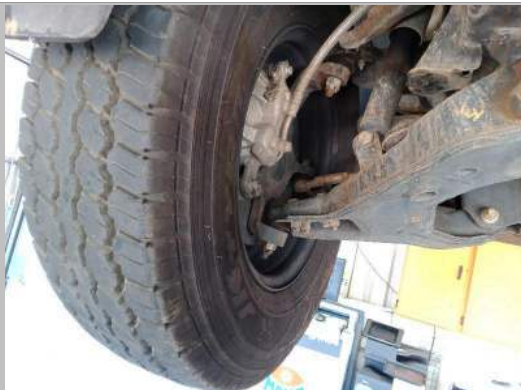
LF TYRE TREAD

Size	Load/Speed Index	Manufacture	Model	Type*	Production Date	Tread Depth (mm)
Front Left	245/75R16	111S	Jk tyre	Elanzo	V	4123	5 mm
Front Right	245/75R16	111S	Jk tyre	Elanzo	V	4123	6 mm
Rear Left	245/75R16	111S	Jk tyre	Elanzo	V	4123	5 mm
Rear Right	245/75R16	111S	Jk tyre	Elanzo	V	4123	6 mm
Spare	245/75R16	111S	Jk tyre	Elanzo	V	///////	7 mm

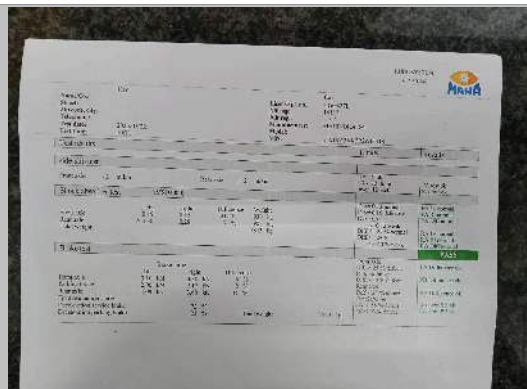
SHOCK & BRAKE REPORT

Left	Right		
	Braking Force [KN]	Braking Force [KN]	Axle Weight [KG]	Deceleration [m/s ²]
Front	3.1	3.1	-	
Rear	3.0	3.6	-	
Emergency / Parking	2	2.1	-
