## CONDITION REPORT

Report No: 2016827489

Vehicle Type	PASSENGER VEHICLE	Registered Owner	MFC
Manufacturer	SUZUKI	Registration Number	KPM692MP
Model	ERTIGA 1.5 GLX MPV [2019-2022]	Register Number	
VIN	MA3BNC22S00460579	Date Of First Licensing	
Engine Number		Last COR	
Doors	5	License Expiry Date	
Color	SILVER	Power / Displacement	
Year Model	2022	Paint Finish	M - METALLIC
Km Reading	111,007 KM	Fuel	PETROL
Cab / Body Type	STATION WAGON	Transmission	MANUAL

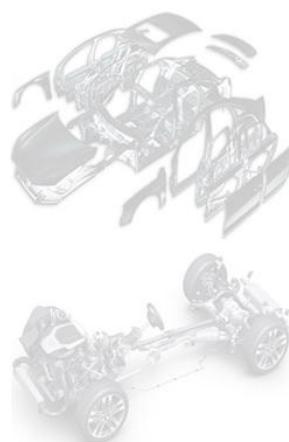
## VEHICLE INSPECTION

Damage	Repair Way
Radio/CD/USB Defective	Repair
Windscreen Wiper Missing	Replace
Side Mirror Right Damaged	Repair
Front Bumper Paintwork • Scratched	Repair
Bonnet Paintwork • Chipmarks	Repair
Rear Fender Left Dented	Repair
Rear Fender Right Paintwork • Scratched	Repair
Door Front Left Dented	Repair
Door Rear Left Dented	Repair
Door Rear Right Dented	Repair
Rear bumper Dented	Repair
Windscreen Cracked	Replace
Tyre Front Left Smooth	Replace
Body exterior	Vehicle got minor scratches, stone chips and dents

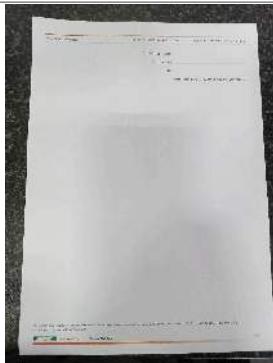
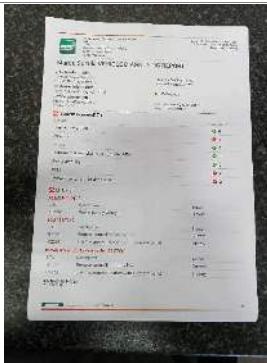
Diagnostic report

No	System	Code	Description	Status
1	CURRENT	B1134	REMOTE CONTROLLER BATTERY LOW

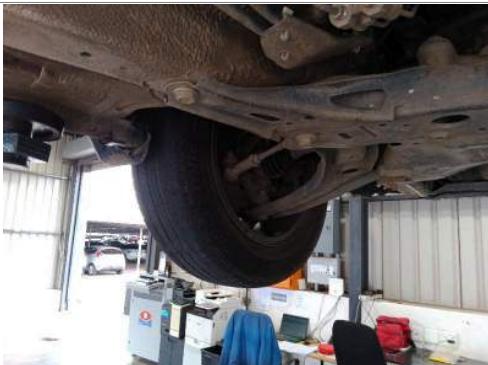
LF TYRE TREAD

Size	Load/Speed Index	Manufacture	Model	Type*	Production Date	Tread Depth (mm)
Front Left	185/65R15	88H	Bridgestone	Ecopia	V	0722	0 mm
Front Right	185/65R15	88H	Bridgestone	Ecopia	V	0722	2 mm
Rear Left	185/65R15	88H	Bridgestone	Ecopia	V	0722	2 mm
Rear Right	185/65R15	88H	Bridgestone	Ecopia	V	0722	2 mm
Spare	185/65R15	88H	Bridgestone	Ecopia	V	0000	4 mm

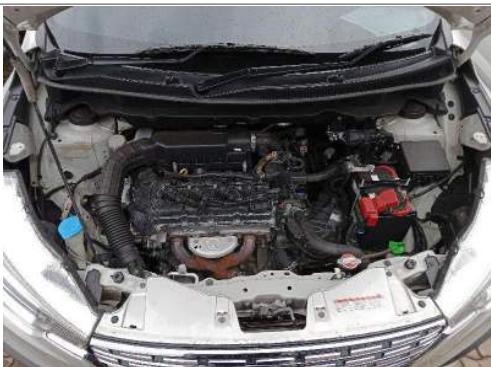
ENGINE 1

- No Test Drive
- Rain at time of inspection
- Battery Flat
- Engine number – not possible to verify engine number (not visible without dismantling)
- Inspection conditions for the vehicle inspection were sufficient
