CONDITION REPORT

Report No: 2016230322

MFC Auction House
M57 Pretoria Rd, Glenmarais, KEMPTON PARK
Gauteng

Vehicle Type	PASSENGER VEHICLE	Registered Owner	MFC AUCTION HOUSE
Manufacturer	SUZUKI	Registration Number	DT43XWGP
Model	SWIFT DZIRE	Register Number	
VIN	MA3GZF62S00480504	Date Of First Licensing	
Engine Number		Last COR	
Doors	4	License Expiry Date	31/12/2020
Color	GREEN	Power / Displacement	
Year Model		Paint Finish	M - METALLIC
Km Reading	84,222 KM	Fuel	PETROL
Cab / Body Type	SEDAN	Transmission	MANUAL

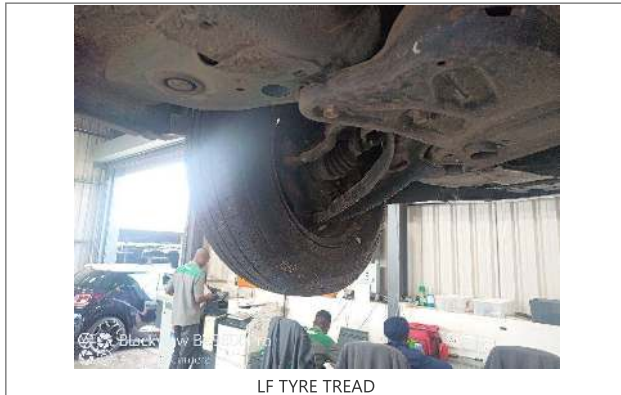
LF TYRE TREAD

Size	Load/Speed Index	Manufacture	Model	Type*	Production Date	Tread Depth (mm)
Front Left	165/80R14	85T	Goodyear	Duraplus	V	0314	3 mm
Front Right	165/80R14	85T	Goodyear	Duraplus	V	0314	3 mm
Rear Left	165/80R14	85T	Goodyear	Duraplus	V	0414	3 mm
Rear Right	165/80R14	85T	Goodyear	Duraplus	V	0414	3 mm
Spare	165/80R14	85T	Goodyear	Duraplus	V	0414	5 mm

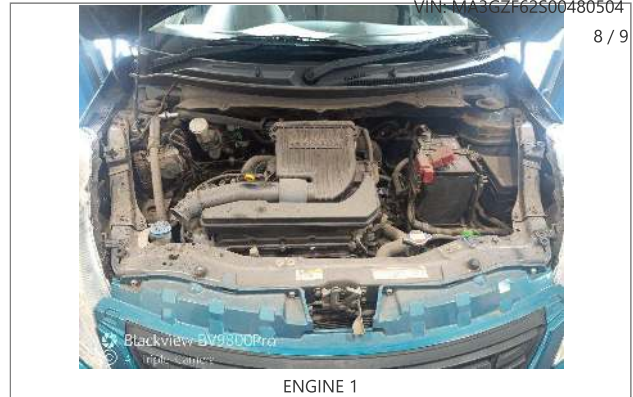
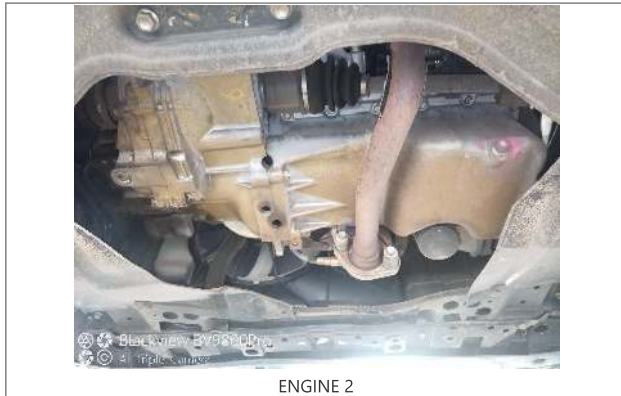
ENGINE 1

No Test Drive
 Battery Flat
 Engine number – not possible to verify engine number (not visible without dismantling)
 Inspection conditions for the vehicle inspection were sufficient

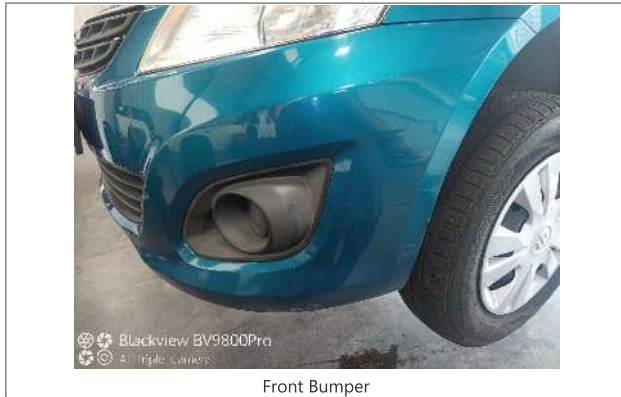
Damage	Repair Way
Front Bumper Paintwork • Scratched	Repair
Front Fender Left Paintwork • Scratched	Repair
Front Fender Right Paintwork • Scratched	Repair
Rear Fender Left Paintwork • Scratched	Repair
Rear Fender Right Paintwork • Scratched	Repair
Door Front Left Paintwork • Scratched	Repair
Door Front Right Paintwork • Scratched	Repair
Door Rear Left Paintwork • Scratched	Repair
Door Rear Right Paintwork • Scratched	Repair
Rear bumper Paintwork • Scratched	Repair
Gearbox Oil Leak	Repair
