CONDITION REPORT

Report No: 2016221832

Vehicle Type	PASSENGER VEHICLE	Registered Owner	MFC
Manufacturer	SUZUKI	Registration Number	LD65CZGP
Model	CELERIO	Register Number	
VIN	MA3KFC42S00439959	Date Of First Licensing	
Engine Number		Last COR	
Doors	5	License Expiry Date	30/04/2024
Color	GREY	Power / Displacement	
Year Model		Paint Finish	M - METALLIC
Km Reading	137,146 KM	Fuel	PETROL
Cab / Body Type	HATCHBACK	Transmission	MANUAL

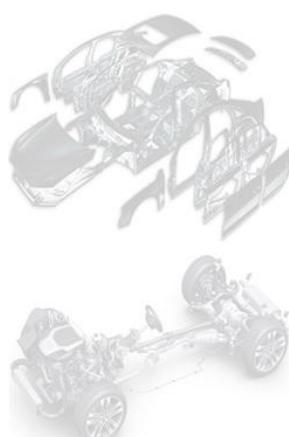
VEHICLE INSPECTION

Damage	Repair Way
Air cleaner Defective	Repair
Center Console / Cubbyhole + Lid Damaged	Repair
Side Mirror Left Damaged	Repair
Side Mirror Right Damaged	Repair
Front Bumper Paintwork • Scratched	Repair
Bonnet Dented	Repair
Front Fender Left Paintwork • Scratched	Repair
Rear Fender Left Paintwork • Scratched	Repair
Door Front Left Dented	Repair
Door Front Right Paintwork • Scratched	Repair
Door Rear Left Paintwork • Scratched	Repair
Door Rear Right Paintwork • Scratched	Repair
Boot Lid / Hatch door Dented	Repair
Rear bumper Paintwork • Flaking	Repair
Sill Panel Right Dented	Repair
Windscreen Chipped	Repair
Tyre Front Left Smooth	Replace
Tyre Front Right Smooth	Replace
Spare Tyre Damaged	Repair
Main Beam Right Dented	Repair
Silencer Missing	Replace
Radiator Cradle Dented	Repair
Tire is damage in boot can't see details	Replace
R/F fender line missing	Replace
L/F fender line damage	Replace

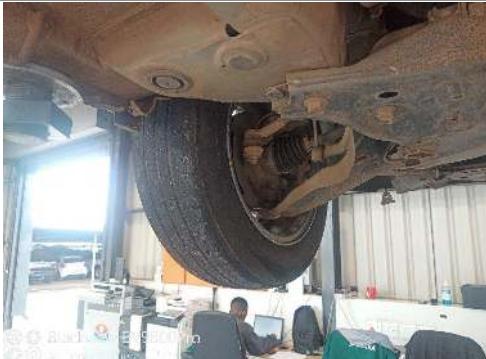
LF TYRE TREAD

Size	Load/Speed Index	Manufacture	Model	Type*	Production Date	Tread Depth (mm)
Front Left	175/65R14	82H	Kumho	Sense	V	5019	0 mm
Front Right	175/70R14	84H	Bridgestone	B391	V	4405	0 mm
Rear Left	165/80R13	83T	Regal	Rst-300	V	2913	2 mm
Rear Right	175/70R14	84T	Goodride	Radial	V	3620	2 mm

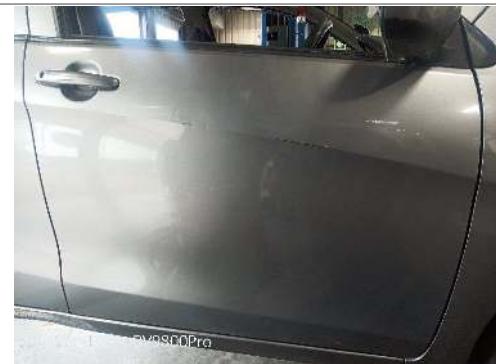
Door Front Right

Body • Exterior: Vehicle got minor scratches, stone chips and dents on some body panels. flaking on some body panels
