**CONDITION REPORT**

Report No: 2016367649

DATE  
06/05/2024

Vehicle Type	PASSENGER VEHICLE	Registered Owner	MFC AUCTION HOUSE
Manufacturer	SUZUKI	Registration Number	JM76ZFGP
Model	S-PRESSO	Register Number	
VIN	MA3RFL41S00141182	Date Of First Licensing	
Engine Number		Last COR	
Doors	5	License Expiry Date	31/01/2023
Color	ORANGE	Power / Displacement	
Year Model		Paint Finish	M - METALLIC
Km Reading	60,891 KM	Fuel	PETROL
Cab / Body Type	HATCHBACK	Transmission	MANUAL

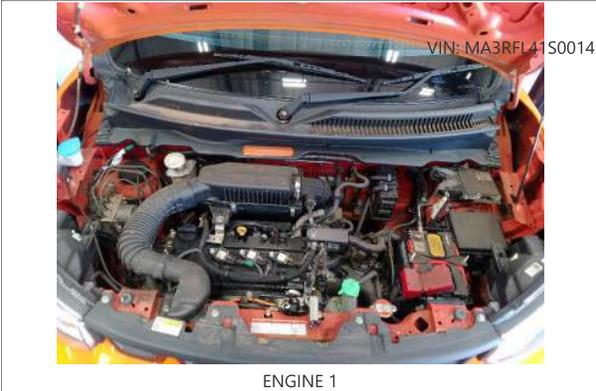
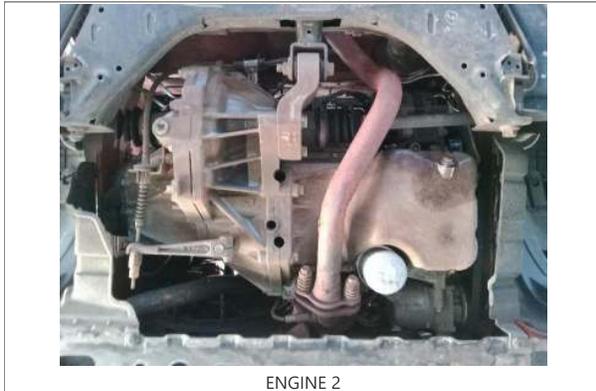
ENGINE 1

Damage	Repair Way
Engine Oil Leak	Repair
Front Bumper Residual Traces of Repair	Repair
Rear bumper Residual Traces of Repair	Repair
Body exterior	Signs of spray work done on some body panels
Body exterior	Minor dents scratches and stone chips on some body

No Test Drive  
 Battery Flat  
 Engine number – not possible to verify engine number (not visible without dismantling)  
 Inspection conditions for the vehicle inspection were sufficient
