MFC Auction House
M57 Pretoria Rd, Glenmarais, KEMPTON PARK
Gauteng

Vehicle Data

VEHICLE INSPECTION

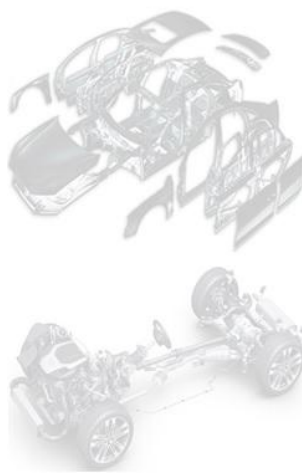
Damage	Repair Way
Side Mirror Left Damaged	Replace
Front Bumper Damaged	Repair
C • Pillar Right Paintwork • Scratched	Repair
Front Fender Left Paintwork • Scratched	Repair
Front Fender Right Residual Traces of Repair	Repair
Rear Fender Left Damaged	Repair
Door Front Left Dented	Repair
Door Front Right Residual Traces of Repair	Repair
Rear bumper Damaged	Repair
Tyre Front Left Smooth	Replace
Body exterior	Signs of spray work done on some body panels
Body exterior	Minor dents scratches stone chips on some body pan
Body exterior	Residual traces of repair work done on some body p

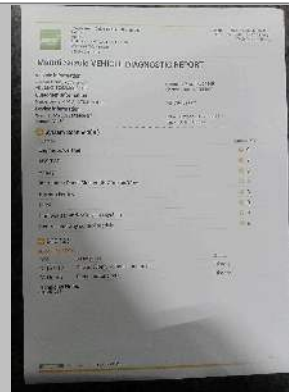
Diagnostic test

During the diagnostic no active error messages were detected. (See also attached Diagnostic Report. For more information regarding the Fault Codes (DTC) and the recommended rectifications please contact the workshops of the vehicle manufacture).

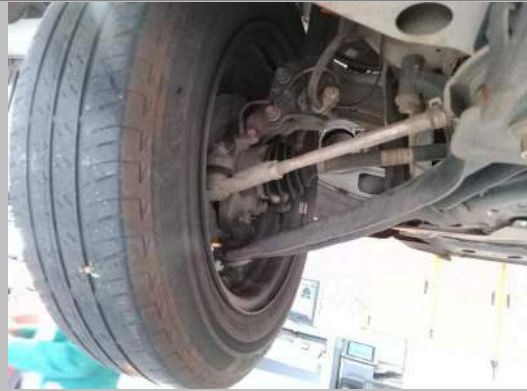
LF TYRE TREAD

Size	Load/Speed Index	Manufacture	Model	Type*	Production Date	Tread Depth (mm)
Front Left	165/70R14	81s	Bridgestone	---	V	1022	0 mm
Front Right	165/70R14	81s	Bridgestone	Ecopia	V	1022	4 mm
Rear Left	165/70R14	81s	Bridgestone	Ecopia	V	1022	5 mm
Rear Right	165/70R14	81s	Bridgestone	Ecopia	V	1022	2 mm
Spare	165/70R14	81S	Bridgestone	Ecopia	V	0000	1 mm
