CONDITION REPORT

Report No: 2016204186

Vehicle Type	PASSENGER VEHICLE	Registered Owner	MFC
Manufacturer	FORD	Registration Number	JJ93YMGP
Model	FIGO	Register Number	
VIN	MAJFXMTKFKY11155	Date Of First Licensing	
Engine Number		Last COR	
Doors	4	License Expiry Date	31/12/2023
Color	WHITE	Power / Displacement	
Year Model		Paint Finish	C - COMMON
Km Reading	162,255 KM	Fuel	PETROL
Cab / Body Type	SEDAN	Transmission	MANUAL

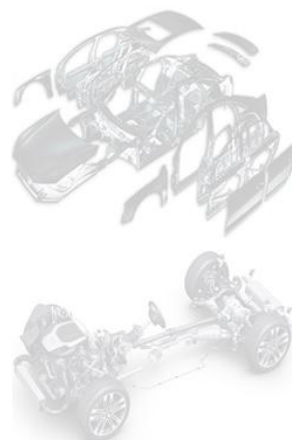
Damage	Repair Way
Engine Wiring Defective	Repair
Park Light Front Left Defective	Repair
Park Light Front Right Defective	Repair
Fog Light Front Left Defective	Repair
Fog Light Front Right Defective	Repair
Front Bumper Paintwork • Scratched	Repair
Front Fender Left Dented	Repair
Rear Fender Left Dented	Repair
Windscreen Cracked	Replace
Ball Joint(s) Front Axle Left Damaged	Replace
Rim Front Right Dented	Repair

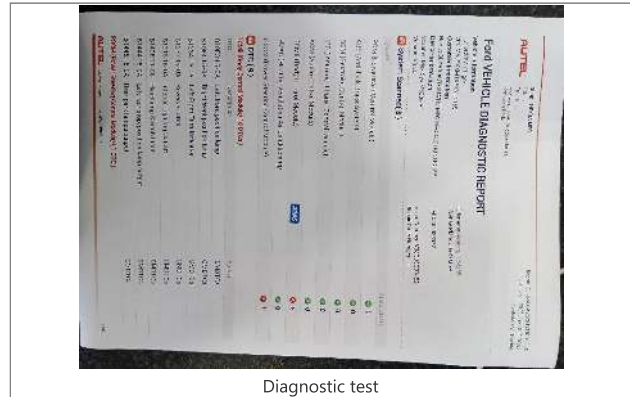
Diagnostic test

During the diagnostic no active error messages were detected. (See also attached Diagnostic Report. For more information regarding the Fault Codes (DTC) and the recommended rectifications please contact the workshops of the vehicle manufacture).

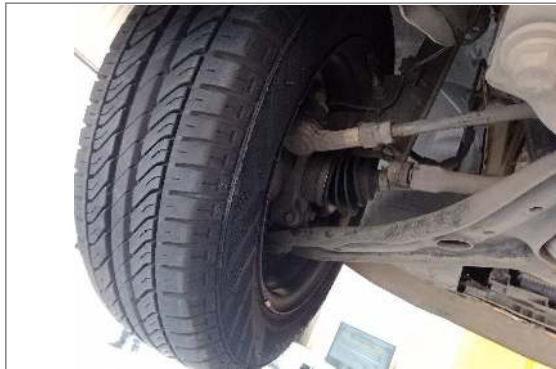
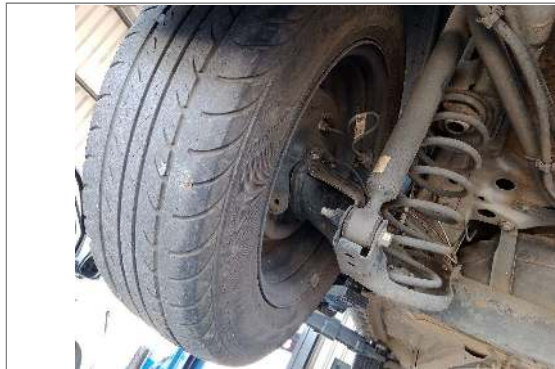
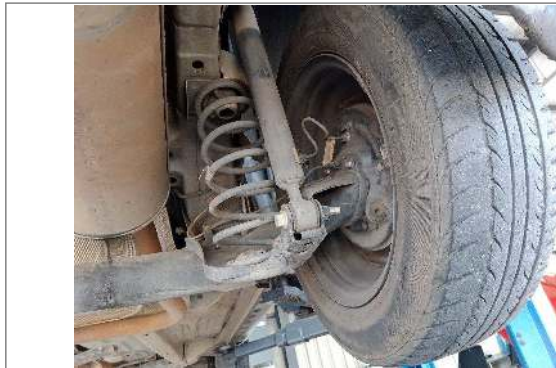
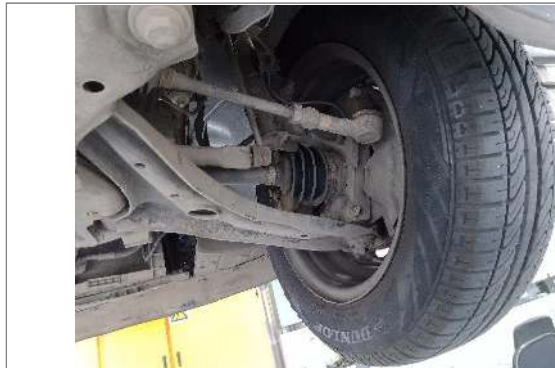
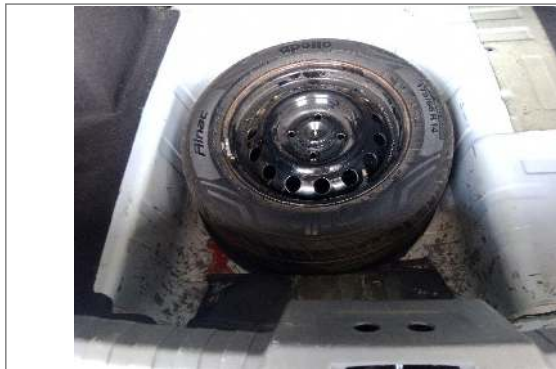
Size	Load/Speed Index	Manufacture	Model	Type*	Production Date	Tread Depth (mm)
Front Left	175/65R14	82T	Dunlop	Sport	V	2623	5 mm
Front Right	175/65R14	82T	Dunlop	Sport	V	2623	5 mm
Rear Left	175/65R14	82H	Apollo	Alnac	V	2319	2 mm
Rear Right	175/65R14	82H	Apollo	Alnac	V	2319	1 mm
Spare	175/65R14	82H	Apollo	Alnac	V	///////	1 mm

LF TYRE TREAD

LR TYRE TREAD

RR TYRE TREAD

RF TYRE TREAD

Sparewheel
