## CONDITION REPORT

Report No:  
2017302371  
DATE  
22/09/2026

| Manufacturer | HYUNDAI | Registration Number | MN94SZGP |
| Model | I10 1.1 MOTION 5-DR [2011-2018] | Register Number | |

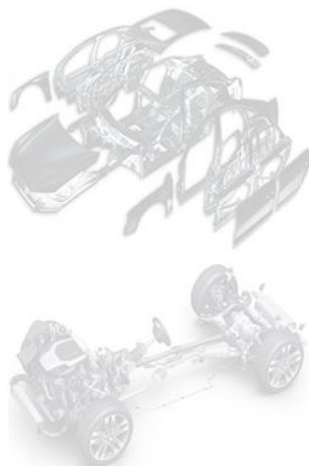
Switch Electrical Window Winder front left Defective  
 Front Bumper Damaged  
 Door Front Right Dented  
 Door Rear Right Dented  
 Rear bumper Paintwork • Scratched  
 Rim Front Left Deformed  
 Rim Rear Left Deformed  
 Rim Rear Right Deformed

Repair  
 Repair  
 Repair  
 Repair  
 Repair  
 Repair  
 Repair  
 Repair

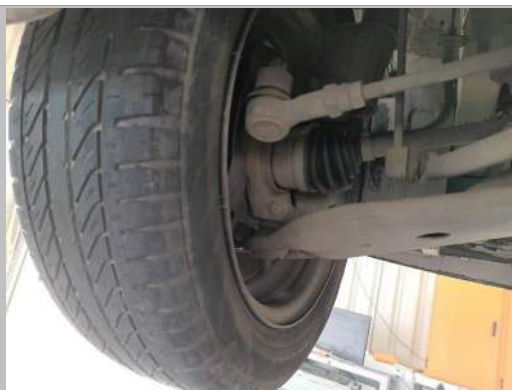
LF TYRE TREAD

| | Size | Load/Speed Index | Manufacture | Model | Type* | Production Date | Tread Depth (mm) |
|---|---|---|---|---|---|---|---|
| Front Left | 165/60R14 | 75H | Dunlop | Sport | V | 2521 | 1 mm |

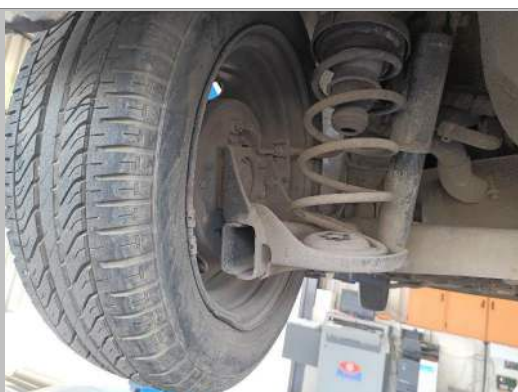
LR TYRE TREAD

| | Size | Load/Speed Index | Manufacture | Model | Type* | Production Date | Tread Depth (mm) |
|---|---|---|---|---|---|---|---|
| Rear Left | 165/60R14 | 75H | Dunlop | Sport | V | 2521 | 5 mm |

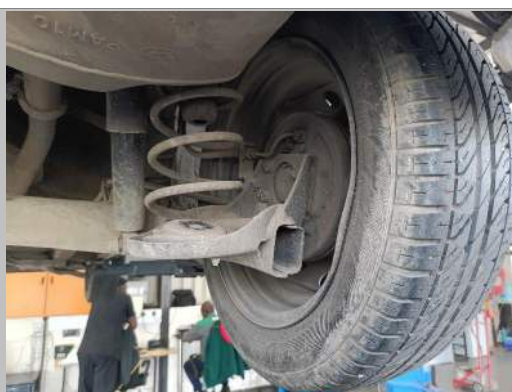
RR TYRE TREAD

| | Size | Load/Speed Index | Manufacture | Model | Type* | Production Date | Tread Depth (mm) |
|---|---|---|---|---|---|---|---|
| Rear Right | 165/60R14 | 75H | Dunlop | Sport | V | 2521 | 6 mm |

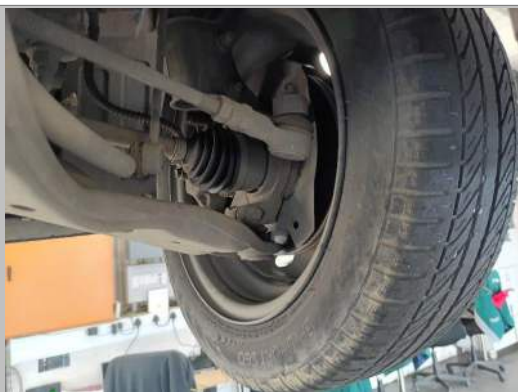
RF TYRE TREAD

| | Size | Load/Speed Index | Manufacture | Model | Type* | Production Date | Tread Depth (mm) |
|---|---|---|---|---|---|---|---|
| Front Right | 165/60R14 | 75H | Dunlop | Sport | V | 2521 | 3 mm |

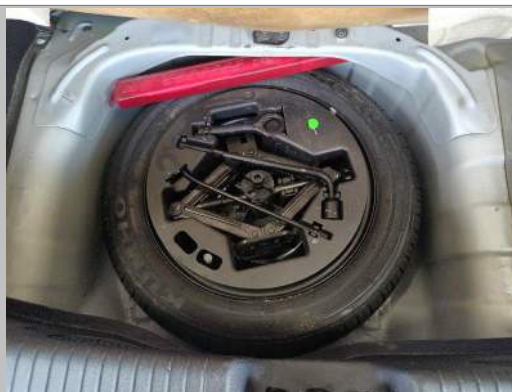
Sparewheel

| | Size | Load/Speed Index | Manufacture | Model | Type* | Production Date | Tread Depth (mm) |
|---|---|---|---|---|---|---|---|
| Spare | 165/60R14 | 75T | Kumho | Solus | V | 0000 | 6 mm |
