## CONDITION REPORT

Report No: 2016840596

| Manufacturer | HYUNDAI | Registration Number | LG14NSGP |
| Model | GRAND I10 | Register Number | |

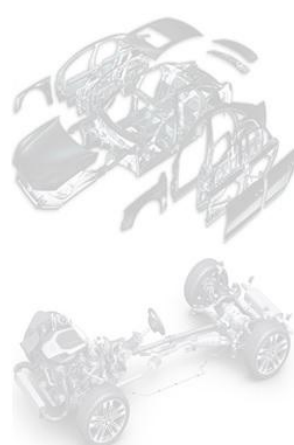
## VEHICLE INSPECTION

| Damage | Repair Way |
|---|---|
| Front Bumper Paintwork • Scratched | Repair |
| Bonnet Dented | Repair |
| Rear Fender Left Paintwork • Scratched | Repair |
| Rear Fender Right Dented | Repair |
| Door Front Right Paintwork • Scratched | Repair |
| Door Rear Left Paintwork • Scratched | Repair |
| Boot Lid / Hatch door Dented | Repair |
| Rear bumper Damaged | Repair |
| Body exterior | Vehicle got minor scratches, stone chips and dents |
| L/F fender liner damage | Replace |

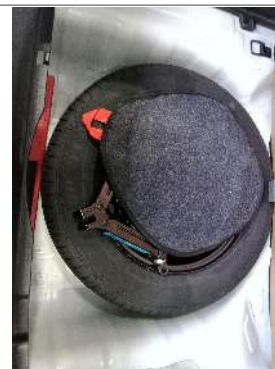
Spare wheel

| | Size | Load/Speed Index | Manufacture | Model | Type* | Production Date | Tread Depth (mm) |
|---|---|---|---|---|---|---|---|
| Spare | 165/70R14 | 81T | Goodyear | Assurance | V | 0000 | 5 mm |

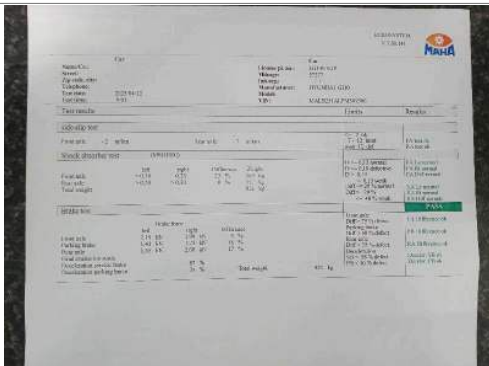
Shock and brake report

#### Brake Test Results

| | Left | Right | | |
|---|---|---|---|---|
| Front | 2.1 | 1.9 | - | |
| Rear | 1.6 | 2.0 | - | |
| Emergency / Parking | 1.4 | 1.7 | - | |

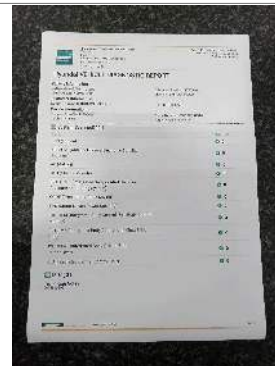
Diagnostic report

During the diagnostic no active error messages were detected. (See also attached Diagnostic Report. For more information regarding the Fault Codes (DTC) and the recommended rectifications please contact the workshops of the vehicle manufacture).

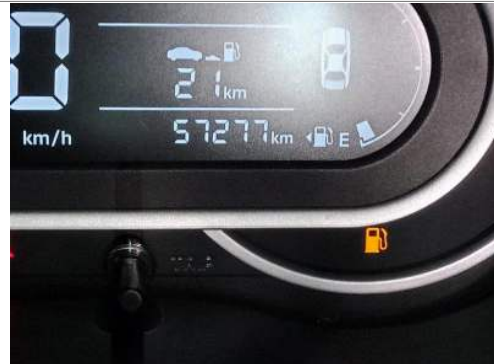
ODOMETER

| Km Reading | 57,277 KM | Fuel | PETROL |

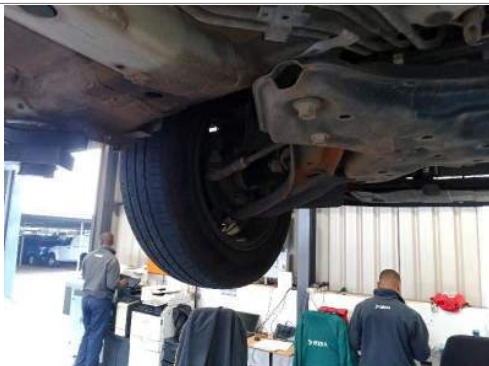
LF TYRE TREAD

| | Size | Load/Speed Index | Manufacture | Model | Type* | Production Date | Tread Depth (mm) |
|---|---|---|---|---|---|---|---|
| Front Left | 165/70R14 | 81T | Goodyear | Assurance | V | 3922 | 3 mm |

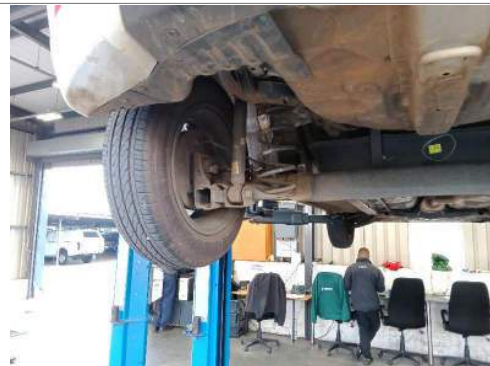
LR TYRE TREAD

| | Size | Load/Speed Index | Manufacture | Model | Type* | Production Date | Tread Depth (mm) |
|---|---|---|---|---|---|---|---|
| Rear Left | 165/70R14 | 81T | Goodyear | Assurance | V | 3922 | 3 mm |

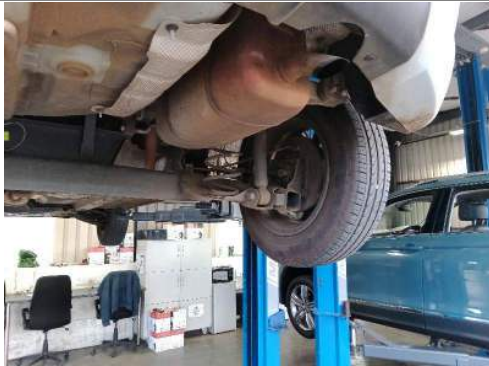
RR TYRE TREAD

| | Size | Load/Speed Index | Manufacture | Model | Type* | Production Date | Tread Depth (mm) |
|---|---|---|---|---|---|---|---|
| Rear Right | 165/70R14 | 81T | Goodyear | Assurance | V | 3922 | 3 mm |

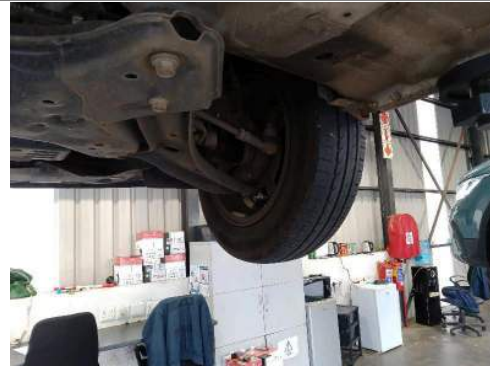
RF TYRE TREAD

| | Size | Load/Speed Index | Manufacture | Model | Type* | Production Date | Tread Depth (mm) |
|---|---|---|---|---|---|---|---|
| Front Right | 165/70R14 | 81T | Goodyear | Assurance | V | 3922 | 3 mm |
