## CONDITION REPORT

2017304602

| Manufacturer | HYUNDAI | Registration Number | LZ33WDGP |
| Model | I20 | Register Number | |

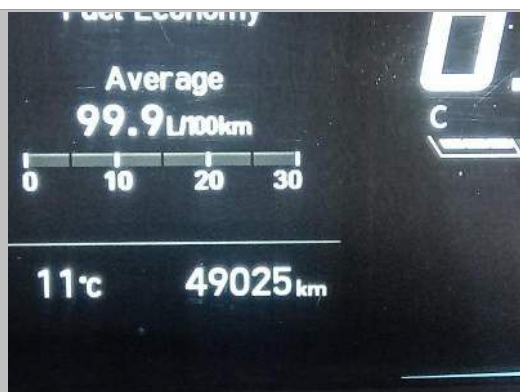
ODOMETER

| Km Reading | 49,025 KM | Fuel | PETROL |

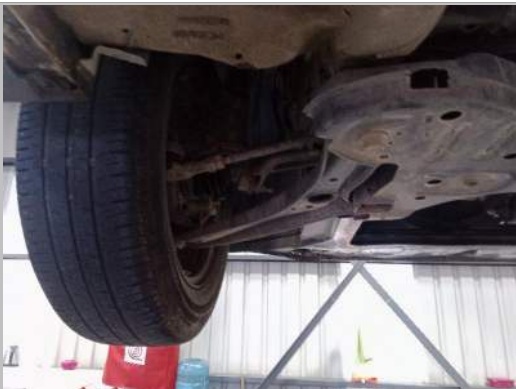
LF TYRE TREAD

| | Size | Load/Speed Index | Manufacture | Model | Type* | Production Date | Tread Depth (mm) |
|---|---|---|---|---|---|---|---|
| Front Left | 185/65R15 | 88H | Bridgestone | Radial | V | 2824 | 2 mm |

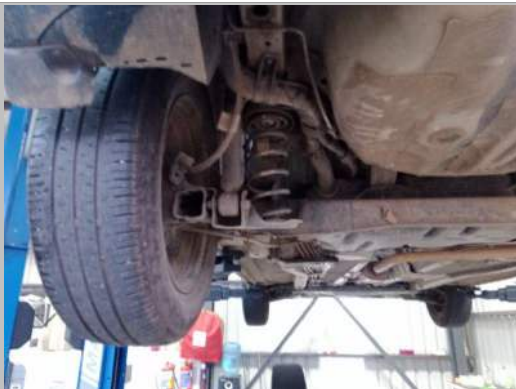
LR TYRE TREAD

| | Size | Load/Speed Index | Manufacture | Model | Type* | Production Date | Tread Depth (mm) |
|---|---|---|---|---|---|---|---|
| Rear Left | 185/65R15 | 88H | Bridgestone | Radial | V | 2824 | 2 mm |

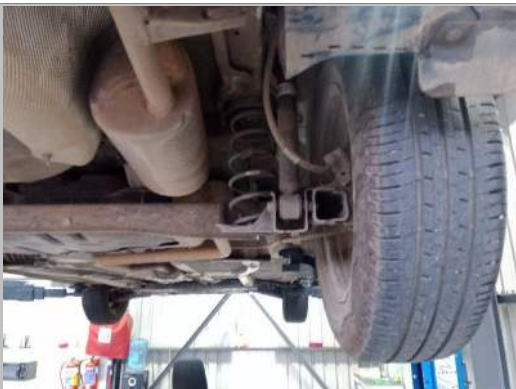
RR TYRE TREAD

| | Size | Load/Speed Index | Manufacture | Model | Type* | Production Date | Tread Depth (mm) |
|---|---|---|---|---|---|---|---|
| Rear Right | 185/65R15 | 88H | Bridgestone | Radial | V | 2824 | 2 mm |

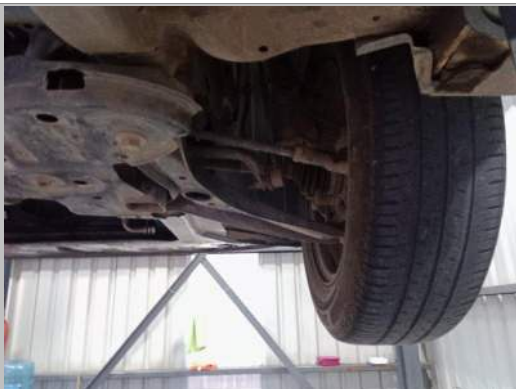
RF TYRE TREAD

| | Size | Load/Speed Index | Manufacture | Model | Type* | Production Date | Tread Depth (mm) |
|---|---|---|---|---|---|---|---|
| Front Right | 185/65R15 | 88H | Bridgestone | Radial | V | 2824 | 3 mm |
