## CONDITION REPORT

Report No:  
2017302490  
DATE  
23/09/2026

| Manufacturer | HYUNDAI | Registration Number | LMJ455MP |
| Model | I20 | Register Number | |

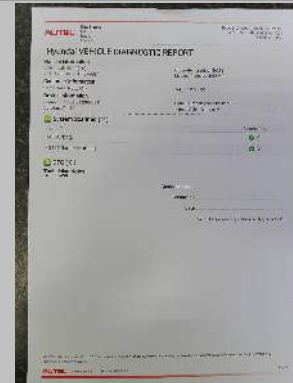
## Brake and shock absorber report

| | Left | Right | | |
|---|---|---|---|---|
| Front | 2.11 | 2.0 | - | |
| Rear | 1.76 | 1.43 | - | |
| Emergency / Parking | 1.49 | 1.39 | - | |

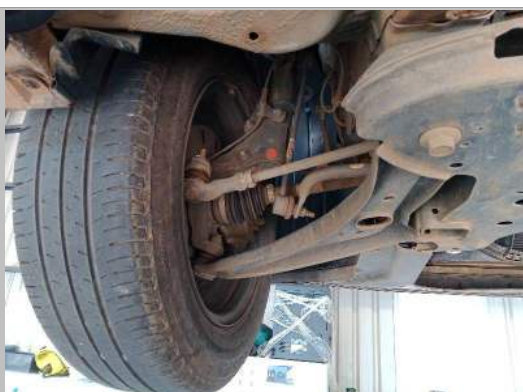
LF TYRE TREAD

| | Size | Load/Speed Index | Manufacture | Model | Type* | Production Date | Tread Depth (mm) |
|---|---|---|---|---|---|---|---|
| Front Left | 185/65 R15 | 88H | Bridgestone | Ecopia | V | 2525 | 4 mm |

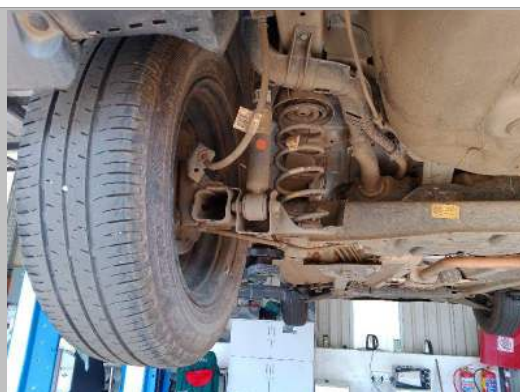
LR TYRE TREAD

| | Size | Load/Speed Index | Manufacture | Model | Type* | Production Date | Tread Depth (mm) |
|---|---|---|---|---|---|---|---|
| Rear Left | 185/65 R15 | 88H | Bridgestone | Ecopia | V | 2525 | 4 mm |

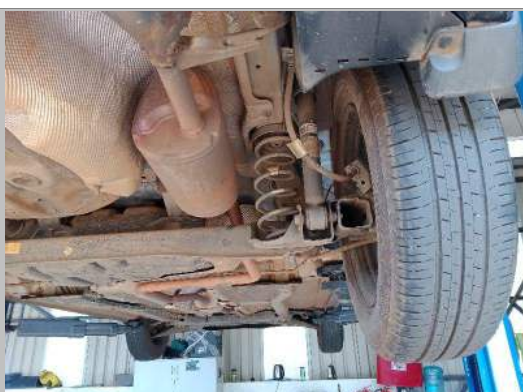
RR TYRE TREAD

| | Size | Load/Speed Index | Manufacture | Model | Type* | Production Date | Tread Depth (mm) |
|---|---|---|---|---|---|---|---|
| Rear Right | 185/65 R15 | 88H | Bridgestone | Ecopia | V | 2525 | 4 mm |

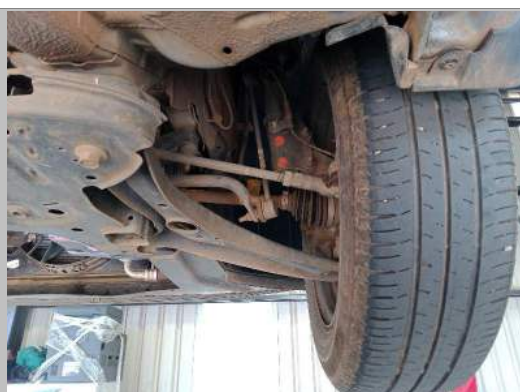
RF TYRE TREAD

| | Size | Load/Speed Index | Manufacture | Model | Type* | Production Date | Tread Depth (mm) |
|---|---|---|---|---|---|---|---|
| Front Right | 185/65 R15 | 88H | Bridgestone | Ecopia | V | 2525 | 4 mm |

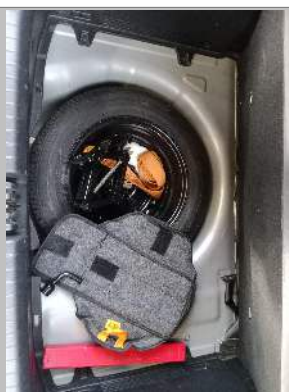
Spare Wheel and Accessories

| | Size | Load/Speed Index | Manufacture | Model | Type* | Production Date | Tread Depth (mm) |
|---|---|---|---|---|---|---|---|
| Spare | 185/65 R15 | 88H | Bridgestone | Ecopia | V | 2525 | 6 mm |

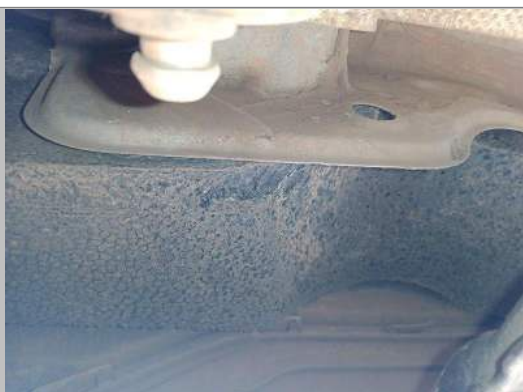
| Rear bumper stiffener damaged | Replace |

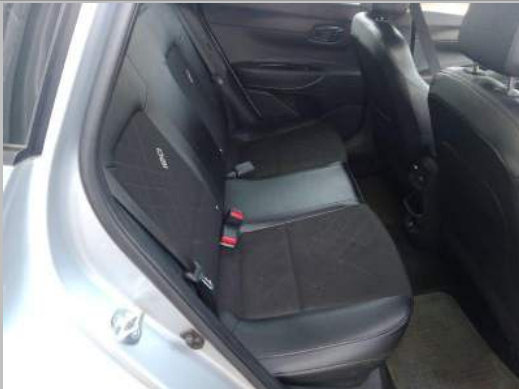
| Seat Rear Dirty | Repair |

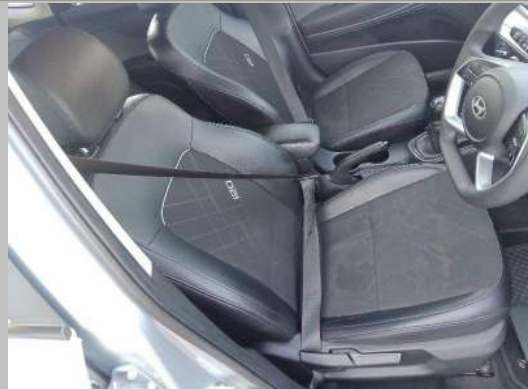
| Seat Front Right Dirty | Repair |

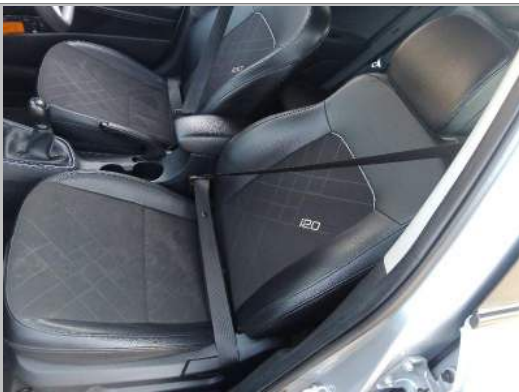
| Seat Front Left Dirty | Repair |

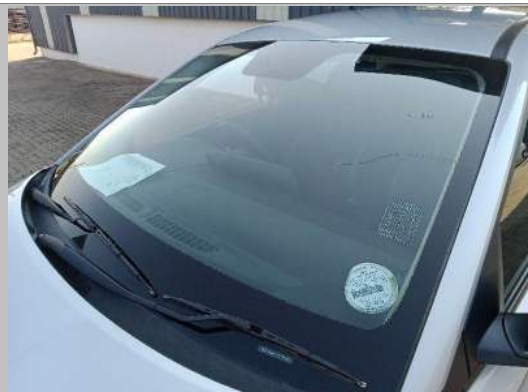
| Windscreen Cracked | Replace |

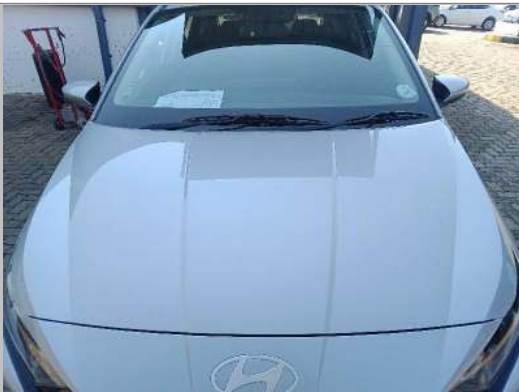
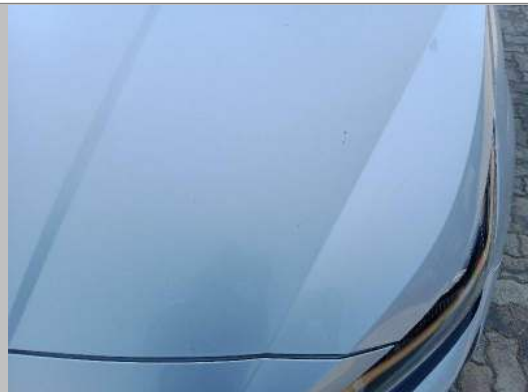
| Bonnet Paintwork • Chipmarks | Repair |

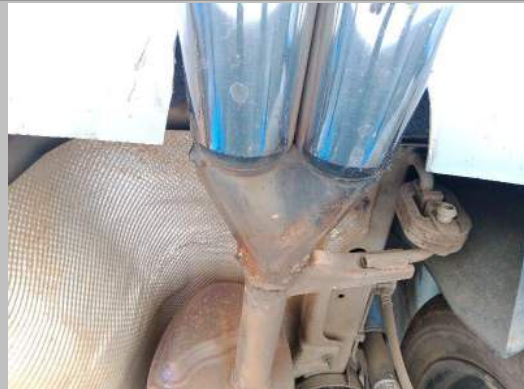
| Engine to silencer pipe Welded | Replace |
