CONDITION REPORT

Report No: 2016421895

Vehicle Type	PASSENGER VEHICLE	Registered Owner	MFC AUCTION HOUSE
Manufacturer	HYUNDAI	Registration Number	HF78PSGP
Model	I20	Register Number	
VIN	MALBM51CLHM350237	Date Of First Licensing	
Engine Number		Last COR	
Doors	5	License Expiry Date	31/01/2024
Color	RED	Power / Displacement	
Year Model		Paint Finish	M - METALLIC
Km Reading	114,260 KM	Fuel	PETROL
Cab / Body Type	HATCHBACK	Transmission	MANUAL

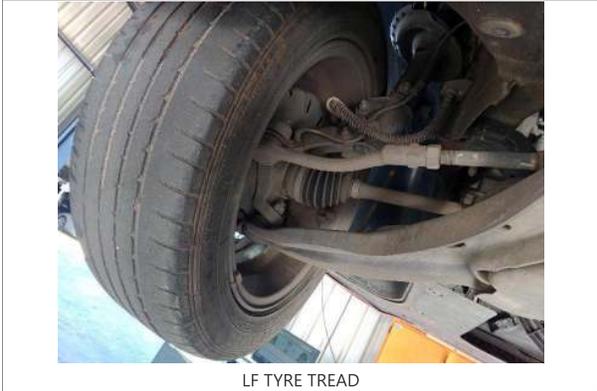
LF TYRE TREAD

Size	Load/Speed Index	Manufacture	Model	Type*	Production Date	Tread Depth (mm)
Front Left	195/55R16	87V	Goodyear	Assurance	V	0117	1 mm
Front Right	195/55R16	87V	Goodyear	Assurance	V	0117	1 mm
Rear Left	195/55R16	87V	Goodyear	Assurance	V	0117	1 mm
Rear Right	195/55R16	87V	Goodyear	Assurance	V	0117	0 mm
Spare	195/55R16	87V	Goodyear	Assurance	V	0000	6 mm

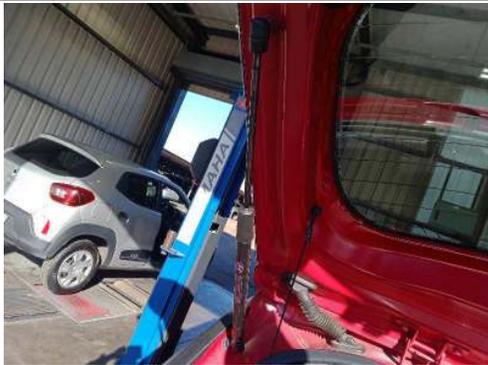
Damage	Repair Way
Front Bumper Paintwork • Scratched	Repair
Door Front Left Paintwork • Scratched	Repair
Door Front Right Paintwork • Scratched	Repair
Boot Lid / Hatch Door Shock Left Defective	Replace
Boot Lid / Hatch Door Shock Right Defective	Replace
Rear bumper Paintwork • Scratched	Repair
Sill Panel Left Damaged	Repair
Sill Panel Right Damaged	Repair
Windscreen Cracked	Replace
Tyre Rear Right Smooth	Replace
Rim Front Left Dented	Repair
Body exterior	Signs of spray work done on some body panels
Axle and suspension	Both front control arm bushes covered
